Scour at the Seawall in Surfside, Texas, During Hurricane Harvey (2017)

ABSTRACT: *Hurricane Harvey was a Category 4 hurricane on the Saffir-Simpson hurricane wind scale. National Oceanic and Atmospheric Administration (NOAA) water level gages documented 1.1 m of water level elevation over predicted tide in Freeport, Texas, on 25 – 26 August 2017. The NOAA wave buoy 42019 offshore off Freeport documented wave heights > 7 m. A reconnaissance team of the Geotechnical Extreme Events Reconnaissance (GEER) Association visited Surfside, Texas, on 3 September 2017. While no significant damage to infrastructure was observed, the GEER team identified a significant scour runnel parallel to the Surfside seawall. The purpose of this article is to present the detailed observations of the scour runnel parallel to the Surfside seawall during Hurricane Harvey (2017). The sloped seawall is separating a shore-parallel street from the beach and is composed of angular boulders of approximately 30-50 cm in diameter. The observed runnel represented a depression of up to ~ 0.3 m in depth and ~ 4 m in width. It maintained mostly a distance of 0-5 m from the visible toe of the seawall. Boulders seemed par

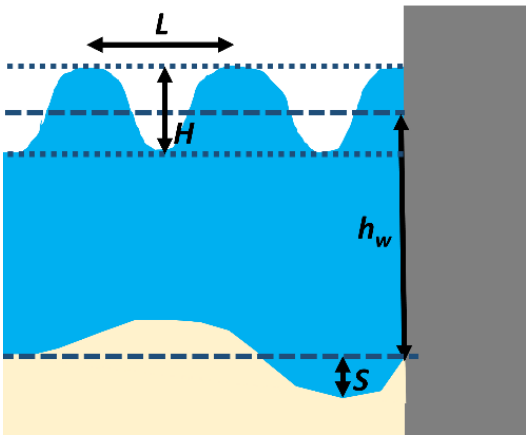
Figure 1. Schematic drawing of a vertical seawall (grey), seabed (beige), and water conditions (blue) introducing relevant symbols: scour depth in front of the seawall S, still water depth at the seawall h_w, wave length L, and wave height H.

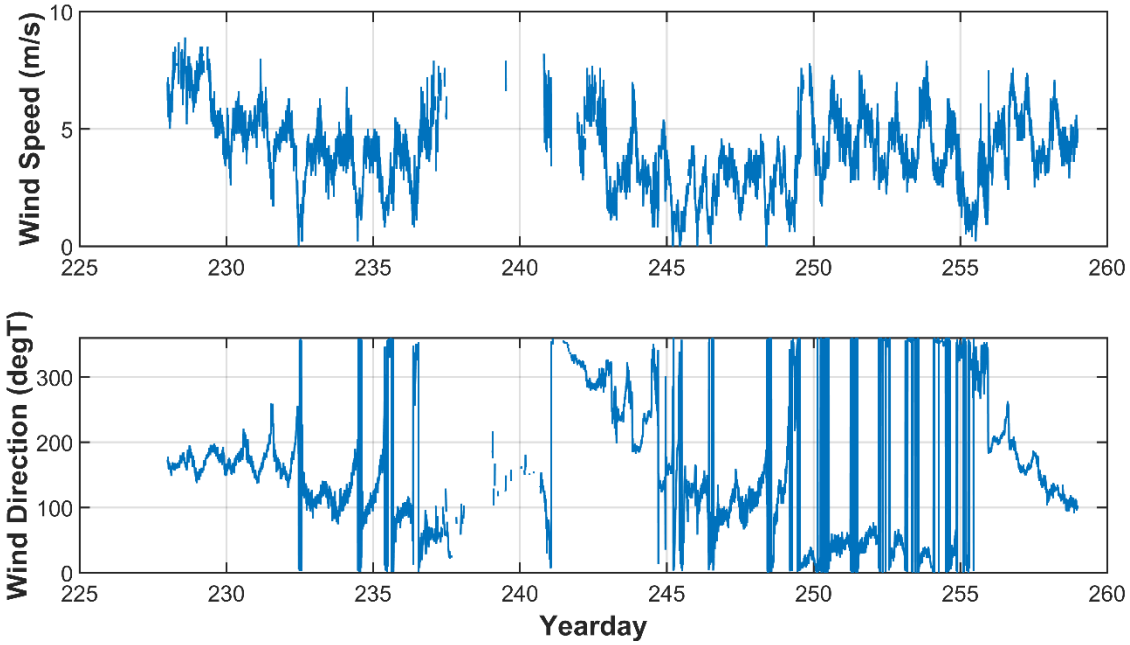
Hurricane Harvey made landfall east of Rockport, Texas, on 25 August 2018, (yearday 237; i.e., day 237 of the year) with estimated sustained wind speeds of about 60 m/s (Blake and Zelinsky 2018). Figure 3 shows the wind data collected at NOAA (National Oceanic and Atmospheric Administration) station FPST2 (8772471) close to Freeport. Wind speeds approximately two weeks before and after Hurricane Harvey's landfall in Texas ranged from phases of approximately 3 m/s to about 8 m/s, and increased rapidly with the approach of Hurricane Harvey. No wind speeds were measured during the hurricane impact on this area and at this station. However, the wind direction developed from approximately 80° (approximately from the East) to approximately 180° (from the South) from yearday 237-246. Wind speeds stabilized to mostly < 5 m/s on yearday 243.

Figure 3. Recordings of wind speed (m/s) and wind direction (degrees from true North) from NOAA station FPST2 (8772471) close to Freeport, Texas, (28.936°N 95.294°W) from 16 August (yearday 228) to 15 September 2017 (yearday 258; landfall of Hurricane Harvey close to Rockport occurred on yearday 237).

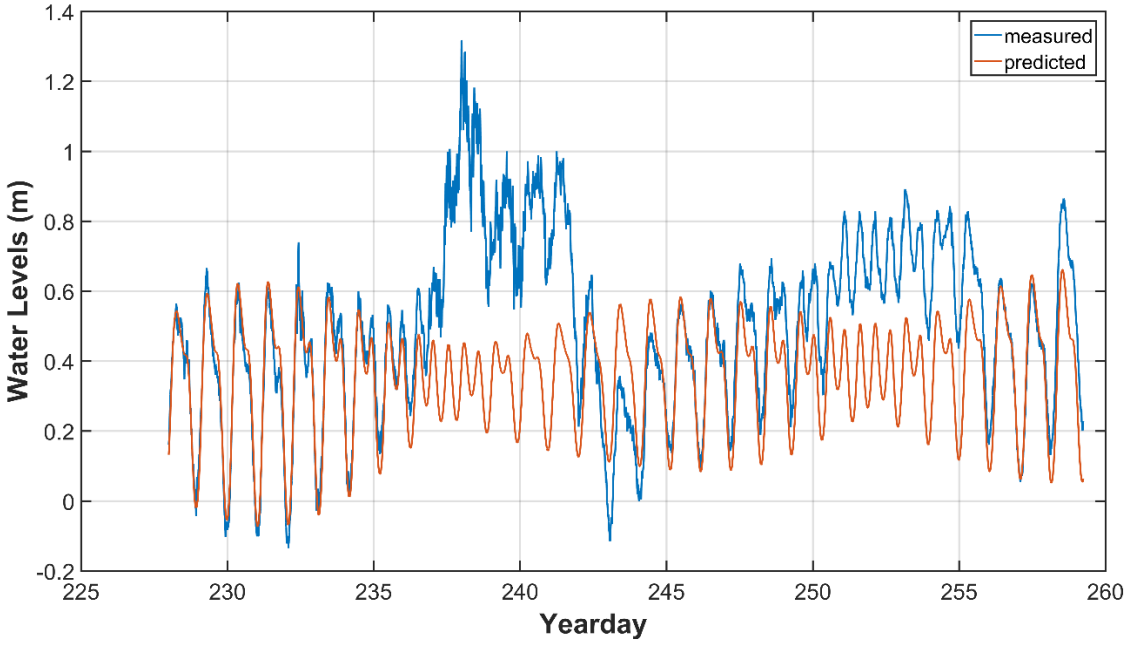
Measured water levels matched the tidal predictions reasonably well up to yearday 236 (Fig. 4). Neap tide conditions with water elevation fluctuating from about 0.2-0.45 m from mean lower low water were predicted for yeardays 236-238. However, the water levels reached up to about 1.3 m on yearday 237 and up to 1 m until yearday 242. Water levels were measured ~ 0.2 m lower than predicted values on yeardays 243-244 before approaching predicted values again. Another phase of elevated water levels in the same month was observed from yearday 251-255 with a water levels being elevated by about 0.3 m

compared to the predicted values. The station is located in the Freeport port entrance in a small embayment on the Surfside Beach side. Effects of the embayment and entrance morphology on the measurements in comparison to the open ocean front of Surfside Beach must be considered.

Figure 4. Measured (blue) and predicted (orange) water levels at NOAA station 8772447 close to Freeport, Texas, (28.943°N 95.302°W) from 16 August 2017 (yearday 228) to 15 September 2017 (yearday 258). The water levels are displayed in relation to mean lower low water (average of the lower low water height observed over the U.S. National Tidal Datum Epoch (NOAA 2019).

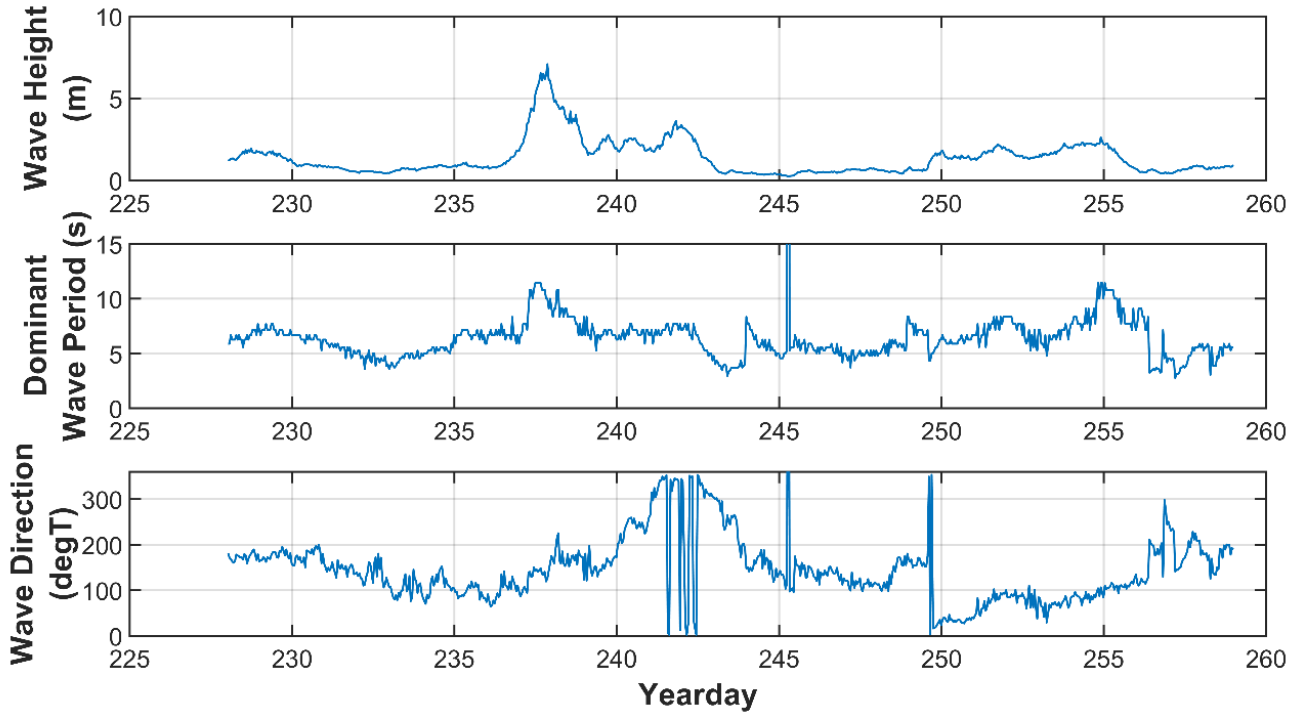
Wave data were collected at NOAA station 42019 (LLNR 1205), being located 60 nautical miles south of Freeport at a water depth of ~ 82 m (Fig. 5). The measured values can be considered deep-water conditions. Wave heights were generally low in the investigated month with significant offshore wave heights mostly < 2 m, and wave periods ~ 5.5 s. On yearday 238, significant wave heights of ~ 7m with dominant wave periods of ~ 11 s were recorded, followed by significant wave heights of 2-4 m with dominant wave periods of 7-9 s until yearday 243. Waves came mostly from the South (~ 180°) during the event, and turned to the opposite direction toward the end of the wave event.

Figure 5. Significant wave heights (top panel), dominant wave periods (center panel), and wave direction (bottom panel) at NOAA station 42019 south of Freeport, Texas, (28.907°N 95.359°W) from 16 August 2017 (yearday 228) to 15 September 2017 (yearday 258).

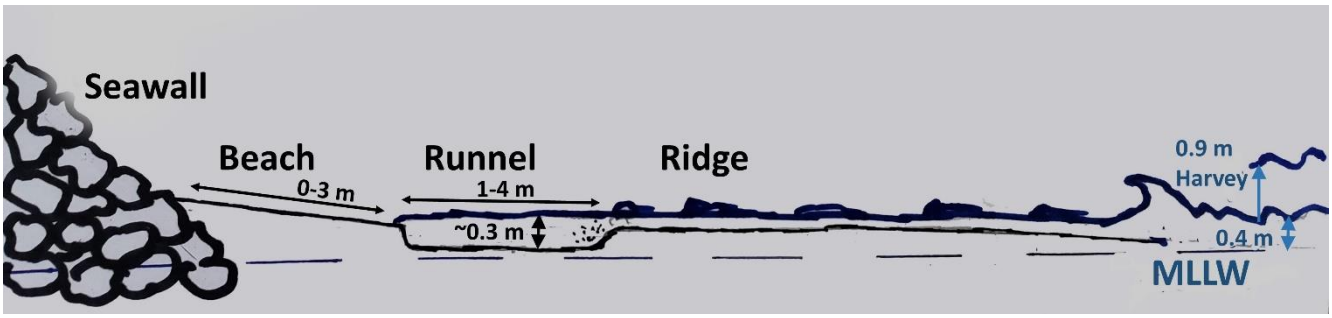
A conceptual sketch of observations is provided in Figure 8. Overall, the runnel appeared to have formed through scour, which was driven by breaking or reflected waves from the seawall. It should be mentioned that the tidal level at the time of the observations was approximately 0.4 m above mean lower low water based on NOAA gage 8772447. This means that during Hurricane Harvey local water levels may have been up to 90 cm higher, submerging the beach entirely.

Figure 8. Conceptual sketch of observations by the GEER team at Surfside beach (yearday 246; 20:00 UTC).

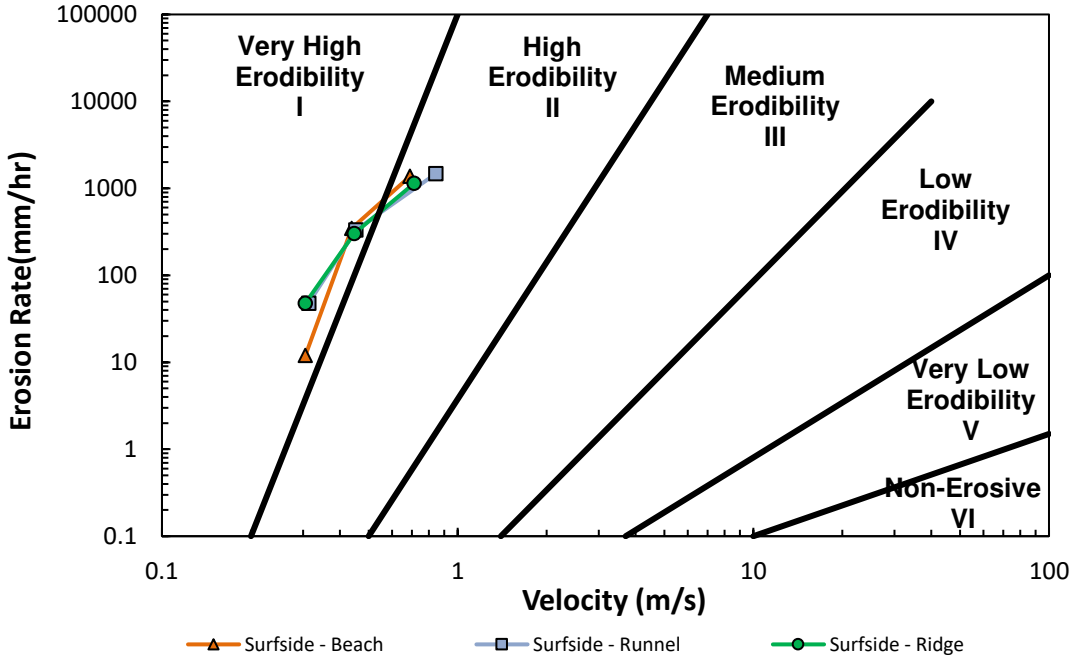
The samples were remolded in the soil erosion laboratory at Texas A&M University. The samples were compacted in three equal layers in Shelby Tubes using a standard compaction hammer to achieve a minimum of 18 kN/m^3 total unit weight. Erosion Function Apparatus (EFA) tests were performed on each of the samples to investigate the erodibility of the material following the procedure outlined in Briaud (2001) and Briaud et al. (2017). The EFA measures the relationship between the erosion rate, water velocity, and hydraulic shear stress at the soil-water interface. Erosion rate was measured in terms of mm of sample height per hour for flow velocities of 0.306 m/s, 0.438 m/s, and 0.691 m/s, corresponding to shear stresses of 0.339 Pa, 0.672 Pa, and 1.55 Pa, respectively. Results for all three samples are shown in Figure 9, classifying the samples at the border of very highly erodible to highly erodible.

Figure 9. Summary of EFA test results.

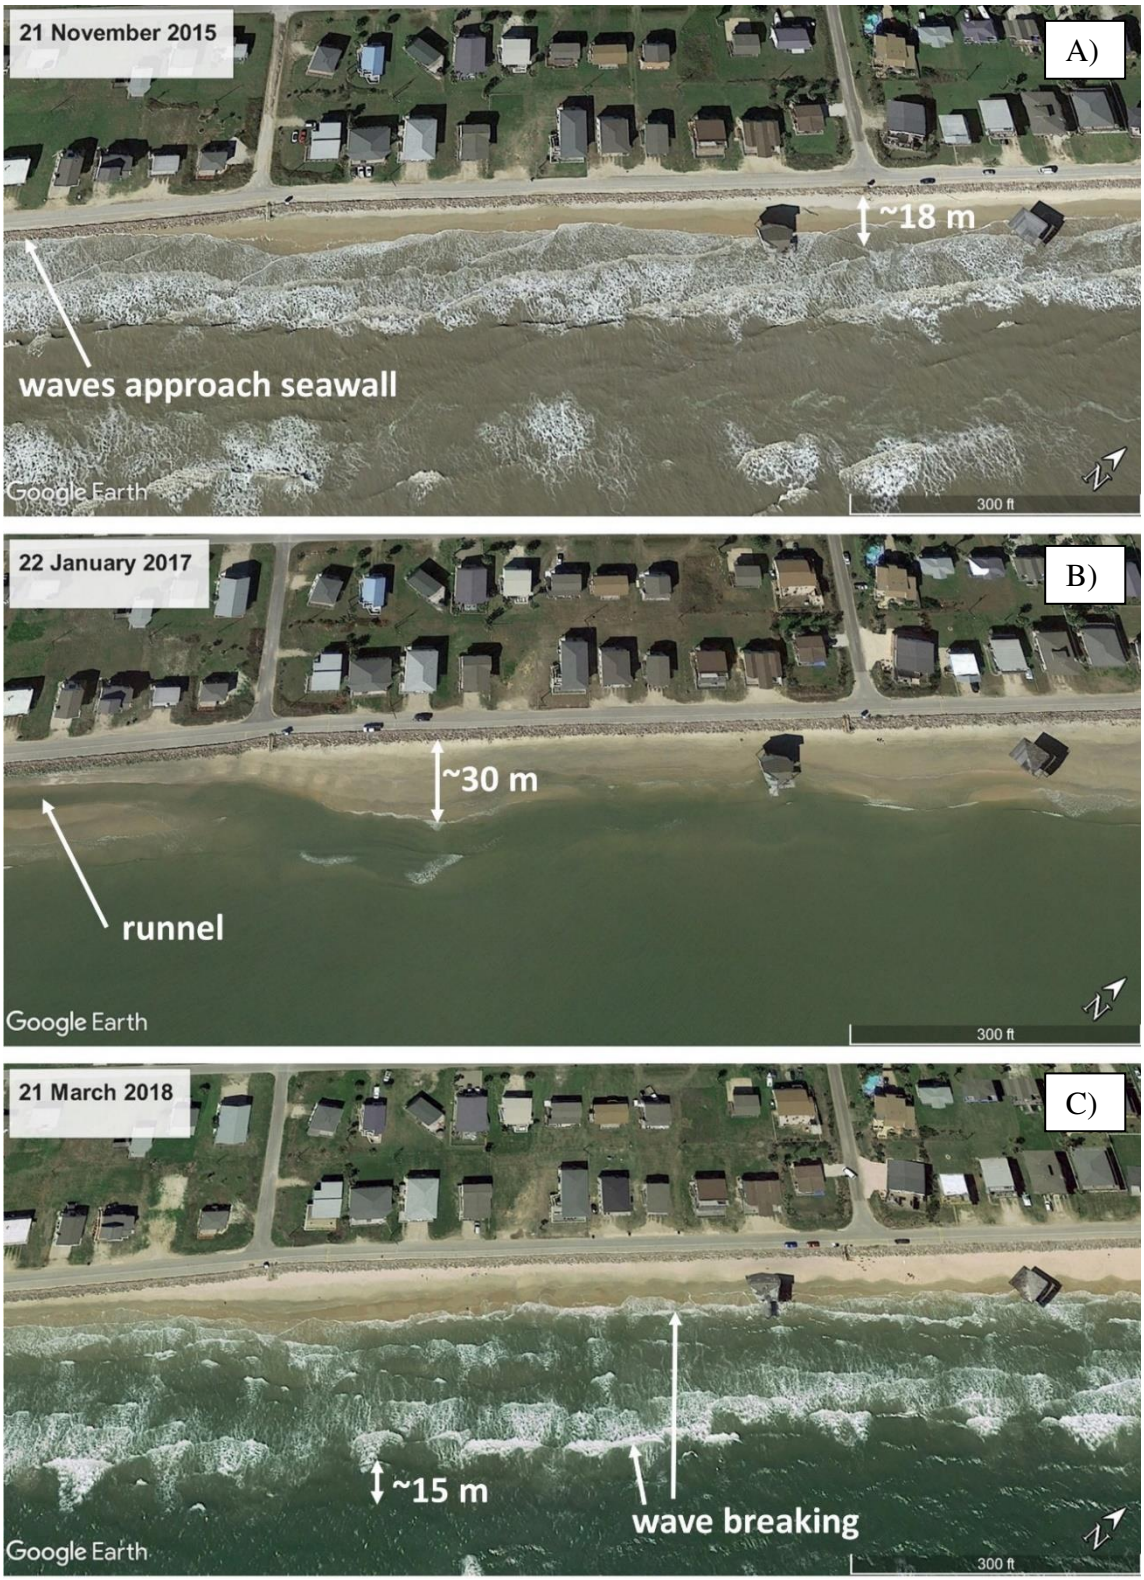
A runnel system is clearly visible with beach widths from less than 2 m to 30 m, and associated variations in the position of the runnel. The runnel width varied similarly to the development of the runnel from less than a meter to about 10 m. It should be noted that wave conditions were overall rather energetic in this month, despite calm conditions at the time of the image. On 21 March 2018, waves were more visible in the image again, having crest-to-crest wave lengths of about 15 m in the area of interest in the image. The beach width reached from 5-20 m, and some wave breaking is visible at the shoreline, while dominant wave breaking occurred at a distance of ~ 60 m from the shoreline. It should be noted that water levels varied for the imagery. On 21 November 2015, water levels were about 0.75 m above mean lower low water at NOAA gage 8772447 at approximately noon local time (being a typical time for optical satellite imagery), and were about 30 cm higher than the predicted tide. On 22 January 2017 at noon local time, the actual water level was 0.12 m above mean lower low water, being about 10 cm lower than the predicted tide. On 21 March 2018 at noon local time, the actual water level was 0.34 m, being within 5 cm from the predicted values.

Figure 10. Google Earth satellite imagery from the area of interest at Surfside Beach well prior to and post Hurricane Harvey (Google Earth 2018a-c for panels A, B, and C, respectively).

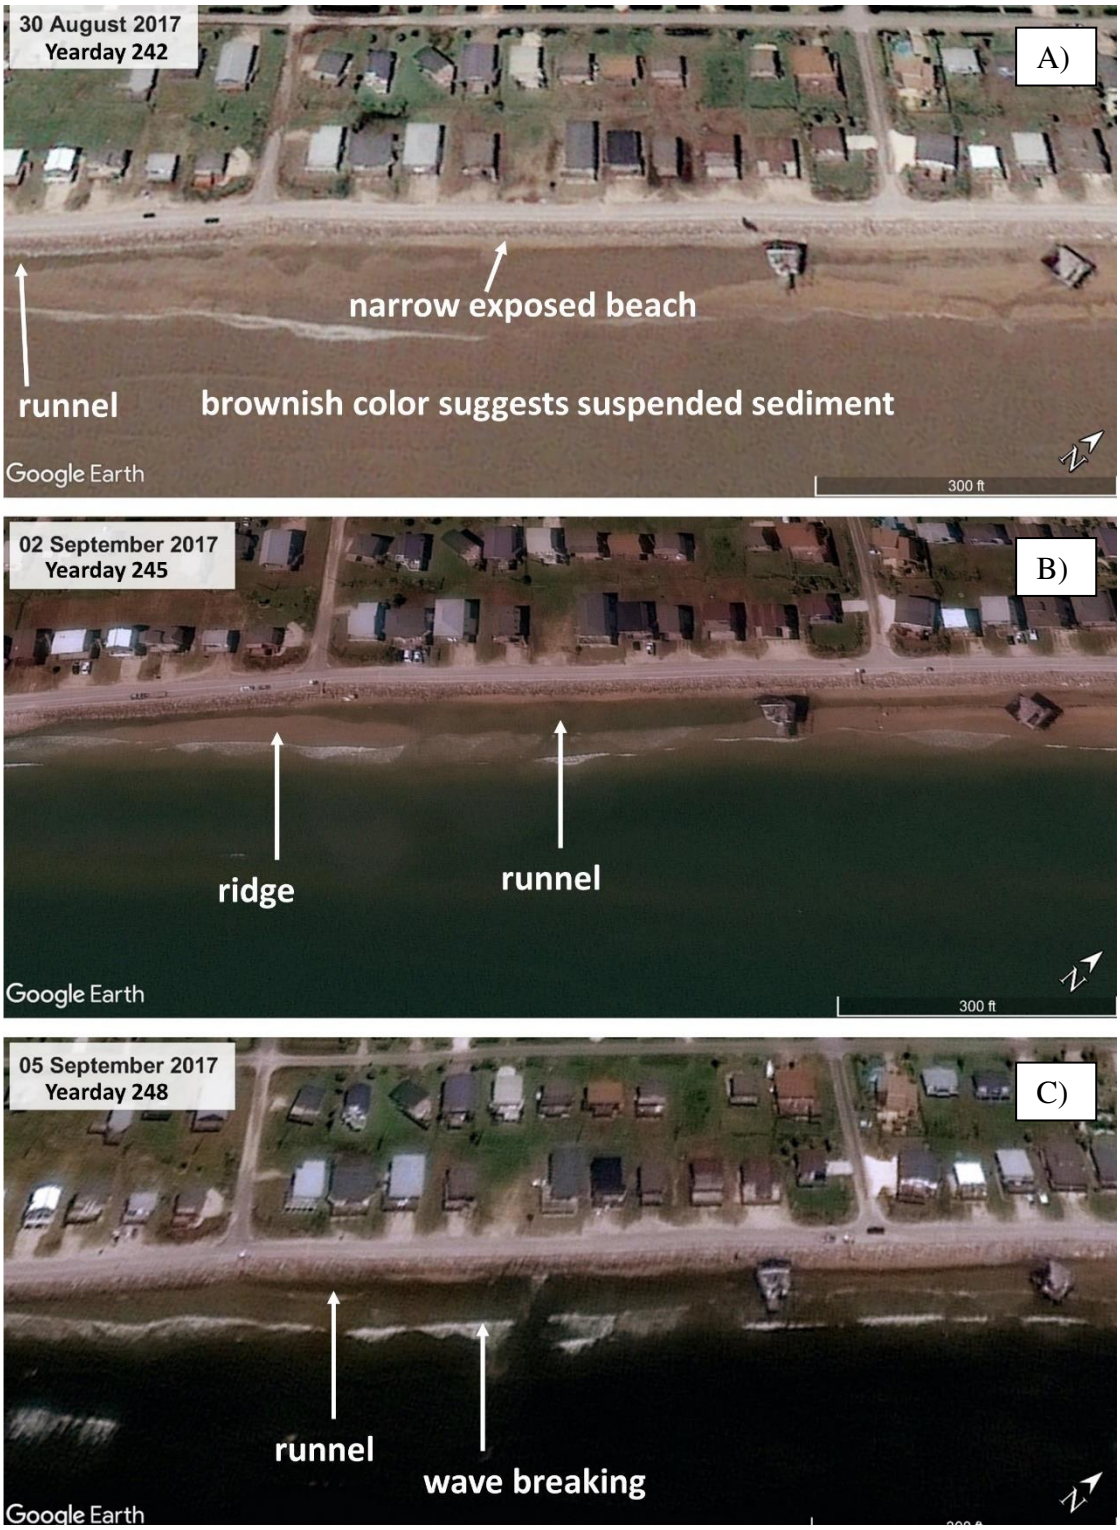
Figure 11 shows satellite images from yeardays 242 (30 August 2017), 245, and 248 during the Hurricane Harvey event. Only yearday 242 still featured elevated water levels in Freeport and somewhat larger offshore waves (Figs. 4 and 5). However, it should be noted that the measured offshore waves were mostly directed offshore at that time (Fig. 5). The satellite image from yearday 242 clearly shows a large amount of suspended sediments in the water. The beach width is narrow (0-7 m) in front of the seawall in the area of interest. It should furthermore be noted that a clearer morphology may not be visible due to the murkiness of the water from suspended sediments. The evolution of a thin runnel close to the seawall (0-4 m) and a partially less well-developed ridge appear visible. Some wave breaking is visible about 35 m from the seawall.

On yearday 245, the day prior to the visit of the GEER team, a well-defined ridge-runnel is visible with a beach width of 0-4 m, a runnel width of 3-10 m, and some wave breaking at the offshore edge of the ridge at a distance of ~ 25 m from the seawall. Imagery may suggest a second ridge at a distance of ~ 50 m from the offshore edge of the clearly visible ridge.

Figure 11. Satellite imagery from the area of interest at Surfside Beach. Images were displayed in Google Earth. Panel A) Yearday 242, collected by Pleiades 1 with an image resolution of 50 cm; Panel B) Yearday 245, collected by WorldView 3 with an image resolution of 30 cm; Panel C) Yearday 248, collected by WorldView 2 with an image resolution of 50 cm.

On yearday 248, the runnel is still visible. However, a decrease in width and a loss in height of the ridge seems to be indicated by the image. Again, assuming that imagery was collected around noon local time, some minor differences in water level must be expected (Fig. 4).

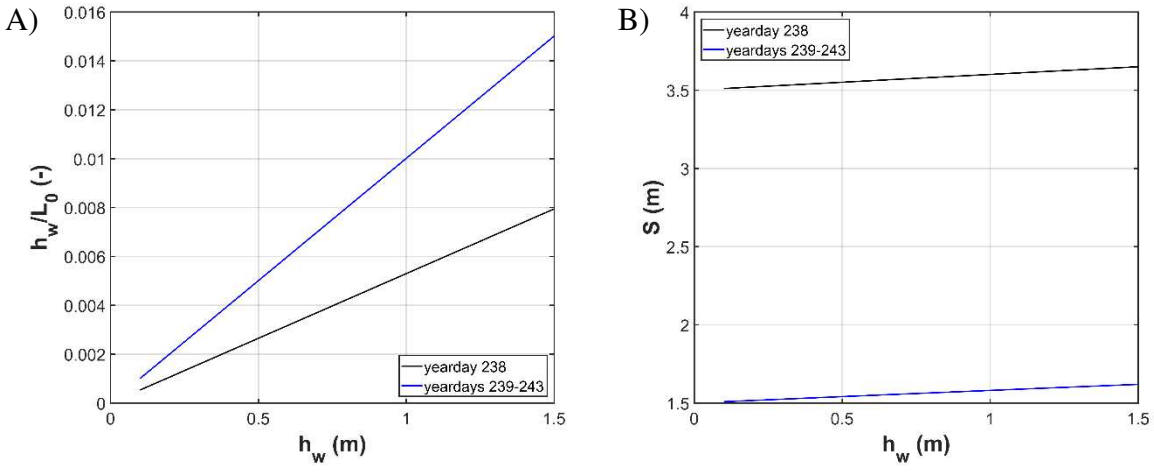
Both scour assessment expressions shown in Equations 1 and 2 were tested. The following parameters were used: H_0= 7 m on yearday 238 and H_0= 3 m on yeardays 239-243; T= 11 s on yearday 238 and T= 8 s on yeardays 239-243; h_w ranging from 0.1-1.5 m, an estimated beach slope of 5°, and a grain size of 0.2 mm. The deep-water wave length was calculated using the dispersion relationship. Results using Equation 1 are shown in Figure 14. Figure 14 also depicts the relationship between h_w/L_0 within the tested range of h_w, showing that the conditions lie within the applicable range of -0.011 < h_w/L_0 < 0.045 for Equation 1 by Fowler (1992). The scour depth is clearly over-predicted (about ten times deeper than observed; Fig. 14 right). Equation 2 led to even larger over-predictions. This is not surprising, as these expressions were developed for vertical wall seawalls, breaking waves, and the associated scour at the seawall. Also, these expressions do not take into account the irregularity of the waves, amongst other limitations. Sumer and Fredsoe (2000) suggested a relationship between the angle of the sloped rubble-mound seawall, the ratio of water depth over wave length h/L, and the ratio of scour depth and wave height S/H. Assuming $0.05 \leq h/L \leq 0.1$ (for example, 1 m in water depth and 20 m in wave length), and a slope of 30-40°, S/H equals 0.1-0.7. To generate a scour depth of 30 cm, wave heights between 0.4-7 m would be needed, being well within the possible range.

Figure 14. A) Water depth at the seawall h_w vs. the relationship between h_w and the deep water wave length L_0 for conditions on yearday 238 (black) and yeardays 239-243 (blue). B) Estimated scour depths S within the same days and range of h_w after Equation 1 (Fowler 1992).
