A Constructability Problem in a Deep Shoring System

Submitted: 27 December 2018; Published: 21 May 2021
Reference: Köpüklü H., Ekli O., Akçakal Ö., Durgunoğlu H. T. (2021). A Constructability Problem in a Deep Shoring System. International Journal of Geoengineering Case Histories, Volume 6, Issue 1, pp. 53-66, doi: 10.4417/IJGCH-06-01-03

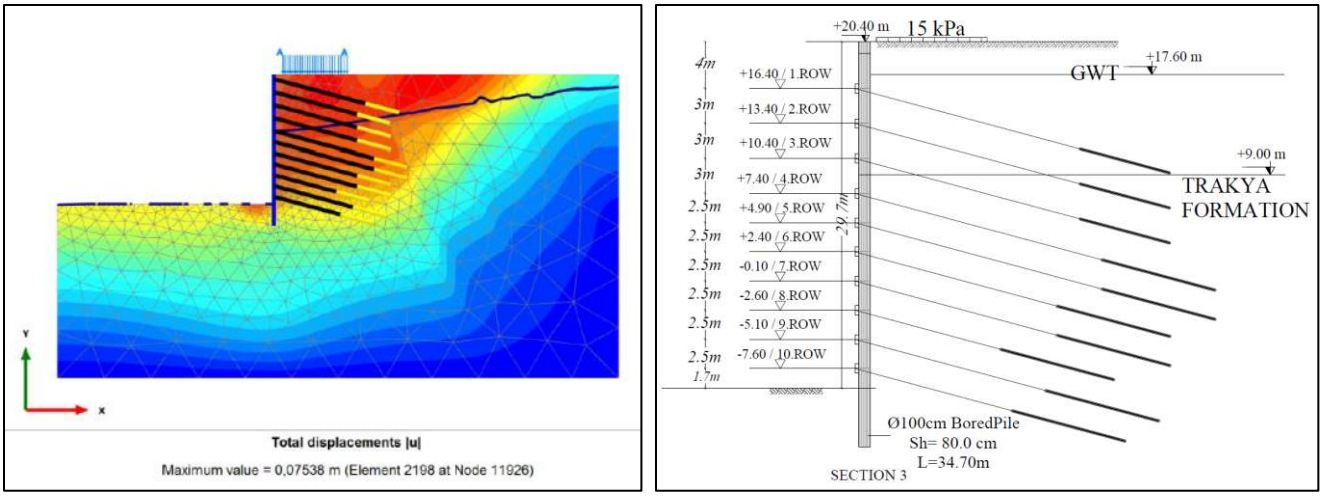
Figure 7. Section View of the Retaining System.

Three types of anchors were used for the calculations. Type 1 has 4.0m-20.0m free length, 8.0m grout length, at a 15º angle from the horizontal placed with 3.20m spacing in alluvial units. The other two are located in the rock unit. The first has 20.0m free length, 8.0m grout length, at a 15º angle from the horizontal (Type 2) placed with 1.6m spacing. The second has 17.0m-22.0m free length, 10.0m grout length, at a 15º angle from the horizontal (Type 3) placed with 1.6m spacing. Ten (10) levels of prestressed anchor rows are considered in the analysis.
