Asynchronous Mobilization of Shear Resistance in Slope Failures

Submitted: 30 November 2021; Published: 25 July 2022
Reference: Zabolotnii, E., Morgenstern, N. R., and Wilson G.W. (2022). Asynchronous Mobilization of Shear Resistance in Slope Failures. International Journal of Geoengineering Case Histories, Volume 6, Issue 3, pp. 54-72,
doi: 10.4417/IJGCH-06-03-03

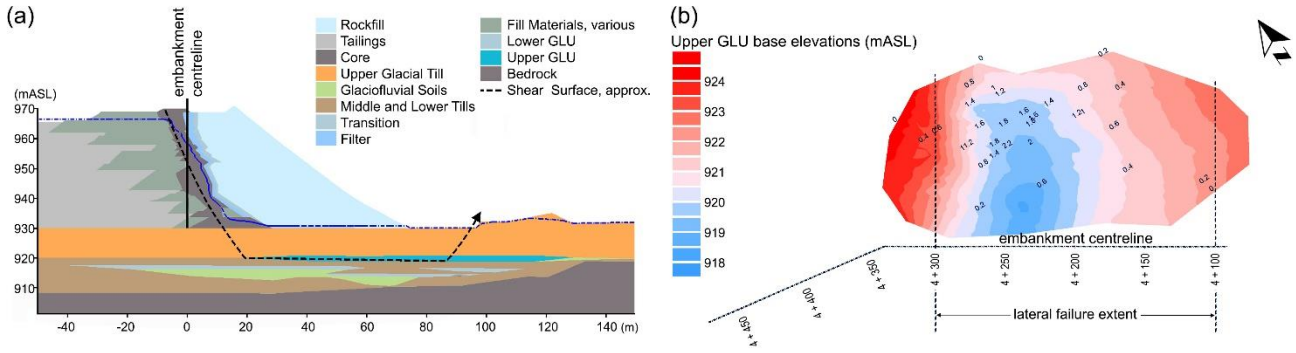
Figure 2. (a) Pre-failure profile of embankment and foundation soils at the failure location, based on KCB's (2015) interpretation; (b) Plan view of the Upper GLU with base elevations and labeled deposit thickness (m) showing slide extent at base.

The soil profile at the failure location, seen in Fig. 2a, was shaped by a complex depositional history involving three or more glaciation periods. Three distinct glacial till deposits, designated as the upper, middle, and lower tills, were separated by discontinuous interstitial deposits of glaciofluvial and glaciolacustrine provenance, including the Upper GLU, a varved deposit consisting of 1-clayey (CL-CH) layers alternating with ~1mm lamina of silt and fine sand (KCB 2015, p. 22). This deposit was located ~10m below original ground, and was spatially limited to a ~300m long, ~200m wide "pancake" with a thickness of ~2m in the middle, tapered to near-zero towards the edges. The disturbance and large shear displacements in this deposit but not below it, along with the good agreement between its spatial location and the lateral extent of slippage at base (sketched in Fig. 2b and evidenced by the ground uplift at the slide's toe, seen in Fig. 4, feature U) underscore its critical role in the failure (IRP 2015, pp. 21-22). The Upper GLU was closely examined and subjected to extensive in-situ and laboratory testing.

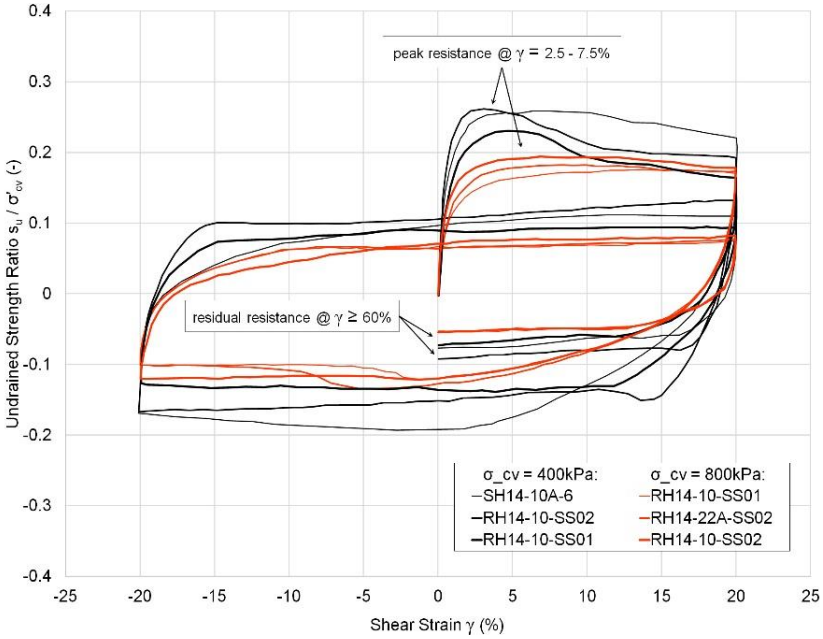
Figure 3. Upper GLU's response to shearing in the DSS tests in the range of vertical consolidation pressures corresponding to a state of normal consolidation in this unit (based on select data adapted from KCB 2015, Fig. 5.23)

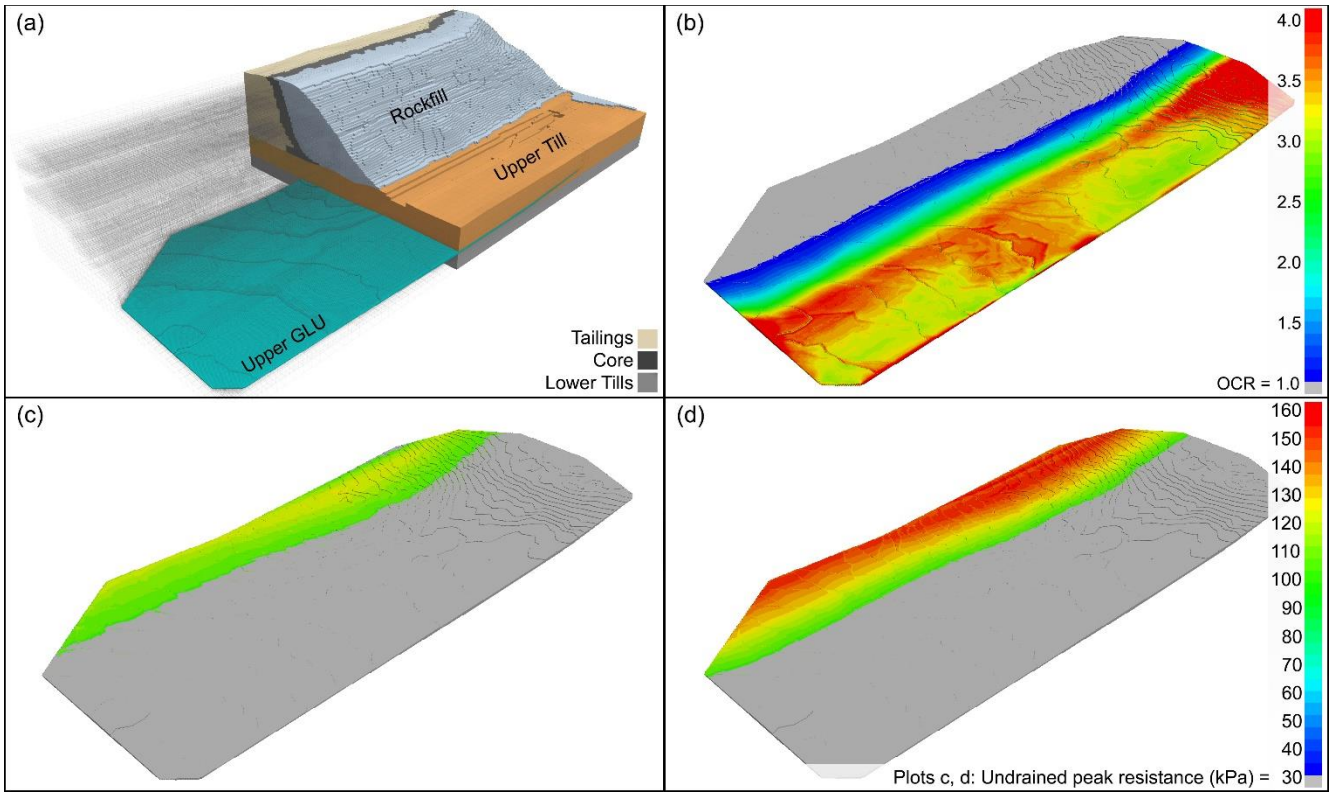
Figure 5. (a) The three-dimensional model of the failure location in Stage 9B (pre-failure) shown in a cross-sectional view through the middle of the slide; the rest of the domain rendered as a mesh, and the Upper GLU is rendered in full; (b) View of the Upper GLU in Stage 9B showing overconsolidation ratios; the rest of the model is rendered invisible; (c), (d) Views of the Upper GLU in Stages 5 and 9B, respectively, showing peak undrained resistance in the normally consolidated zone.

In the simulation, the Upper GLU's transition from an overconsolidated to a normally consolidated state denotes a change in its mechanical response from drained to undrained. The Upper GLU material under the crest becomes normally consolidated by Stage 5. With growing embankment heights, this zone continues to expand until Stage 9A, encompassing, prior to collapse, ~¼ of its total area. The extent of the normally consolidated zone at failure is pictured in Fig. 5b.

The hardening of the Upper GLU is illustrated in Fig. 5c-d. Unlike other changes in the Upper GLU described here, its consolidation-induced hardening has a beneficial effect on the stability of the structure, buffering it to some degree against failure.

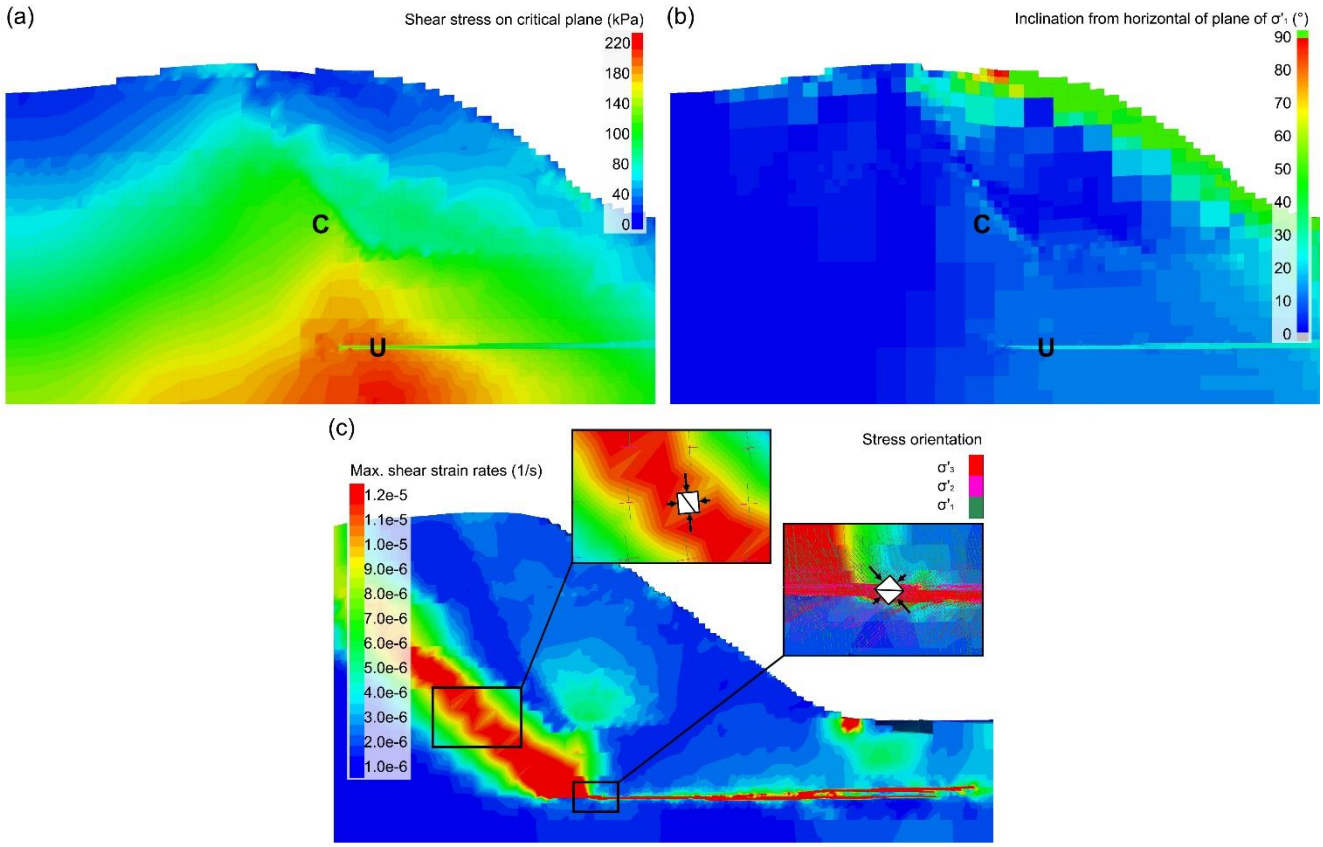
A region of high shear stresses develops in the core and below it (Fig. 6a). At this location, the Upper GLU, being the weakest of the units, is the first material to reach yield; this takes place as early as Stage 5. Its yielding is evidenced by the band of

Figure 6. A cross-sectional view through the middle of the slide showing: (a) shear stresses on the critical plane after the adjustment to Stage 6 loads; (b) the deviation from horizontal of the plane of major principal stress after the adjustment to Stage 6 loads; and (c) maximum shear strain rates, the orientation of principal stresses, and of the planes of critical stress at an advanced point of collapse in Stage 9B. Labels: C – core; U – upstream portion of the Upper GLU.

lower shear stresses indicating that a downward adjustment had taken place within this unit. This material is mobilizing plastic shear strain.

The reorientation of the planes of critical stress influences the position and alignment of the slip surface. This effect is illustrated in Fig. 6c, showing the inclination of principal stresses and that of the planes of critical stress at two key locations, the core and the upstream portion of the Upper GLU, superimposed on the plot of maximum shear strain rates in the cross-section through the middle of the slide at an advanced point of collapse. The plot demonstrates the good alignment of critical planes with the dominant shearing directions at large shear strains during failure. One may surmise that these processes are mirrored in situ, although confirmatory evidence is indirect in the form of matching performance as stress tensors are calculated, not measured.

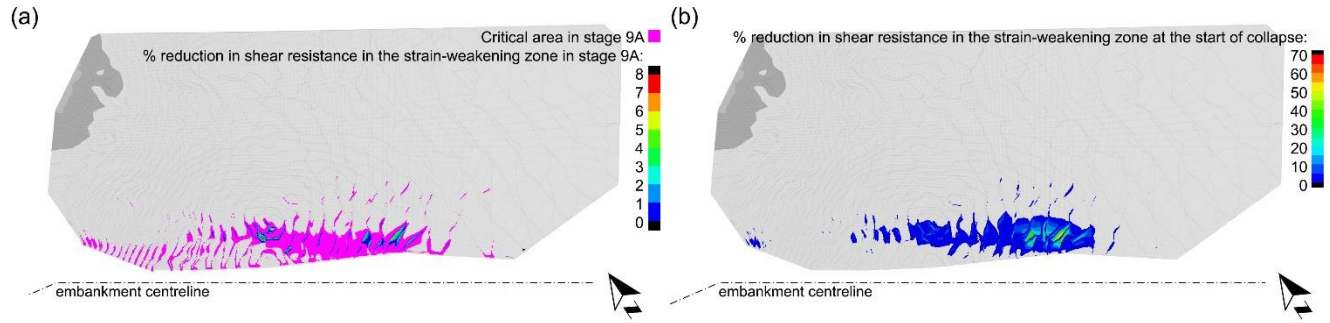
Figure 7. Plan view of the Upper GLU. (a) The critical area and the strain-weakening zone with % strength reduction below peak in Stage 9A. (b) The strain-weakening zone at the onset of global failure with % strength reduction below peak.

after the adjustment to Stage 9A loads is estimated at 4,000-6,000m^2 (Fig. 7a). This material engulfs the strain-weakening zone.

In the Mount Polley numerical analysis, the onset of global failure is precipitated by a surge in the aggregate rate of loss of shear resistance to strain-weakening largely owing to a ~30-fold areal expansion of the strain-weakening zone. The expansion of this zone after the application of Stage 9B loads is illustrated in Fig. 7, showing side-by-side its areal extent at the end of Stage 9A and at the onset of global failure. The figure showcases the good agreement between the locations of the critical area in Stage 9A and the strain-weakening zone at the onset of global failure.

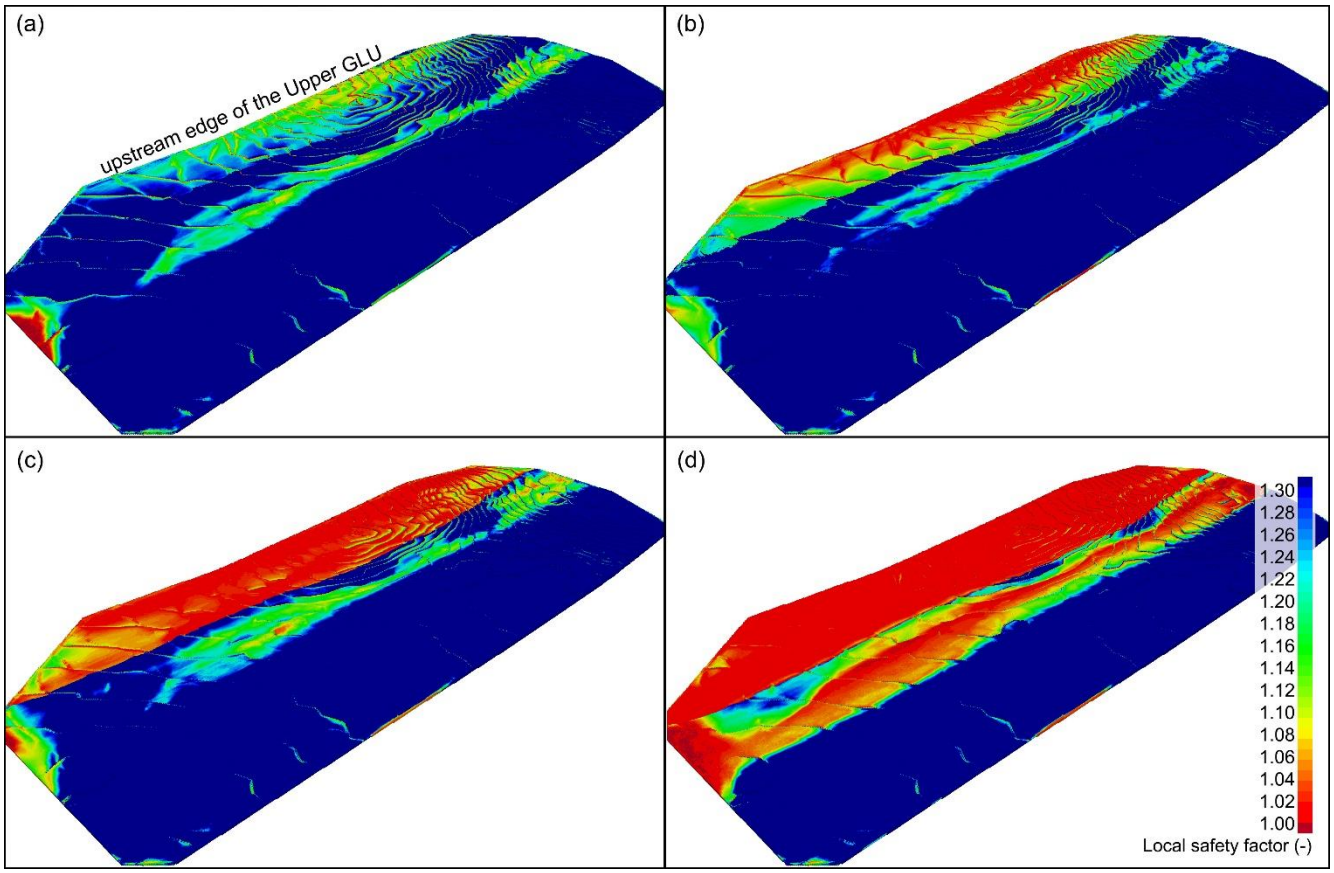
Figure 8. Plots of local safety factors in the Upper GLU after the adjustment to loading conditions corresponding to: Stages (a) 5, (b) 6, (c) 7, and (d) 8 respectively.

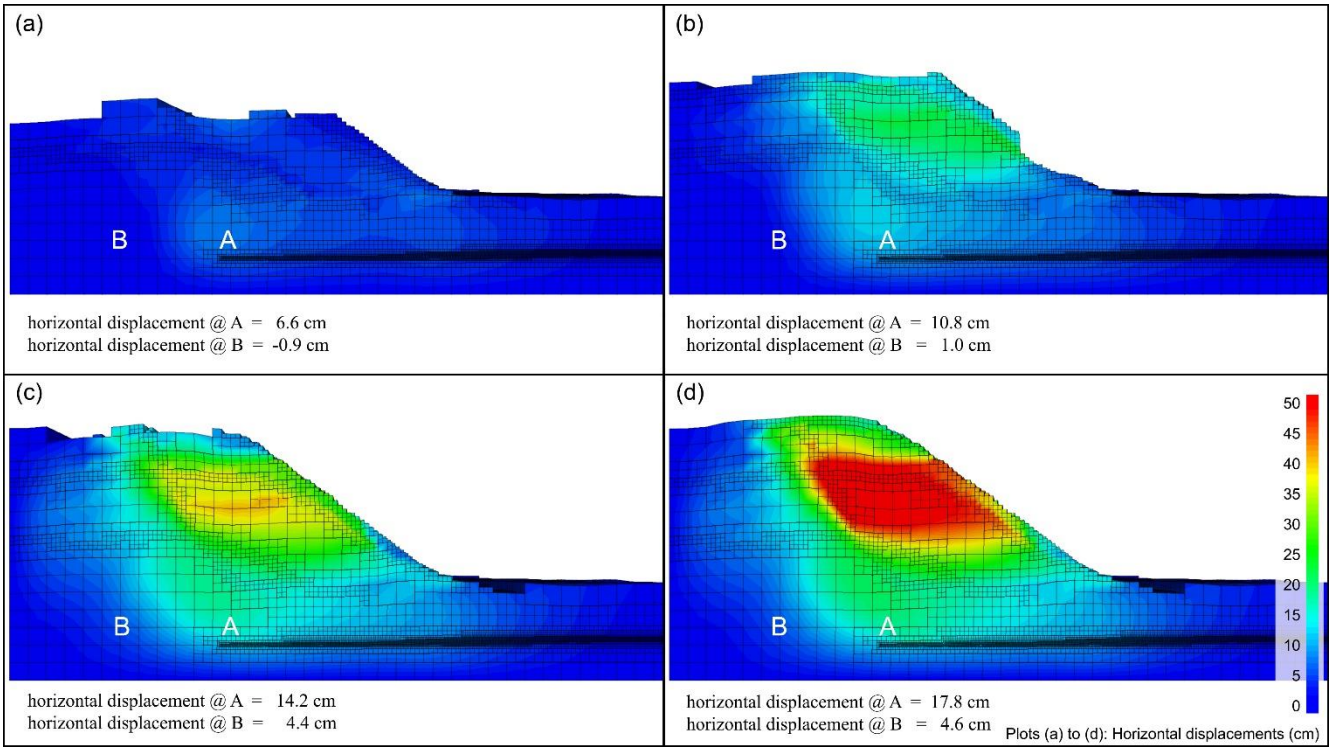
Figure 9. A cross-sectional view of the fine model through the middle of the slide showing horizontal displacements in the downstream direction in Stages (a) 5, (b) 7, (c) 9A, and (d) 9B at the start of Phase II. Labels: A – the upper till above the strain-weakening zone; and B – the upper till on the upstream of the slide (adapted with permission from Zabolotnii 2020, Figure 6.11).

Finally, ongoing plastic processes in the Upper GLU cause an accumulation of shear displacements in this region, predominantly in the downstream direction. Starting around Stage 7, the upper glacial till deposit located directly above the Upper GLU carried with it. Figure 9 illustrates the horizontal displacements in the downstream direction of the slide at its mid-point. Point A, located in the upper till above the strain-weakening zone in the upstream region of the slide, displaces by ~6.6cm in Stage 5 (Fig. 9a), and by ~14.2cm in Stage 9A (Fig. 9c); in contrast, point B, located in the upper till immediately upstream of the failing soil mass, is displacing considerably less. These displacements suggest that, to accommodate the growing shear displacements in the foundation, the upper till is extending. In the figure, the horizontal displacements in the upstream region of the slide (point A) increase from ~7cm in Stage 5 to ~14cm in Stage 9A.

After the addition of Stage 9B loads, the foundation materials, already at yield, respond by straining. The critical area begins strain-weakening, causing an upsurge in the rate of loss of shear resistance. The broader Upper GLU deposit surrounding the strain-weakening zone, also at yield, is now readily accumulating plastic shear strains approaching the onset of strain-weakening. Associated with the increase in the rate of strain-weakening is a renewed accumulation of shear displacements in the downstream direction. The glacial till above it continues to accommodate these displacements until 500-3,000 mechanical steps into the simulation; at this point, the differential horizontal displacements in this unit above the strain-weakening zone increase to ~14-18cm, up from 12-14cm prior to the addition of new loads (Fig. 9c-d).

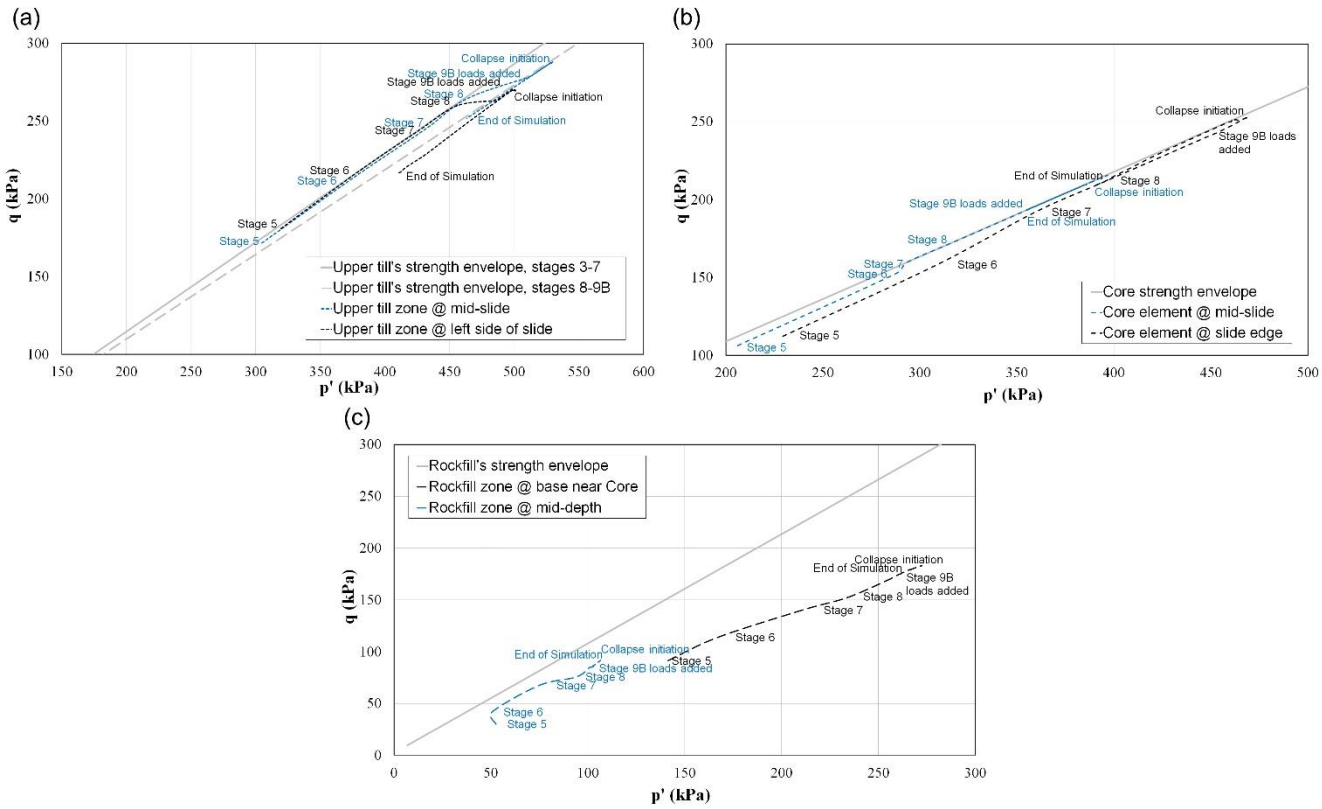
Figure 10. (a,b,c) Stress states in representative elements of the upper till and core materials in the upstream regions of the slide, and in the rockfill, respectively.

About 500-3,000 mechanical calculation steps after the addition of Stage 9B loads (depending on the location in the failing soil mass), the stress response in the till unit changes qualitatively: in this region, the effective stress states, which until this point were experiencing a steady increase in response to growing loads, are now decreasing owing to a relaxation of confining stresses. This produces, among other things, a gradual reduction in the levels of mobilized shear resistance acting along the planes of critical stress in this region. This effect is seen in Fig. 10a, illustrating the stress responses recorded at two representative locations in the upper till, one at the slide mid-point another ~30m south-east of it. At these points, the stress states increase consistently throughout the simulation in response to the loads imposed by the newly added embankment materials, until shortly after the addition of Stage 9B loads when the stress states begin steadily decreasing. This process sets in earlier at the slide mid-point, located directly above the middle of the strain-weakening zone, and later at the point located further away from the slide epicenter.

stress response noted previously in the upper till is also observed in the core in step with the propagation of the shear surface (Fig. 10b).

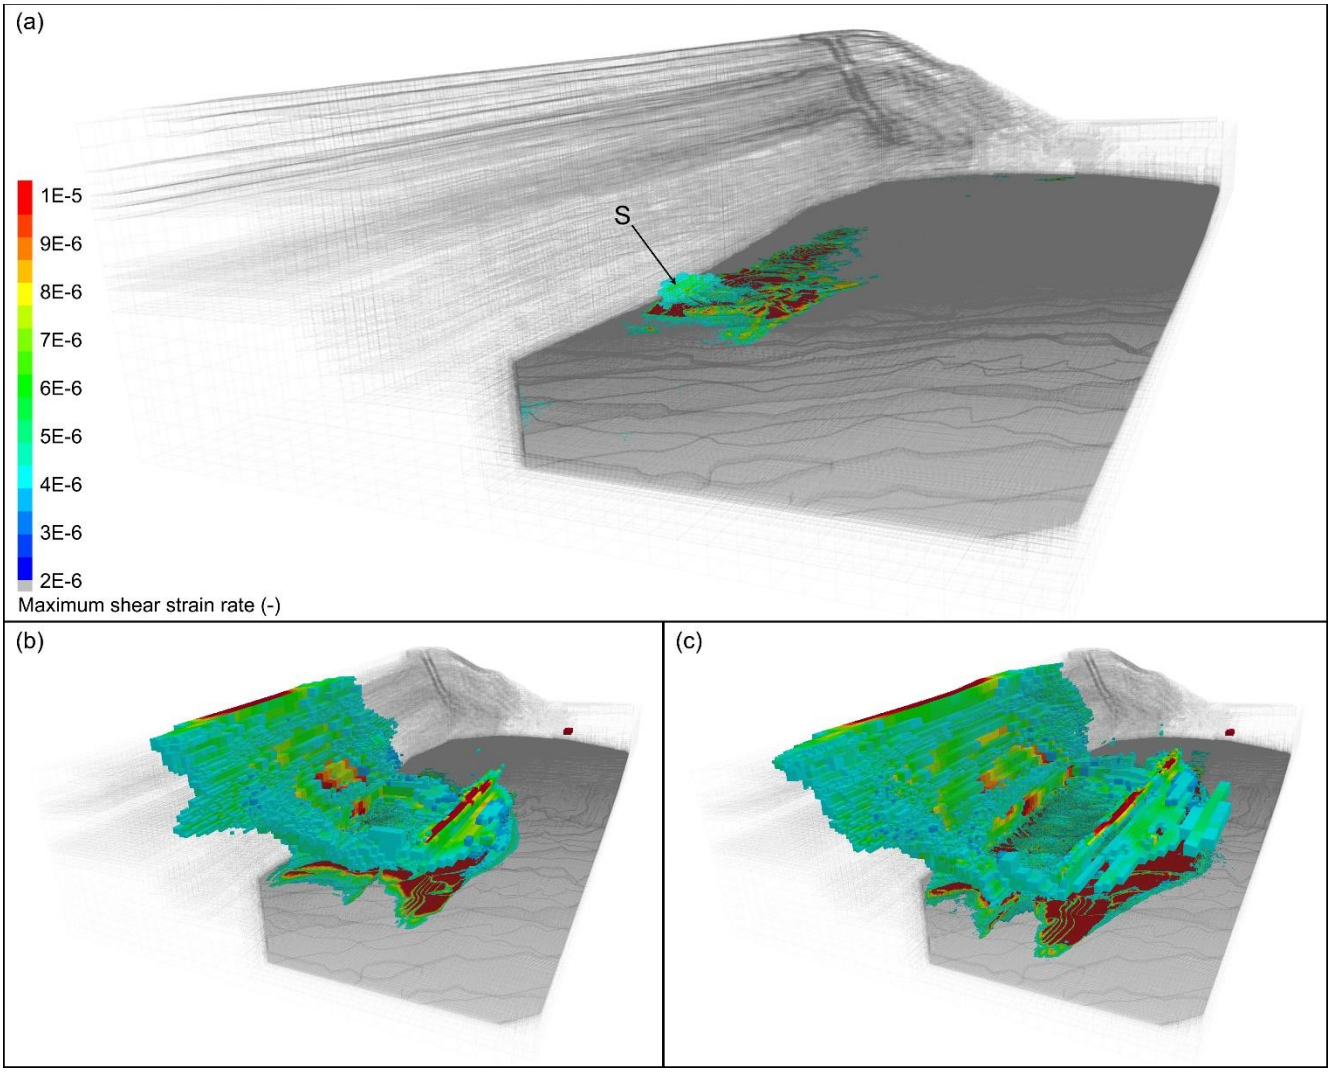
The qualitative change in the stress response of the upper till in the upstream region of the slide precedes the moment when global failure develops in the simulation, evidenced by the overall acceleration of the soil mass ~3,000 mechanical steps into the simulation of Stage 9B (Zabolotnii 2020, p. 313 & Fig. 4.41). At this point in the simulation, the rate of loss of shear resistance to strain-weakening has increased ~30-fold. The rate of accumulation of shear displacements at the middle of the strain-weakening zone increases three- to fourfold (Zabolotnii 2020, p. 309 & Fig. 6.12). The growing shear displacements in the foundation drive the shear surface upward into the core as well as laterally, as seen in Fig. 11b-c. The change in the

Figure 11. (a,b,c) Shear surface 2,700, 5,200 and 6,700 mechanical steps after the application of Stage 9B loads, respectively. Elements with maximum shear rates ranging between $2*10^{-6}$ and 10^{-5}(-) are rendered in color; all other zones are shown as transparent mesh. Labels: S – location where the shear surface propagates outside the Upper GLU and into the upper till at ~2,700 mechanical steps into the simulation of Stage 9B.
