Liquefaction Ejecta Case Histories for 2010-11 Canterbury Earthquakes

Submitted: 1 January 2022; Published: 29 August 2022
Reference: Mijic, Z., Bray, J. D., and van Ballegooy, S. (2022). Liquefaction Ejecta Case Histories for 2010-11 Canterbury Earthquakes. International Journal of Geoengineering Case Histories, Volume 6, Issue 3, pp. 73-93, doi: 10.4417/IJGCH-06-03-04

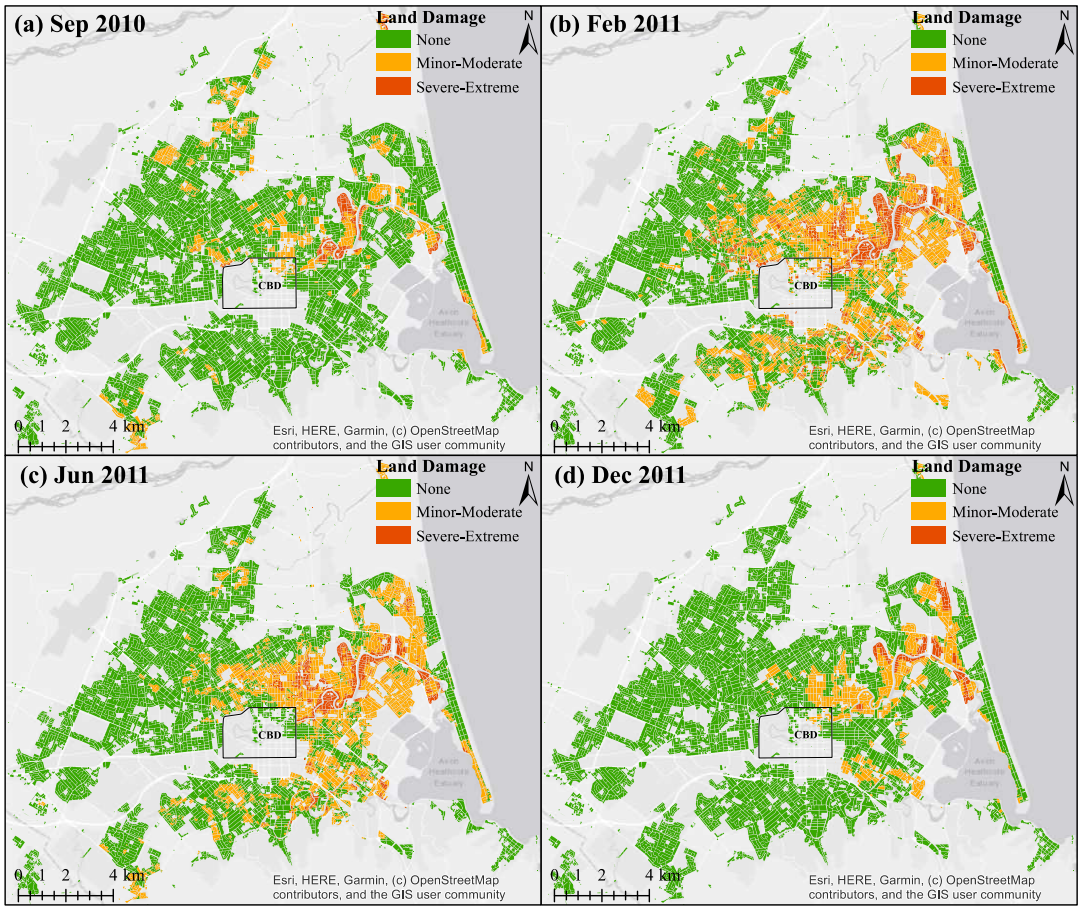
Sites throughout Christchurch were shaken multiple times and experienced no-to-extreme quantities of liquefaction ejecta (see Figure 2). The degree of liquefaction ejecta-induced damage varied from site to site and from earthquake to earthquake. Although direct measurements of ejecta after the Canterbury earthquakes are not available, liquefaction ejecta coverage and amounts for each of the four major Canterbury earthquakes can be characterized with access to the comprehensive T+T (2015) and LDAT (2021) databases. The T+T (2015) database contains aerial photographs for each earthquake, pre- and post-earthquake airborne Light Detection And Ranging (LiDAR) surveys, thousands of CPTs and boreholes with installed piezometers, earthquake-specific groundwater depth models, and robust estimates of PGA with uncertainties. The LDAT (2021) database is comprised of ground photographs and detailed land damage inspection notes.

Figure 2. Liquefaction observations at the ground surface for the (a) 4 Sep 2010, (b) 22 Feb 2011, (c) 13 Jun 2011, and (d) 23 Dec 2011 earthquakes (T+T, 2015). (CBD = Christchurch Business District)

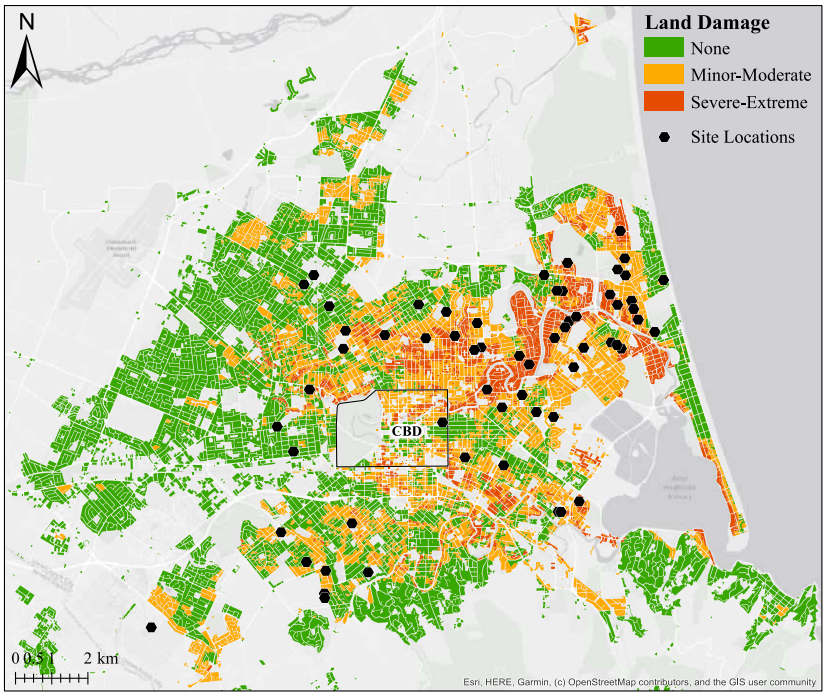
Figure 3. The maximum liquefaction ejecta-induced damage map (T+T, 2015) with site locations. (CBD = Christchurch Business District)

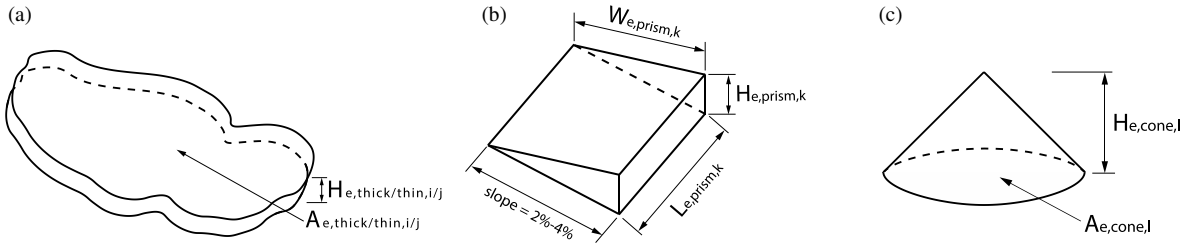
For ejecta shaped as a prism with irregular curvilinear bases (see Figure 4a), the differing thicknesses of ejecta were identified on a high-resolution aerial photograph as having different colors (i.e., darker colors were assumed to correspond to thicker ejecta layers because of the longer time required to dry the soil) and the corresponding areas were measured using a polygon tool in Google Earth Pro. The height of each ejecta layer was estimated based on the available ground photographs, LDAT property inspection maps, reports that occasionally included the height of ejecta remnants, visibility of the ejecta layer in the aerial photograph, and measurements of the ejecta height in neighboring, similarly affected areas. The volume of ejecta shaped as a prism with irregular curvilinear bases, $V_{E,thick+thin}$, was then estimated as

Figure 4. (a) Ejecta shaped as a prism with irregular curvilinear bases, (b) ejecta on the road shaped as a prism with triangular bases, and (c) ejecta occurring naturally as a cone.

Ejecta on the road were typically shaped as a series of triangular-base prisms with different dimensions (see Figure 4b). The rectangular shapes of ejecta on the road were outlined on the high-resolution aerial photograph for each earthquake, and their dimensions were measured using the Google Earth Pro tools. The width of a rectangle, $W_{E,prism,k}$, is perpendicular to the curb, while the length of a rectangle, $L_{E,prism,k}$, aligns with the curb. The lower and upper estimates of the height of ejecta at the curb, $H_{E,prism,k}$, were based on the typical cross-slopes of normal crown of 2% and 4%, respectively. The height of ejecta was capped at a typical curb height of 150 mm unless ejecta extended above the curb and onto the ground surface toward properties. The volume of ejecta shaped as a triangular-base prism, $V_{E,prism}$, was estimated as

Ejecta that occurred naturally in a form of an isolated cone (see Figure 4c) had its area $A_{E,cone,l}$ measured on a high-resolution aerial photograph in Google Earth Pro, and its height $H_{E,cone,l}$ estimated based on the best available physical evidence to obtain the volume, $V_{E,cone}$, as

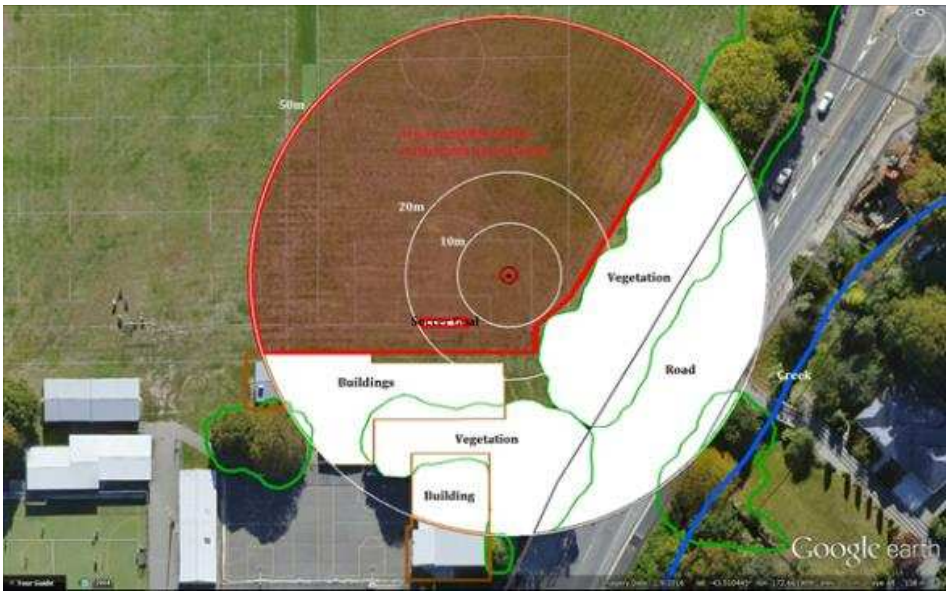
The detailed evaluation of one site is presented to illustrate the methods employed to develop the ejecta-induced ground settlement case histories. The Shirley Intermediate School site (see Table 1) is a level, open-field site covered largely in grass and did not undergo lateral spreading during the Canterbury earthquakes. The nearest free-face feature is a creek that is approximately 55 m from the center of the site. Ten percent of the site's 50-m buffer is occupied by school buildings, which were constructed between Apr 2011 and Jun 2011, and 15% of the site is covered by a road. Some minor earthwork was performed in the building area between Oct 2009 and Feb 2011. Trees, bushes, and plants other than grass (all termed vegetation) cover 10% of the 20-m buffer and 20% of the 50-m buffer. All these features and anthropogenic changes were considered when selecting the settlement assessment area, as they could affect the LiDAR survey measurements. The area selected for the ejecta-induced settlement analysis excludes vegetation, buildings, and significant anthropogenic changes (see Figure 5). This area also has good spatial distribution of ejecta (see Figure 6).

Figure 5. The Shirley Intermediate School site plan with the area analyzed for ejecta-induced settlement.

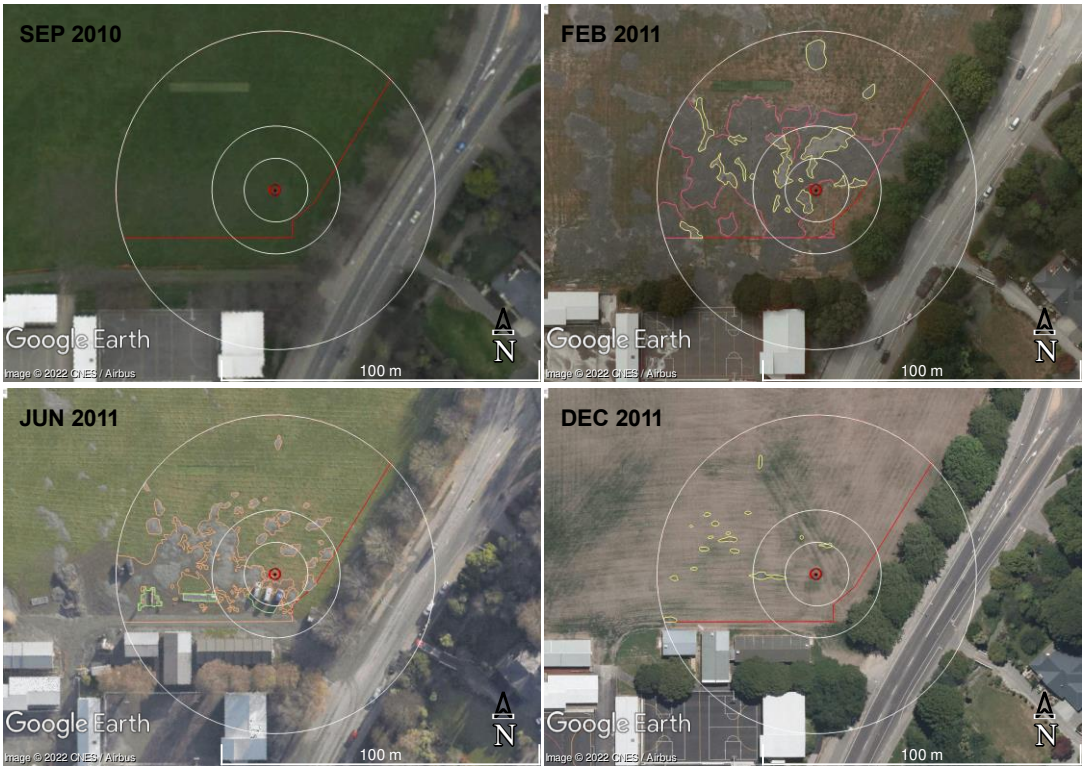
Figure 6. Aerial photographs acquired for Shirley Intermediate School in Sep 2010, Feb 2011, Jun 2011, and Dec 2011 (CGD, 2012a) with ejecta outlines for the 10-, 20-, and 50-m buffers.

The aerial photographs in Figure 6 were used to estimate the occurrence of ejecta and to measure the area of ejecta coverage within the assessment area (the red outline). The absence of ejecta is evident for the Sep 2010 earthquake. For the Feb 2011 earthquake, ejecta occurred across the site in a pattern of interconnected soil deposits originating from different fissures and forming irregularly shaped ejecta blankets rather than in a pattern of individual conically shaped soil boils. Different shades of gray of the ejecta were interpreted as different ejecta thicknesses. The light gray ejecta outlined in yellow were classified

as thin ejecta, while the dark gray ejecta outlined in pink were classified as thick ejecta. The total areas of the outlined thick ejecta layers and the outlined thin ejecta layers ($A_{E,thick}$ and $A_{E,thin}$, respectively) were measured in Google Earth Pro. The $A_{E,thick}$ and $A_{E,thin}$ values for the 10-m buffer are summarized in Table 2. In the absence of ground photographs, the height range for the thick and thin ejecta layers ($H_{E,thick}$ and $H_{E,thin}$, respectively) was estimated based on the typical height of similar-looking ejecta for the neighboring area and observations made by people (Table 2). Finally, the volume of ejecta was estimated using Eq. 1 and was divided by the total assessment area, A_T, to obtain the areal ejecta-induced free-field settlement, S_{E,P_areal} (Table 3), while the localized ejecta-induced settlement, $S_{E,P_localized}$ (Table 3) was obtained by dividing the total volume of ejecta within A_T by the coverage area of ejecta, A_E. Figure 6 also shows the presence of ejecta for the Jun 2011 earthquake. However, ejecta appeared to be partially cleaned from the site. To account for this uncertainty, the height of ejecta was provided as a wider range, while assuming ejecta covered the portion of the site in light brown color. The area for the Jun 2011 earthquake reported in Table 2 corresponds to the area outlined in orange and within the 10-m buffer. Also, cars, shadows, and construction equipment obscured a portion of the assessment area in the Jun 2011 aerial photograph, resulting in that portion of the site being excluded from the analysis. For the Dec 2011 earthquake, only minor ejecta (outlined in yellow in Figure 6) were present.

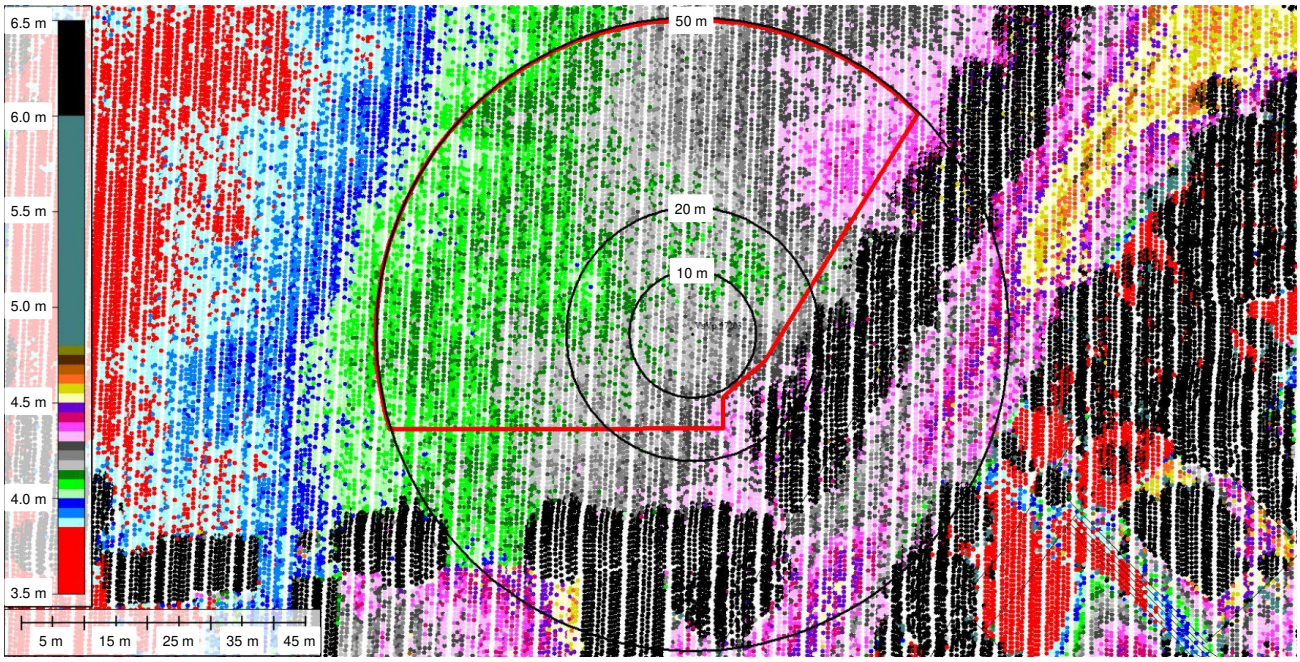
To estimate the LiDAR-based ejecta-induced settlement, the change in the ground surface elevation within the assessment area was determined for individual LiDAR points, such as those shown in Figure 7, for each earthquake (Table 4). These values were then adjusted for the LiDAR flight error, global offset, and tectonic movement (Table 5). The site is in the apparent zone of higher ground surface subsidence for the Sep 2010 earthquake and the apparent zone of lower ground surface subsidence for the Feb 2011 earthquake (Figure 8). To account for this LiDAR flight error, 100 mm were subtracted from the ground surface elevation change in Table 4 for the Sep 2010 earthquake and 100 mm were added to the ground surface elevation change in Table 4 for the Feb 2011 earthquake. The final estimates of liquefaction-induced ground surface subsidence provided in Table 6 were compared with the coarse estimates of the ground surface subsidence using the LiDAR DEMs (Figure 9). No major discrepancies between the two sets of estimates were observed. The average S_{V1D} was then calculated and subtracted from the values in Table 6 to obtain $S_{E,L}$ (Table 7). The PGA ranged from 0.19 g for the Sep 2010 earthquake to 0.38 g for the Feb 2011 earthquake. The depth to groundwater was in the range from 2.0 m below ground surface (BGS) for the Dec 2011 earthquake to 2.5 m BGS for the Sep 2010 and Feb 2011 earthquakes. All CPTs shown in Figure 10 were used to calculate the average S_{V1D} for the 50-m buffer (four of them were outside the 50-m buffer; CPT 55672 was 90 m away from the center of the site), whereas only CPTs 56473 and 57366 were used to calculate the average S_{V1D} for the 10-m and 20-m buffers. The S_{V1D} values for individual CPTs for each earthquake event are provided in Table 8. Figure 11 illustrates the cyclic resistance ratio (CRR) and the cyclic stress ratio (CSR) for each main earthquake event, which were computed in Cliq v.3.0.3.2 for CPTs 56473 and 57366 using the Boulanger and Idriss (2016) procedure.

Figure 7. LiDAR survey points used to compute the average ground surface elevation in Global Mapper within the assessment area (outlined in red) for Mar 2011 (T+T, 2015).

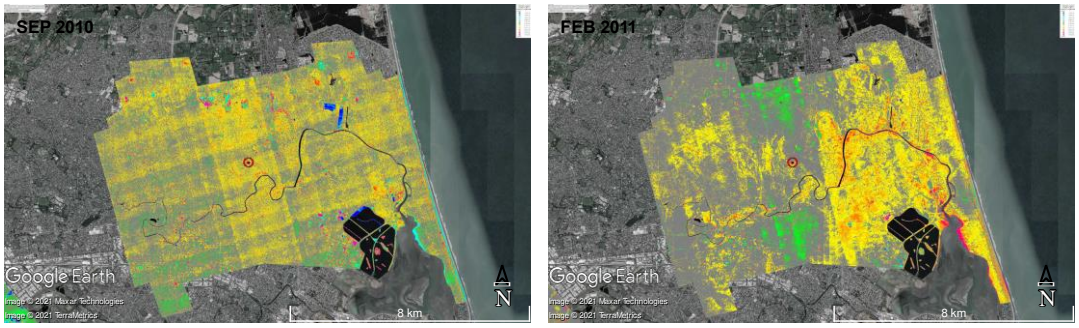
Figure 8. Vertical Ground Movements (adjusted for the tectonic component) for the Sep 2010 and Feb 2011 earthquakes (CGD, 2012b) – the site is in the zone of overestimated ground surface subsidence for the Sep 2010 earthquake and the zone of underestimated ground surface subsidence for the Feb 2011 earthquake.

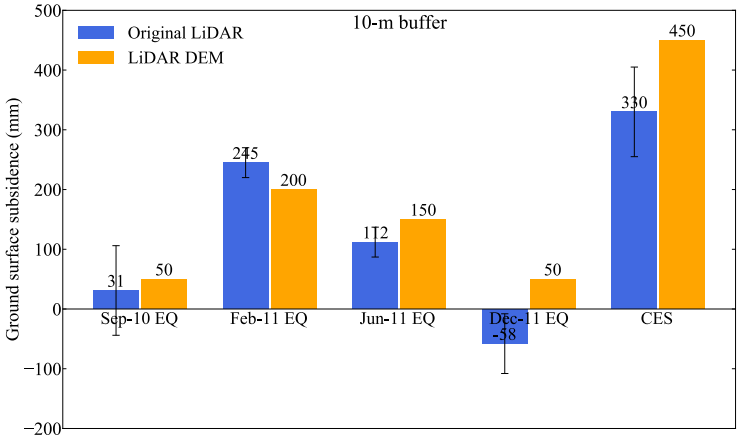
Figure 9. Comparison between the ground surface subsidence determined using the individual LiDAR elevation points and the ground surface subsidence estimated using the LiDAR DEMs.

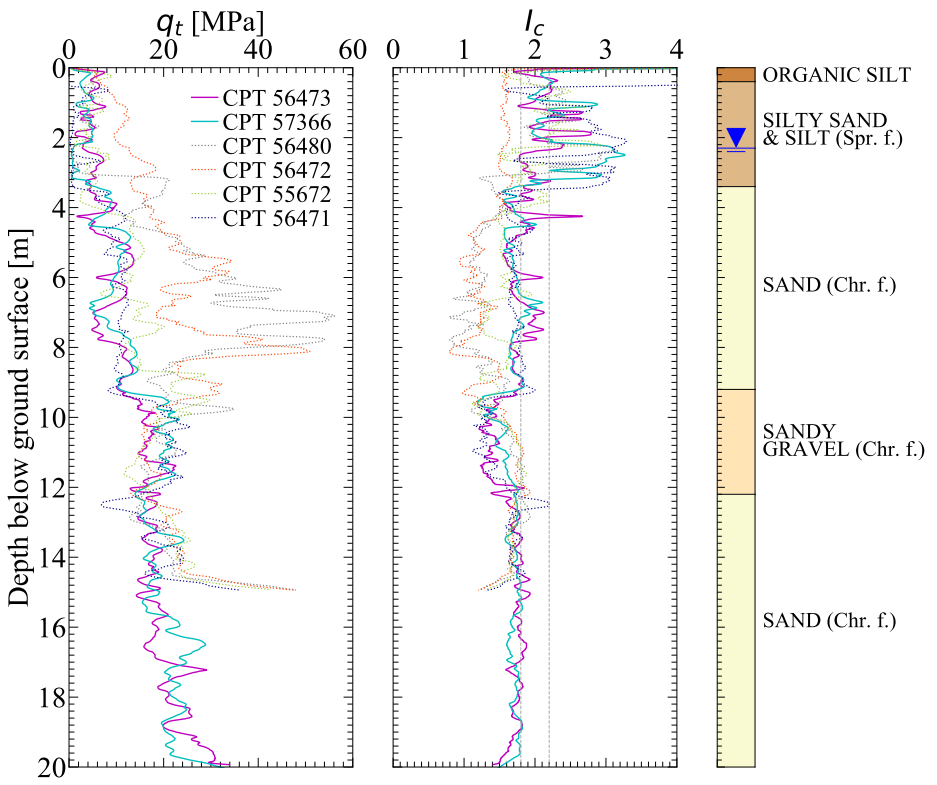
Figure 10. CPT traces and simplified soil profile for Shirley Intermediate School. (The soil layer colors are arbitrary.)

The soil profile at the Shirley Intermediate School site indicates a thick, clean sand site. A borehole log at the center of the site and the CPTs indicate a 5.5 m thick layer of fine to medium sand, SP, in the upper 10 m (from the 3.5 m to 9 m depth) and below the average groundwater depth of approximately 2.3 m BGS (Figure 10). This marine/estuarine SP layer of the Christchurch formation has an average q_t of 9 MPa. The top 3.5 m of the soil profile consist of the 0.4 m thick organic silty, OL, topsoil ($q_{t,avg}$ = 4 MPa) and underlying interchangeable layers of alluvial non-plastic to low plasticity silt, ML, and alluvial silty sand, SM, of the Springston formation ($q_{t,avg}$ = 4 MPa). Below the 9 m depth, sandy subrounded marine/estuarine gravel, GW, with $q_{t,avg}$ = 18 MPa extends to a depth of 12 m and overlies fine to coarse marine/estuarine sand, SP, which extends to a depth of 20 m. The provided q_t values corrected for thin-layer effects using the de Greef and Lengkeek (2018) procedure are based on CPTs 56473 and 57366. Two additional CPTs from outside the 50-m buffer show the presence of gravelly layers at depths shallower than 8 m close to the rim of the 50-m buffer.

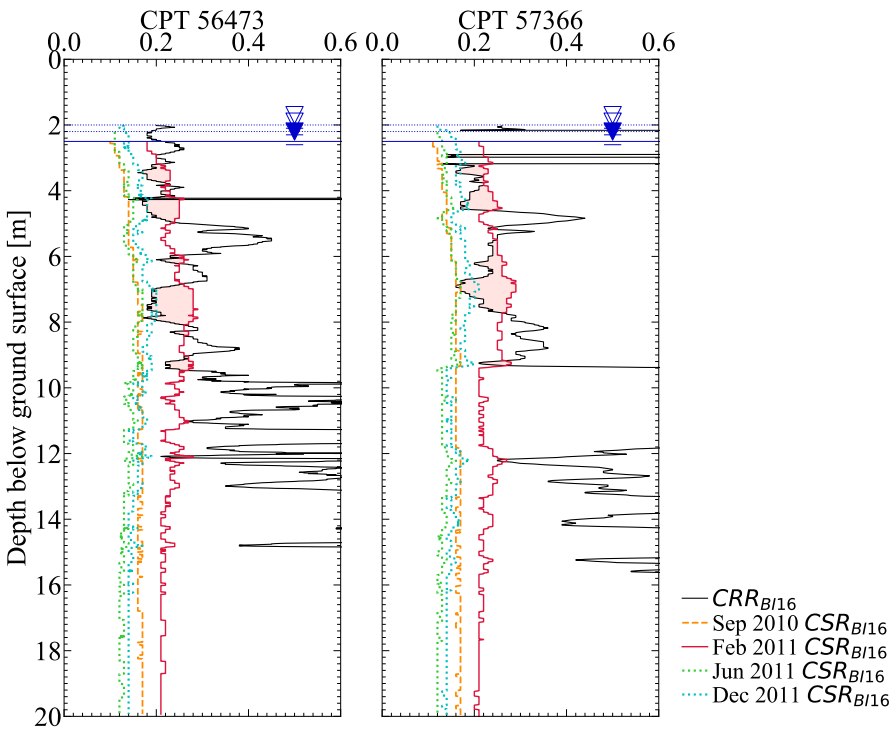
Figure 11. The Boulanger and Idriss (2016) estimated cyclic resistance (CRR_{BI16}) and the cyclic stress ratio (CSR_{BI16}) adjusted for M_w = 7.5 and σ'_{vo} = 1 atm for the Sep 2010, Feb 2011, Jun 2011, and Dec 2011 earthquakes for CPTs 56473 and 57366 at Shirley Intermediate School. Layers with FS_L < 1 for the Feb 2011 event are shaded.
