Liquefaction Ejecta Case Histories for 2010-11 Canterbury Earthquakes

KEYWORDS: liquefaction, ejecta, case histories, Christchurch, earthquakes, photographs, LiDAR

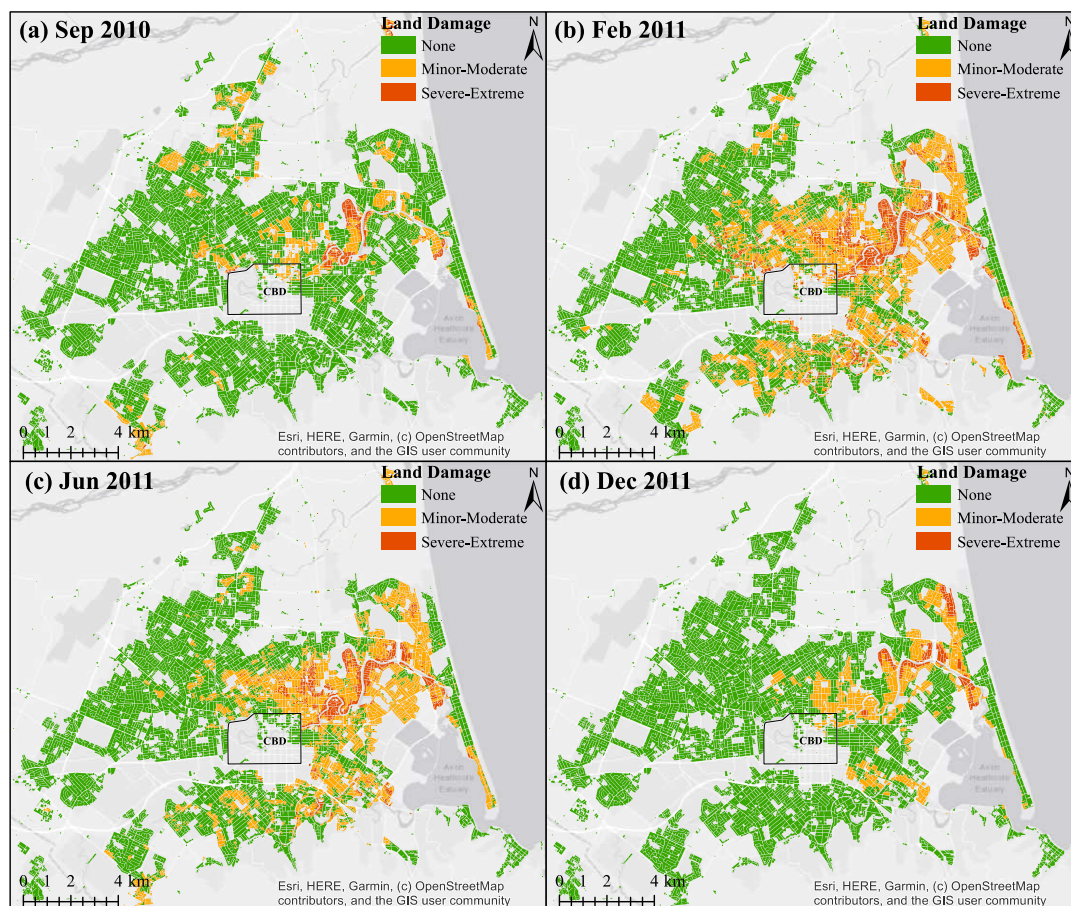
Sites throughout Christchurch were shaken multiple times and experienced no-to-extreme quantities of liquefaction ejecta (see Figure 2). The degree of liquefaction ejecta-induced damage varied from site to site and from earthquake to earthquake. Although direct measurements of ejecta after the Canterbury earthquakes are not available, liquefaction ejecta coverage and amounts for each of the four major Canterbury earthquakes can be characterized with access to the comprehensive T+T (2015) and LDAT (2021) databases. The T+T (2015) database contains aerial photographs for each earthquake, pre- and post-earthquake airborne Light Detection And Ranging (LiDAR) surveys, thousands of CPTs and boreholes with installed piezometers, earthquake-specific groundwater depth models, and robust estimates of PGA with uncertainties. The LDAT (2021) database is comprised of ground photographs and detailed land damage inspection notes.

Figure 2. Liquefaction observations at the ground surface for the (a) 4 Sep 2010, (b) 22 Feb 2011, (c) 13 Jun 2011, and (d) 23 Dec 2011 earthquakes (T+T, 2015). (CBD = Christchurch Business District)

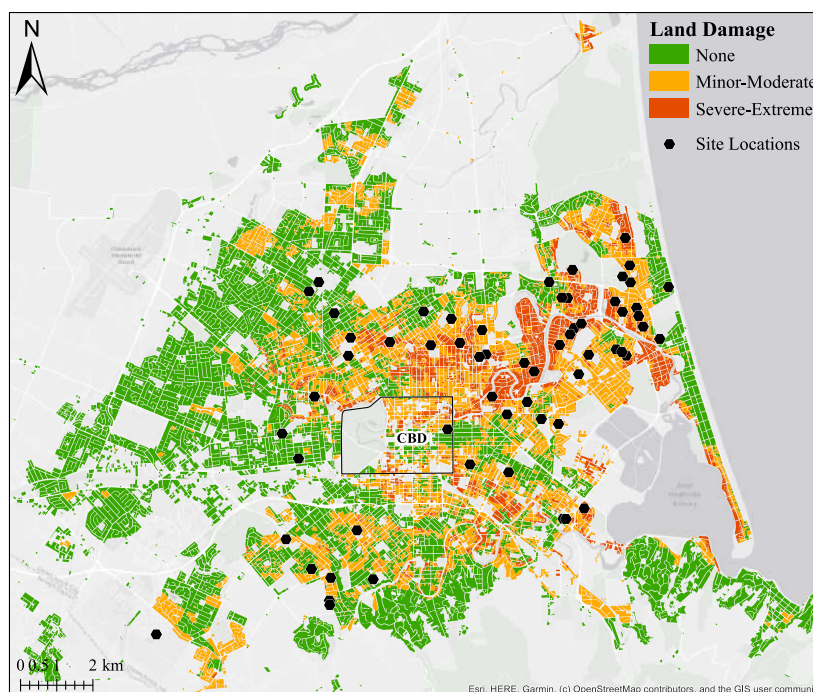
Figure 3. The maximum liquefaction ejecta-induced damage map (T+T, 2015) with site locations. (CBD = Christchurch Business District)

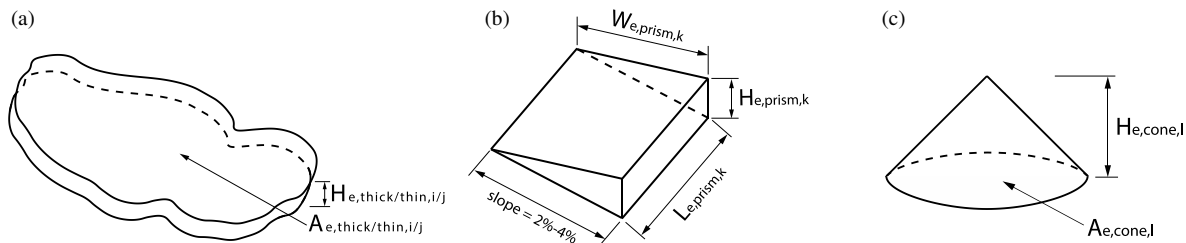
For ejecta shaped as a prism with irregular curvilinear bases (see Figure 4a), the differing thicknesses of ejecta were identified on a high-resolution aerial photograph as having different colors (i.e., darker colors were assumed to correspond to thicker ejecta layers because of the longer time required to dry the soil) and the corresponding areas were measured using a polygon tool in Google Earth Pro. The height of each ejecta layer was estimated based on the available ground photographs, LDAT property inspection maps, reports that occasionally included the height of ejecta remnants, visibility of the ejecta layer in the aerial photograph, and measurements of the ejecta height in neighboring, similarly affected areas. The volume of ejecta shaped as a prism with irregular curvilinear bases, $V_{E,thick+thin}$, was then estimated as

Figure 4. (a) Ejecta shaped as a prism with irregular curvilinear bases, (b) ejecta on the road shaped as a prism with triangular bases, and (c) ejecta occurring naturally as a cone.

Ejecta on the road were typically shaped as a series of triangular-base prisms with different dimensions (see Figure 4b). The rectangular shapes of ejecta on the road were outlined on the high-resolution aerial photograph for each earthquake, and their dimensions were measured using the Google Earth Pro tools. The width of a rectangle, $W_{E,prism,k}$, is perpendicular to the curb, while the length of a rectangle, $L_{E,prism,k}$, aligns with the curb. The lower and upper estimates of the height of ejecta at the curb, $H_{E,prism,k}$, were based on the typical cross-slopes of normal crown of 2% and 4%, respectively. The height of ejecta was capped at a typical curb height of 150 mm unless ejecta extended above the curb and onto the ground surface toward properties. The volume of ejecta shaped as a triangular-base prism, $V_{E,prism}$, was estimated as

Ejecta that occurred naturally in a form of an isolated cone (see Figure 4c) had its area $A_{E,cone,l}$ measured on a high-resolution aerial photograph in Google Earth Pro, and its height $H_{E,cone,l}$ estimated based on the best available physical evidence to obtain the volume, $V_{E,cone}$, as

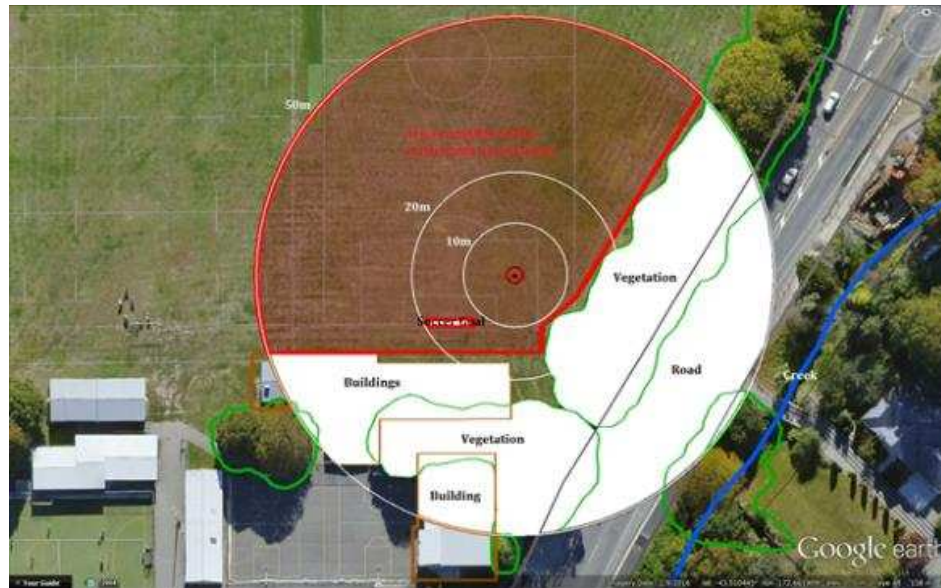
Figure 5. The Shirley Intermediate School site plan with the area analyzed for ejecta-induced settlement.

Figure 6. Aerial photographs acquired for Shirley Intermediate School in Sep 2010, Feb 2011, Jun 2011, and Dec 2011 (CGD, 2012a) with ejecta outlines for the 10-, 20-, and 50-m buffers.

The aerial photographs in Figure 6 were used to estimate the occurrence of ejecta and to measure the area of ejecta coverage within the assessment area (the red outline). The absence of ejecta is evident for the Sep 2010 earthquake. For the Feb 2011 earthquake, ejecta occurred across the site in a pattern of interconnected soil deposits originating from different fissures and forming irregularly shaped ejecta blankets rather than in a pattern of individual conically shaped soil boils. Different shades of gray of the ejecta were interpreted as different ejecta thicknesses. The light gray ejecta outlined in yellow were classified

as thin ejecta, while the dark gray ejecta outlined in pink were classified as thick ejecta. The total areas of the outlined thick ejecta layers and the outlined thin ejecta layers ($A_{E,thick}$ and $A_{E,thin}$, respectively) were measured in Google Earth Pro. The $A_{E,thick}$ and $A_{E,thin}$ values for the 10-m buffer are summarized in Table 2. In the absence of ground photographs, the height range for the thick and thin ejecta layers ($H_{E,thick}$ and $H_{E,thin}$, respectively) was estimated based on the typical height of similar-looking ejecta for the neighboring area and observations made by people (Table 2). Finally, the volume of ejecta was estimated using Eq. 1 and was divided by the total assessment area, A_T, to obtain the areal ejecta-induced free-field settlement, S_{E,P_areal} (Table 3), while the localized ejecta-induced settlement, $S_{E,P\_localized}$ (Table 3) was obtained by dividing the total volume of ejecta within A_T by the coverage area of ejecta, A_E. Figure 6 also shows the presence of ejecta for the Jun 2011 earthquake. However, ejecta appeared to be partially cleaned from the site. To account for this uncertainty, the height of ejecta was provided as a wider range, while assuming ejecta covered the portion of the site in light brown color. The area for the Jun 2011 earthquake reported in Table 2 corresponds to the area outlined in orange and within the 10-m buffer. Also, cars, shadows, and construction equipment obscured a portion of the assessment area in the Jun 2011 aerial photograph, resulting in that portion of the site being excluded from the analysis. For the Dec 2011 earthquake, only minor ejecta (outlined in yellow in Figure 6) were present.

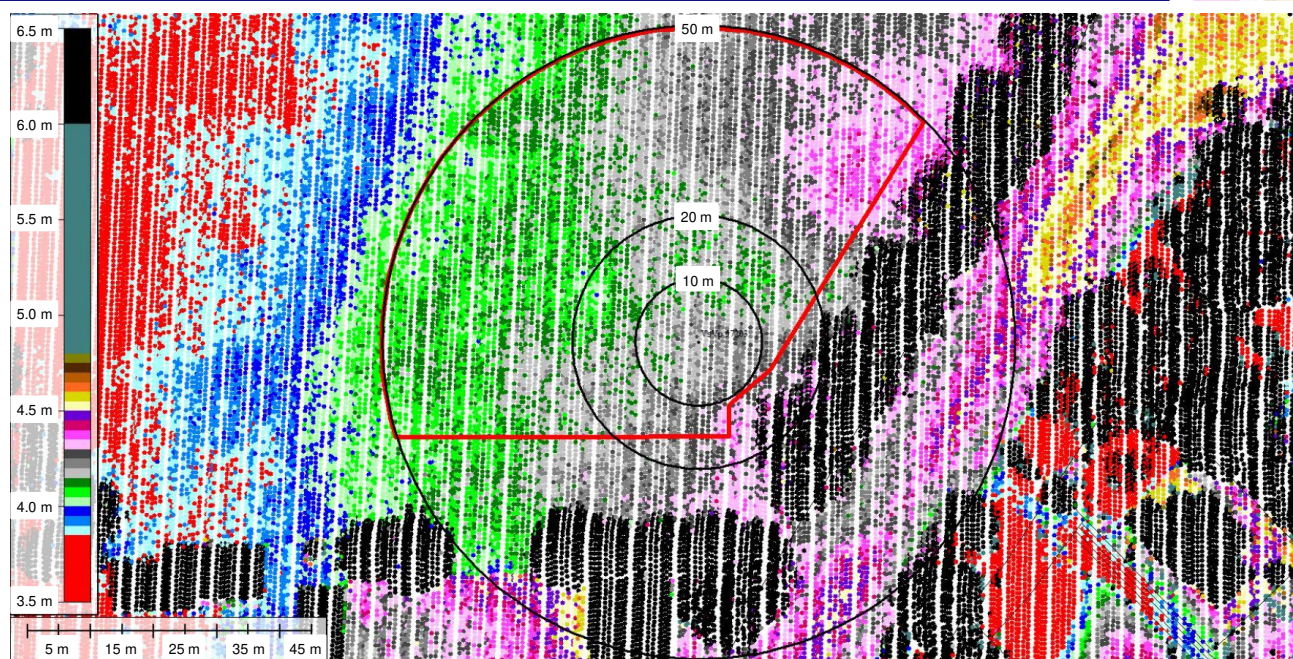
To estimate the LiDAR-based ejecta-induced settlement, the change in the ground surface elevation within the assessment area was determined for individual LiDAR points, such as those shown in Figure 7, for each earthquake (Table 4). These values were then adjusted for the LiDAR flight error, global offset, and tectonic movement (Table 5). The site is in the apparent zone of higher ground surface subsidence for the Sep 2010 earthquake and the apparent zone of lower ground surface subsidence for the Feb 2011 earthquake (Figure 8). To account for this LiDAR flight error, 100 mm were subtracted from the ground surface elevation change in Table 4 for the Sep 2010 earthquake and 100 mm were added to the ground surface elevation change in Table 4 for the Feb 2011 earthquake. The final estimates of liquefaction-induced ground surface subsidence provided in Table 6 were compared with the coarse estimates of the ground surface subsidence using the LiDAR DEMs (Figure 9). No major discrepancies between the two sets of estimates were observed. The average S_{V1D} was then calculated and subtracted from the values in Table 6 to obtain $S_{E,L}$ (Table 7). The PGA ranged from 0.19 g for the Sep 2010 earthquake to 0.38 g for the Feb 2011 earthquake. The depth to groundwater was in the range from 2.0 m below ground surface (BGS) for the Dec 2011 earthquake to 2.5 m BGS for the Sep 2010 and Feb 2011 earthquakes. All CPTs shown in Figure 10 were used to calculate the average S_{V1D} for the 50-m buffer (four of them were outside the 50-m buffer; CPT 55672 was 90 m away from the center of the site), whereas only CPTs 56473 and 57366 were used to calculate the average S_{V1D} for the 10-m and 20-m buffers. The S_{V1D} values for individual CPTs for each earthquake event are provided in Table 8. Figure 11 illustrates the cyclic resistance ratio (CRR) and the cyclic stress ratio (CSR) for each main earthquake event, which were computed in Cliq v.3.0.3.2 for CPTs 56473 and 57366 using the Boulanger and Idriss (2016) procedure.

Figure 7. LiDAR survey points used to compute the average ground surface elevation in Global Mapper within the assessment area (outlined in red) for Mar 2011 (T+T, 2015).

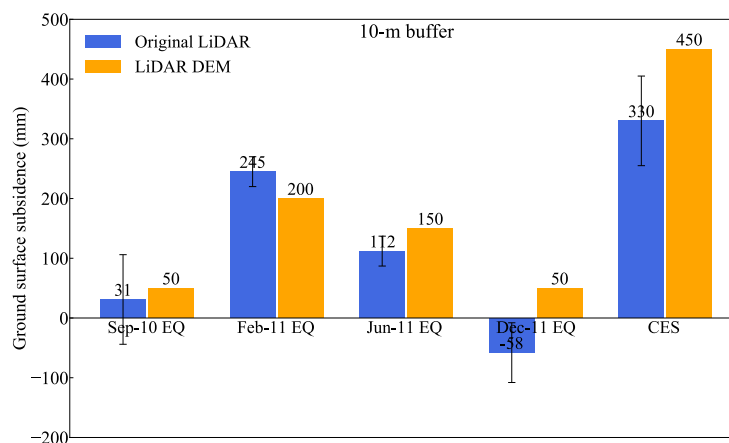
Figure 9. Comparison between the ground surface subsidence determined using the individual LiDAR elevation points and the ground surface subsidence estimated using the LiDAR DEMs.

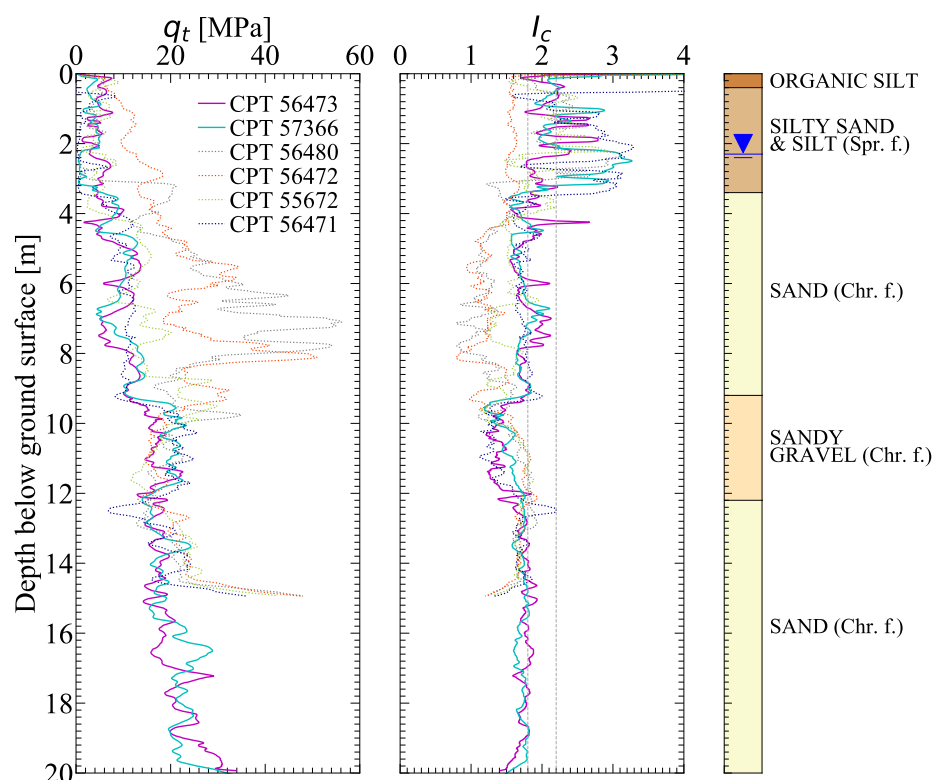
Figure 10. CPT traces and simplified soil profile for Shirley Intermediate School. (The soil layer colors are arbitrary.)

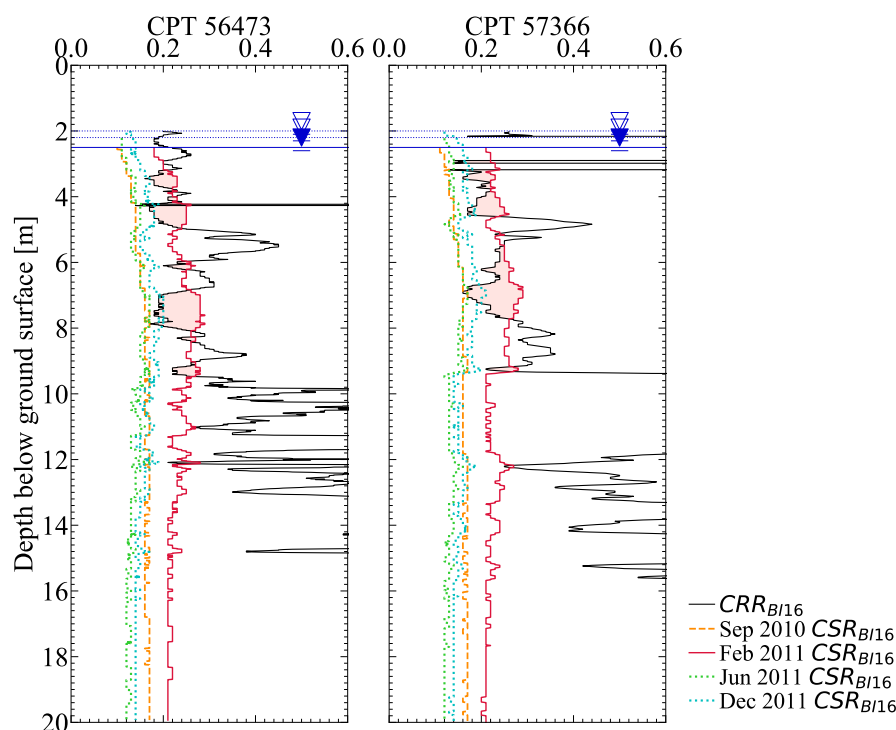
Figure 11. The Boulanger and Idriss (2016) estimated cyclic resistance (CRR$_{BI16}$) and the cyclic stress ratio (CSR$_{BI16}$) adjusted for $M_w = 7.5$ and $\sigma'_{vo} = 1$ atm for the Sep 2010, Feb 2011, Jun 2011, and Dec 2011 earthquakes for CPTs 56473 and 57366 at Shirley Intermediate School. Layers with FS$_L$ < 1 for the Feb 2011 event are shaded.
