Liquefaction and Non-liquefaction Cases from the Mataquito Bridge, Chile, after the M_w 8.8 (2010) and M_w 6.6 (2019) Earthquakes

Ricardo Moffat, *Civil Engineer, Universidad Adolfo Ibáñez, Santiago, Chile; email: ricardo.moffat@uai.cl*
Robb Moss, *Civil Engineer, California Polytechnic State University, San Luis Obispo, USA; email: rmoss@calpoly.edu*

KEYWORDS: liquefaction; lateral displacement; seismic settlement

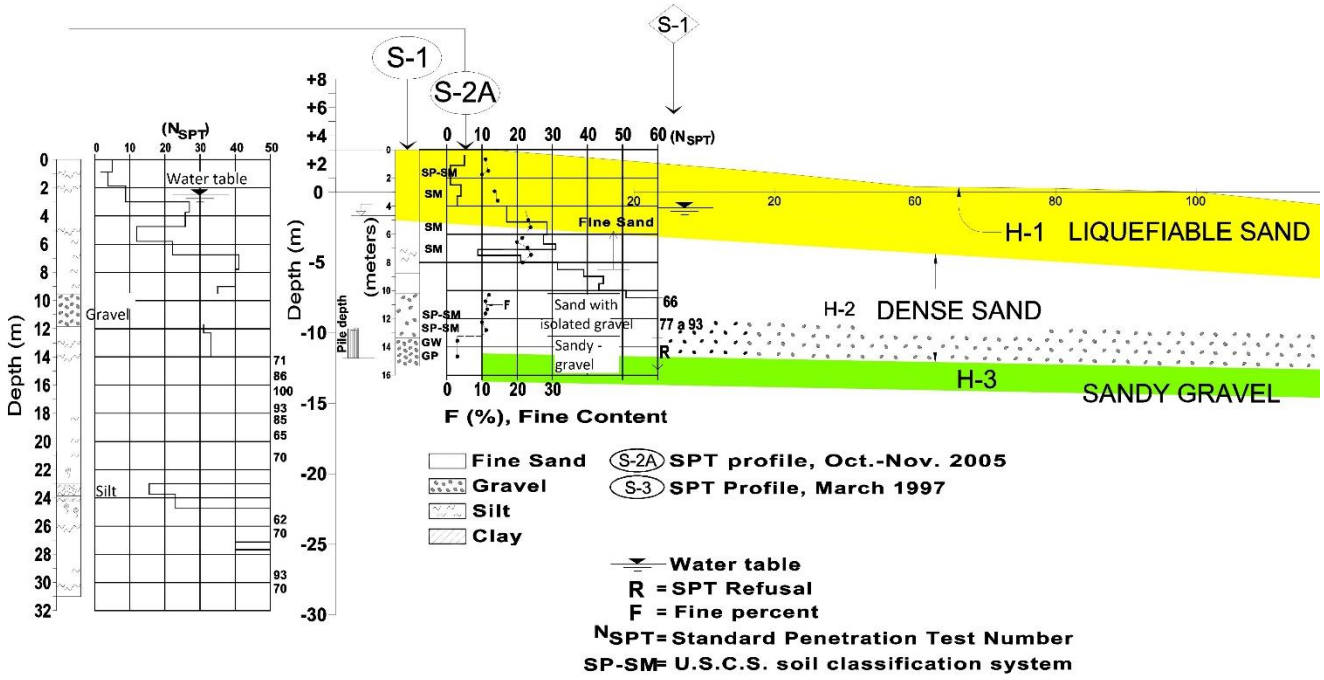
Figure 7. Subsurface information from the 1996 and 2005 investigations. The north side of the bridge is shown (modified from Petrus Consultores, 2006).

layer up to a depth of 4 m to 6 m was susceptible to liquefaction (shown in Figures 7 and 8). According to this soil exploration, the upper sand layer has a variable non-plastic fines content between 1% and 25%. As a result of this, it was recommended to use piles that reach the dense gravelly sand at about 15 m below the surface, and thus mitigate liquefaction-induced foundation failure and/or large post-liquefaction settlements of the foundations.

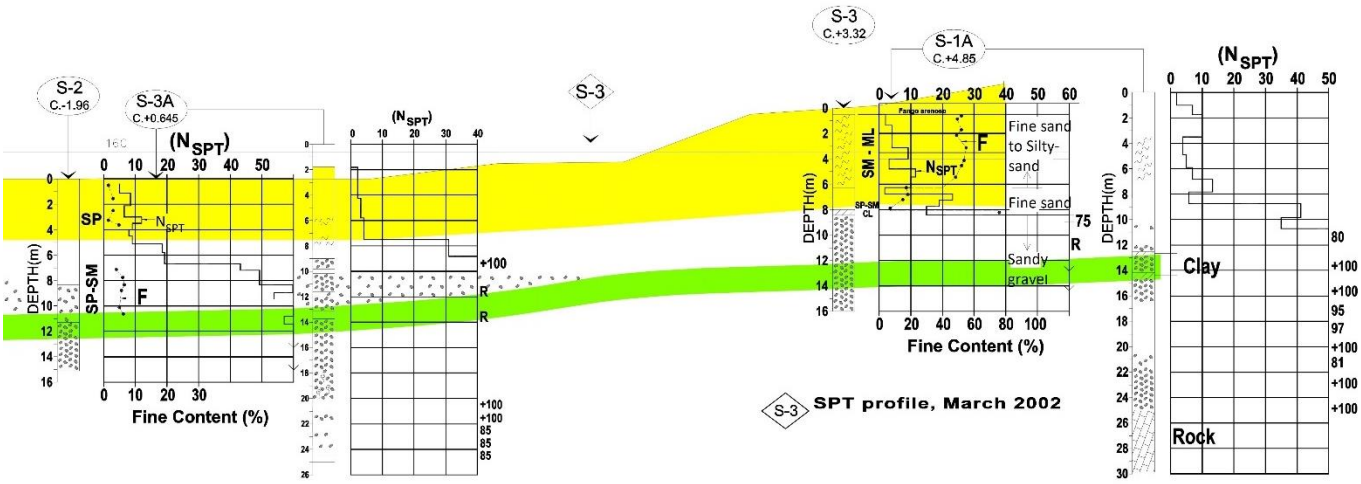
Figure 8. Subsurface information from the 1996 and 2005 investigations. The south side of the bridge is shown (modified from Petrus Consultores, 2006).

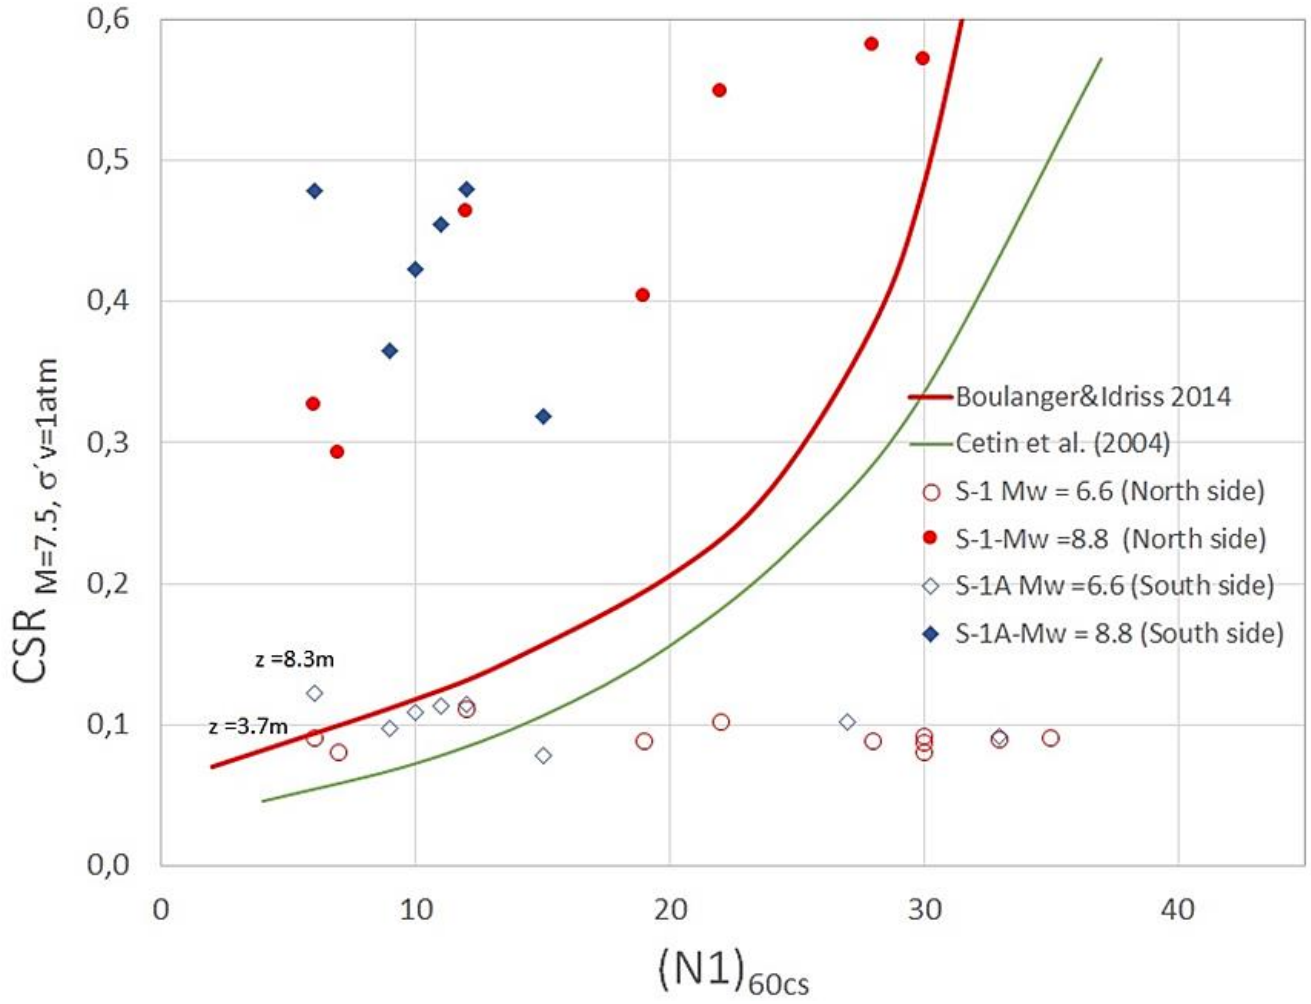
Figure 9. Liquefaction analysis with information prior to the 2010 earthquake.

Figure 9 shows the result of the liquefaction analysis using procedures (Cetin et al., 2004 and Boulanger and Idriss, 2014) with the original SPT data. Soil exploration S-1A was performed in the south side of the bridge, and soil exploration S-1 was performed in the north side. The NSPT blow count in both places are evaluated for the M_w 8.8 2010 and M_w 6.6 2019 earthquakes. Both soil explorations were located in places where the liquefaction manifestation was observed at the surface for the 2010 earthquake and no manifestation was observed for the 2019 earthquake. The evaluation for the 2010 earthquake using a PGA value of 0.44 g indicates potential liquefaction in both places (S-1 and S-1A) from depths just below the water table and down to a depth of 9 m. (Boroschek et al., 2012) proposed an attenuation relation for horizontal accelerations using the database of Chilean accelerograms located on different types of soils and recorded during earthquakes that occurred between 1985 and 2010. In Figure 10, this curve is shown together with another proposed by Zhao et al. (2006) using data from crustal and slab strong earthquakes recorded on soils. In both cases, at the rupture distance estimated for 2010 at the Mataquito Bridge, the PGA value is close to the 0.44 g used in this analysis. For the 2019 earthquake, a value of PGA equal to 0.14g was used for liquefaction evaluation. In this case, there is a border line point for data obtained at 3.7m deep at the

north side, and liquefaction potential is deduced at a depth of 8.3m in the south side (see Figure 9). This last case is probably too deep to exhibit liquefaction manifestation even if liquefaction was triggered at that depth (Ishihara, 1985 and Youd et al., 1995). Evaluation using both original data seems to correlate with field observations for both earthquakes, especially when considering the Boulanger and Idriss (2014) method.

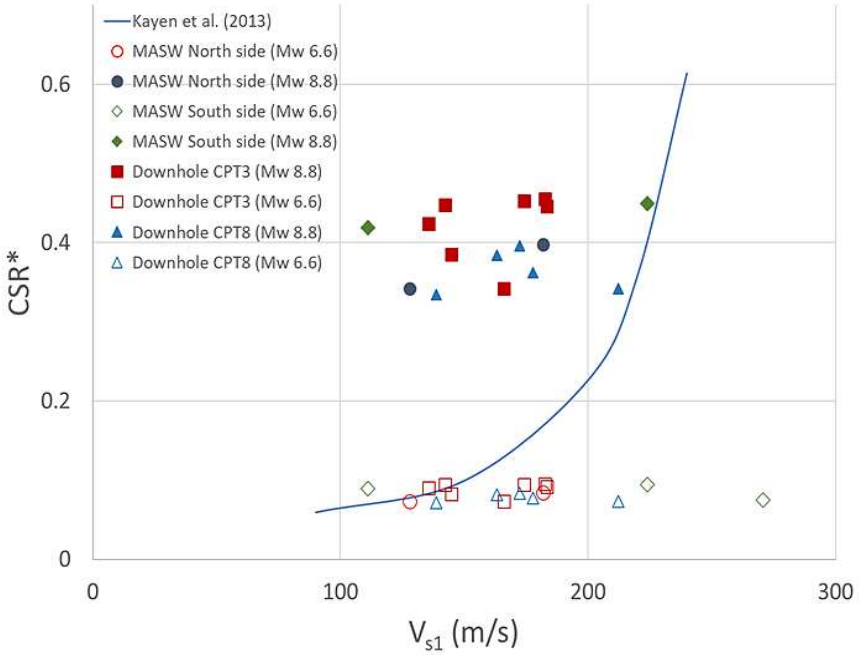
Liquefaction triggering was studied for both MASW profiles and downhole SCPT measurements using the procedure explained at Kayen et al. (2013). A 15% probability contour for initial liquefaction was considered as the deterministic boundary curve shown in Fig. 12. The results of this analysis, using MASW data, are shown in Fig. 12, where liquefaction is deduced from 3 m to 6 m at both sides of the river. Downhole CPT 3 is located at the south side of the bridge, and downhole CPT 8 is located at the north side. The analysis was performed for both earthquakes, where CPT 3 data was for depths between 1.5 m to 8.3 m, and CPT 8 was from 1.5 m to 6.3 m. The MASW and downhole shear wave velocity analysis seemed to correlate adequately with the observations from both earthquakes.

Figure 12. Liquefaction assessment using V_s from MASW and SCPT.

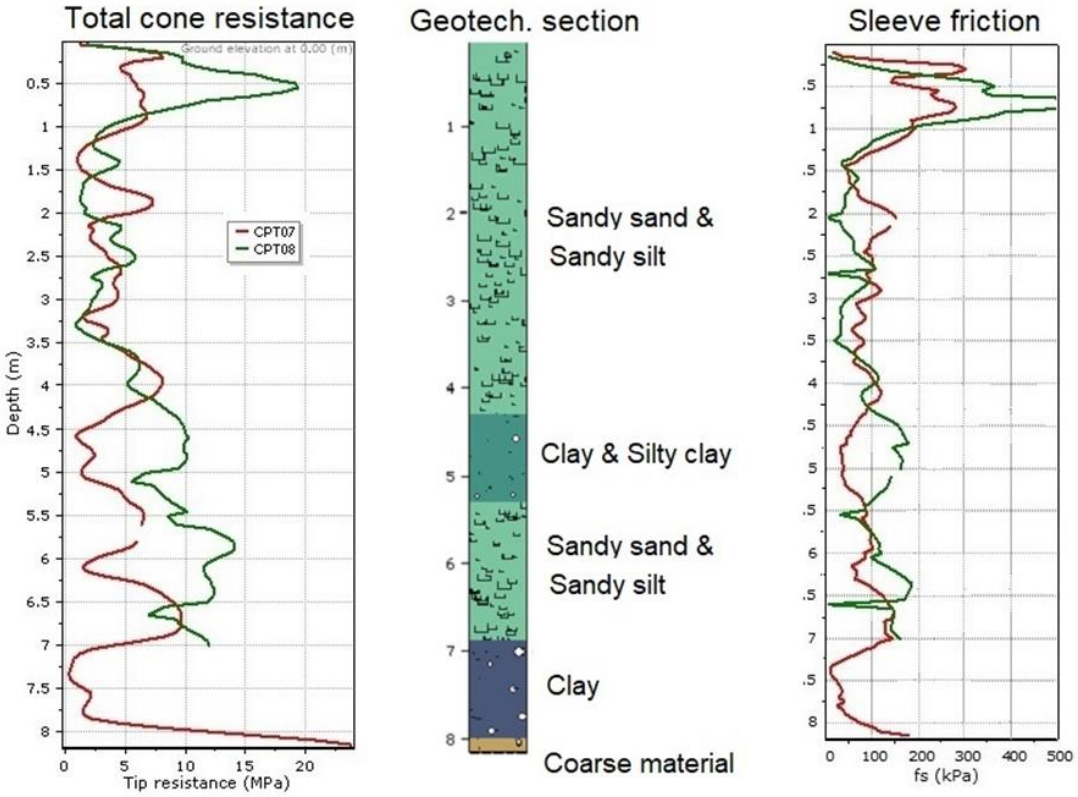
Figure 13. CPT soundings on the north side with the water table located at roughly at 2.5 m.

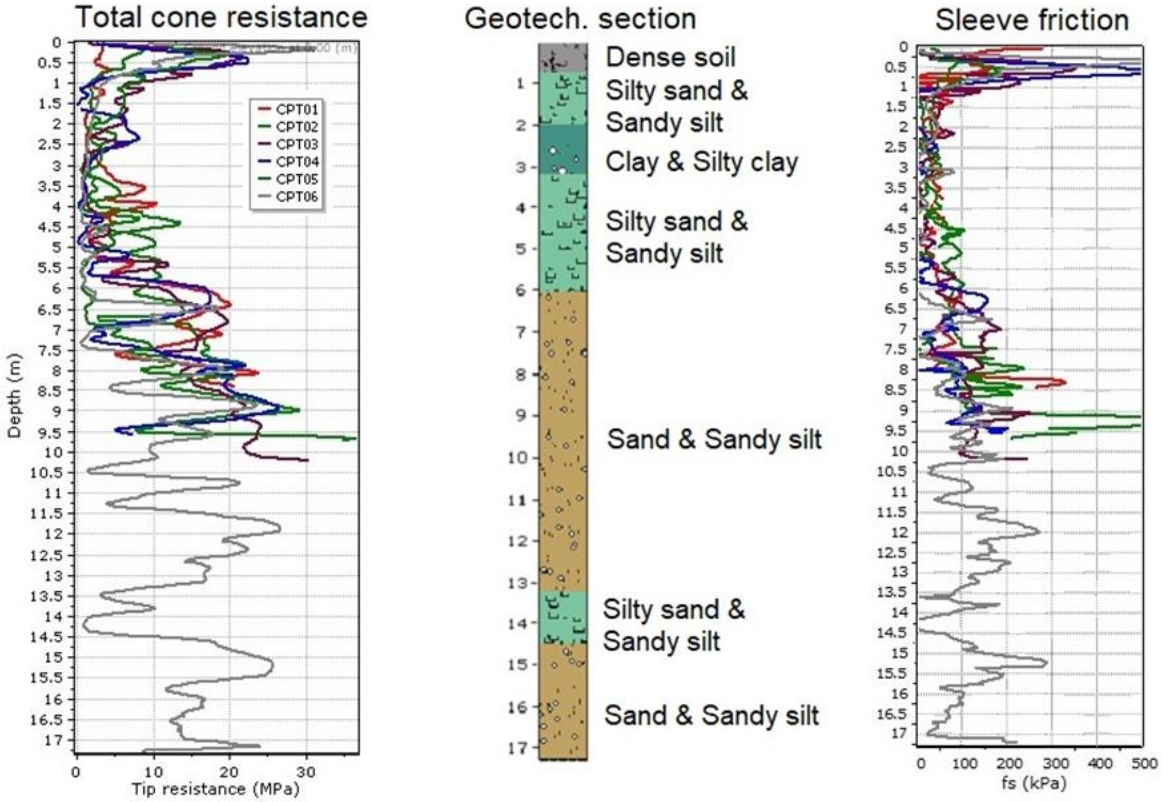
Figure 14. CPT soundings on the south side; the water table varies between 2 m to 5 m across the measured locations.

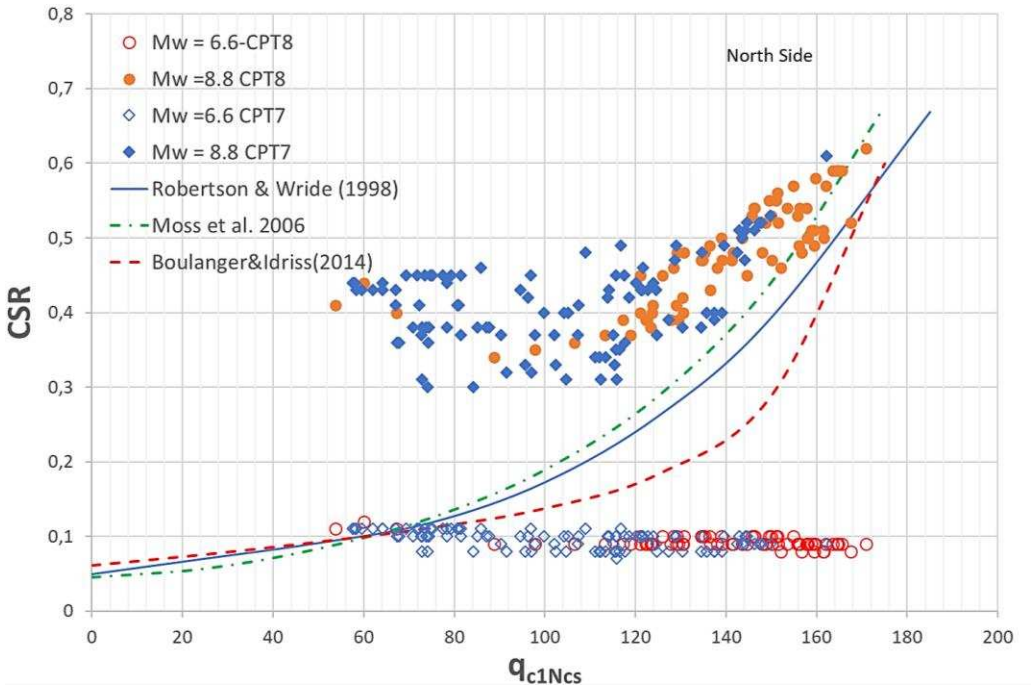
The liquefaction analysis using the CPT data and procedures Robertson and Wride (1997), Moss et al. (2006), and Boulanger and Idriss (2014) are shown in Figure 15. Boundary curves are deterministic or a 15% probability contour is used as deterministic. The analysis shown in this figure was performed for both earthquakes (M_w 8.8 and M_w 6.6), and used all CPT data until the gravel layer was reached. On the north side, the results agreed with what was observed in the field (see Figure 15). Liquefaction potential was deduced from the M_w 8.8 earthquake for almost any depth. Regarding the M_w 6.6, only a few points were on the liquefaction side, and these corresponded to depths between 7.3 m and 7.55 m, too deep to have a manifestation in surface of liquefaction (Ishihara, 1985, Youd et al., 1995).

Figure 15. Liquefaction analysis on the north side (CPTs 7 and 8) with three triggering relationships.

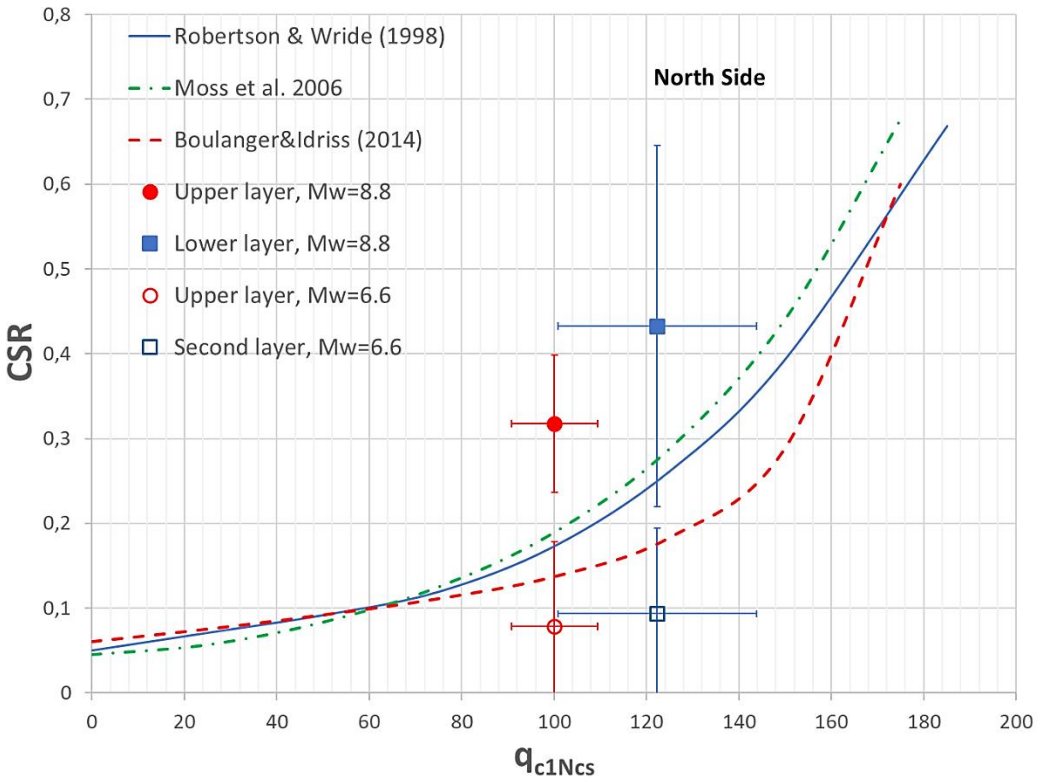
Figure 16 shows the average values for an upper layer (between 2.5 m and 3.5 m) and lower layer (between 3.5 m and 6.5 m). In addition to the mean values shown in Figure 16, the standard deviation for calculated values of CSR and q_{c1ncs} are also shown. The standard deviation of CSR was calculated following the methodology recommended by Cetin et al. (2018). As aforementioned, horizontal accelerations deduced from the attenuation relations and data from strong motion records relatively close to the Mataquito Bridge are consistent, and the coefficient of variation of maximum acceleration is assumed equal to 0.1. Ground water table standard deviation was assumed equal to 1 m. Moist and saturated unit weight were assumed to have a standard deviation equal to 0.5 kN/m3. Standard deviation of the participation factor (r_d) was calculated according to Cetin and Seed (2004). On the other hand, standard deviation of q_{c1Ncs} was calculated from the actual data from CPT sounding measurements in each critical layer considered for the analysis. The results are consistent with what was observed on the field: liquefaction occurred during the 2010 earthquake, and no effects happened during the 2019 earthquake. The Zhang et al. (2002) method was used to estimate, from CPT data, the vertical settlements due to liquefaction. In order to obtain vertical settlement similar to what was observed on the field (20 to 30 cm), it is necessary to consider that both layers liquefied. Similarly, it will be shown later that lateral spreading would also need both layers to liquefy in order for the models to match the observed horizontal displacement.

Figure 16. Liquefaction analysis on the north side; average values for CPTs 7 and 8 along with plus/minus one standard deviation.

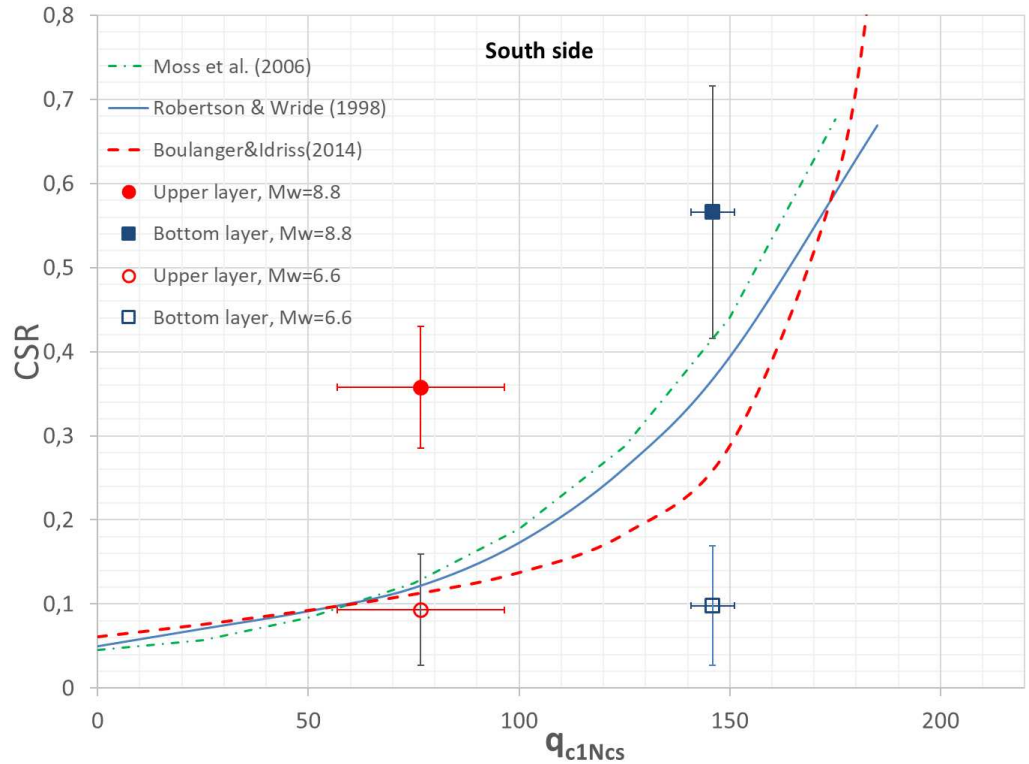
Figure 17. Liquefaction analysis on the south side; average values for CPTs 1 to 3 along with plus/minus one standard deviation.

The liquefaction analysis performed with data from CPTs 1 to 3 on the south side matches what was observed in the field. Special attention is given to the upper layer, as it is very close to the liquefaction triggering curve for the 2019 earthquake. Both Figures 16 and 17 show the standard deviation of CSR and q_{c1Ncs}, as previously explained.

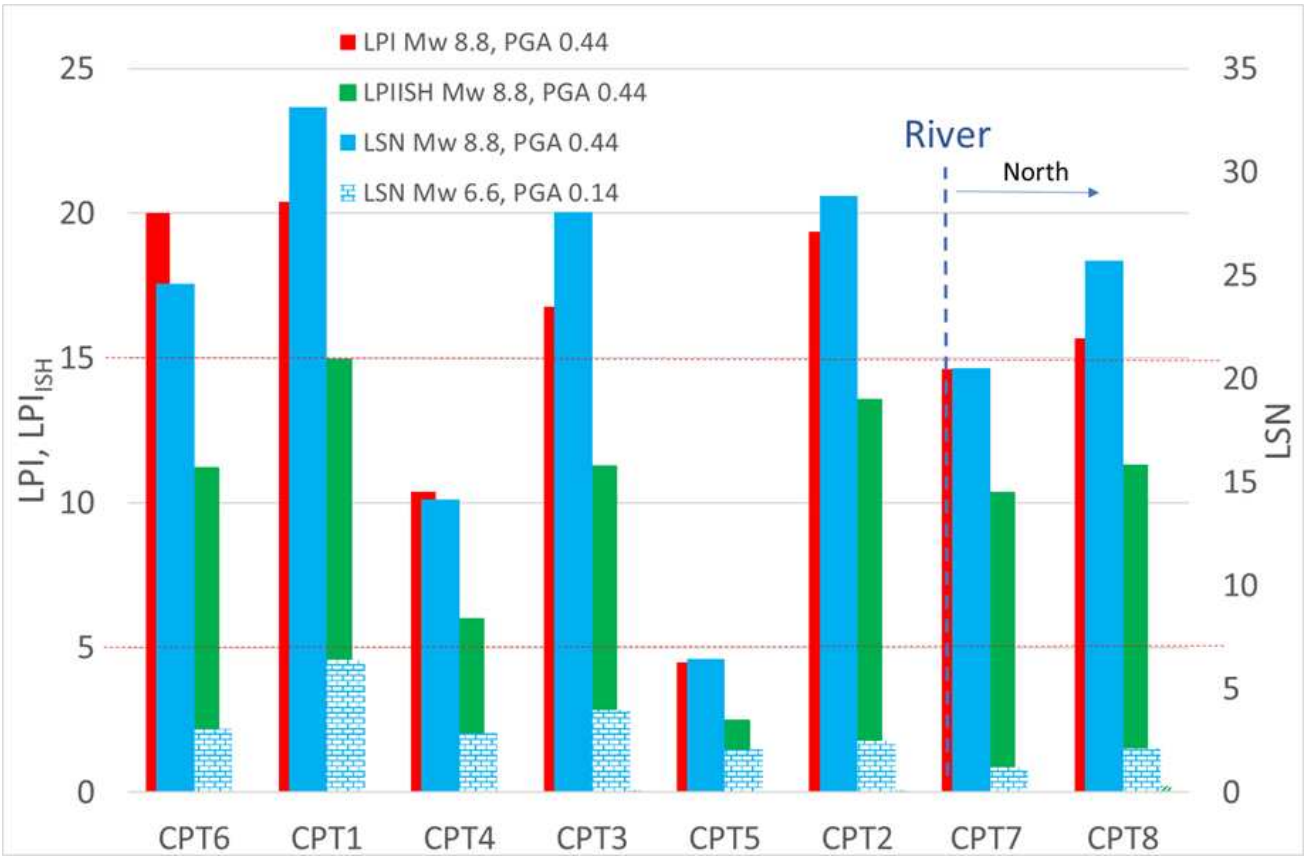
CPT data was also used to evaluate the surface manifestation, using an index such as: LPI, LPI_{ISH}, and LSN for all CPT soundings (Iwasaki et al., 1978, Maurer et al., 2015, Van Ballegooy et al., 2014). Figure 18 shows values of LSN, LPI, and LPI_{ISH}. Values of LPI and LPI_{ISH} are very sensitive when passing from the 2010 to the 2019 earthquake. According to this case history, LPI of 10 showed the liquefaction manifestation on the surface, and LPI of 0.5 did not. Calculated values of LPI and LPI_{ISH} for the 2019 earthquake were so low that they couldn't be observed in this figure. Similarly, values of LPI_{ISH} showed that for LPI_{ISH} of 6, there is liquefaction manifestation; for values lower than 0.2, however, liquefaction is not shown. On the other hand, LSN-calculated values showed that LSN above 15 liquefaction was observed—yet for values of LSN below 6.4, no liquefaction manifestation was observed.

Data from CPT 6—the CPT furthest south from the river's edge—is analyzed to show the possible variation of LPIISH with the main variables used for its liquefaction calculation, in order to check the robustness of the calculated values. A sensitivity analysis was performed for this sounding using fictional values of non-liquefaction layer (H1), fine content in depth, and PGA values to check for a possible effect of variation from the values derived from the in-situ soil exploration. The calculated average value of LPIISH was 11.2 with a standard deviation of 2.0. Similarly, for LSN, an average value of 26.4 and a standard deviation of 7.2 were obtained. For LPI, an average value of 20.0 and a standard deviation of 3.1 were obtained. Therefore, even a significant change in input values does not explain why there was no clear manifestation of liquefaction for the Mw 8.8 earthquake further away from the river's edge. One possible explanation is that the gravel layer, below the liquefied layer, and/or the ground slope are steeper further to the south from the river. And/or, this could be due to limitations of the simplified procedure used in this work to evaluate liquefaction. It has been shown that the use of the simplified method can overestimate or underestimate the potential of liquefaction as compared to a dynamic analysis of the soil. Correspondingly, assumptions such as horizontally layered soil profile, horizontal ground surface, and vertically propagating waves are not particularly accomplished at the location of CPT 6.

Figure 18. Liquefaction manifestation indexes; LSN, LPI, and LPI_{ISH}.

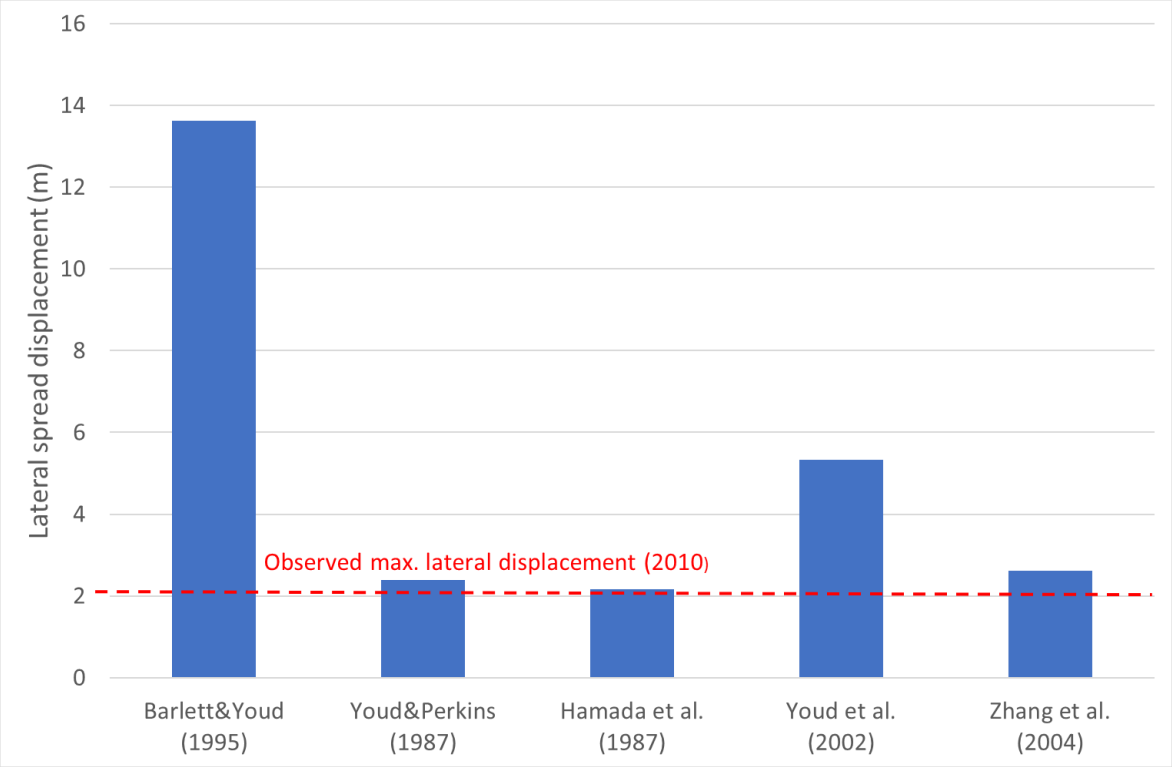
It is possible to observe that all methods (Zhang et al., 2002, Barlett and Youd, 1995, Youd et al., 1987, Hamada et al., 1987, Youd et al., 2002), with the exception of Barlett and Youd (1995) that was superseded by Youd et al. (2002), adequately predict the observed lateral displacement. This is consistent with what was mentioned by Youd et al. (2002), that erroneous data estimates were used on Barlett and Youd (1995). That caused this model to over-predict lateral spreading. Upper and lower layers were necessarily considered by these models to predict the observed displacement on the field. This confirms what was also aforementioned in this work: both layers must have liquefied during the 2020 earthquake.

Figure 19. Calculated values of lateral displacement for different predictive models.
