Liquefaction and Non-liquefaction Cases from the Mataquito Bridge, Chile, after the M$_w$ 8.8 (2010) and M$_w$ 6.6 (2019) Earthquakes

Ricardo Moffat, *Civil Engineer, Universidad Adolfo Ibáñez, Santiago, Chile; email:* *ricardo.moffat@uai.cl*
Robb Moss, *Civil Engineer, California Polytechnic State University, San Luis Obispo, USA; email:* *rmoss@calpoly.edu*

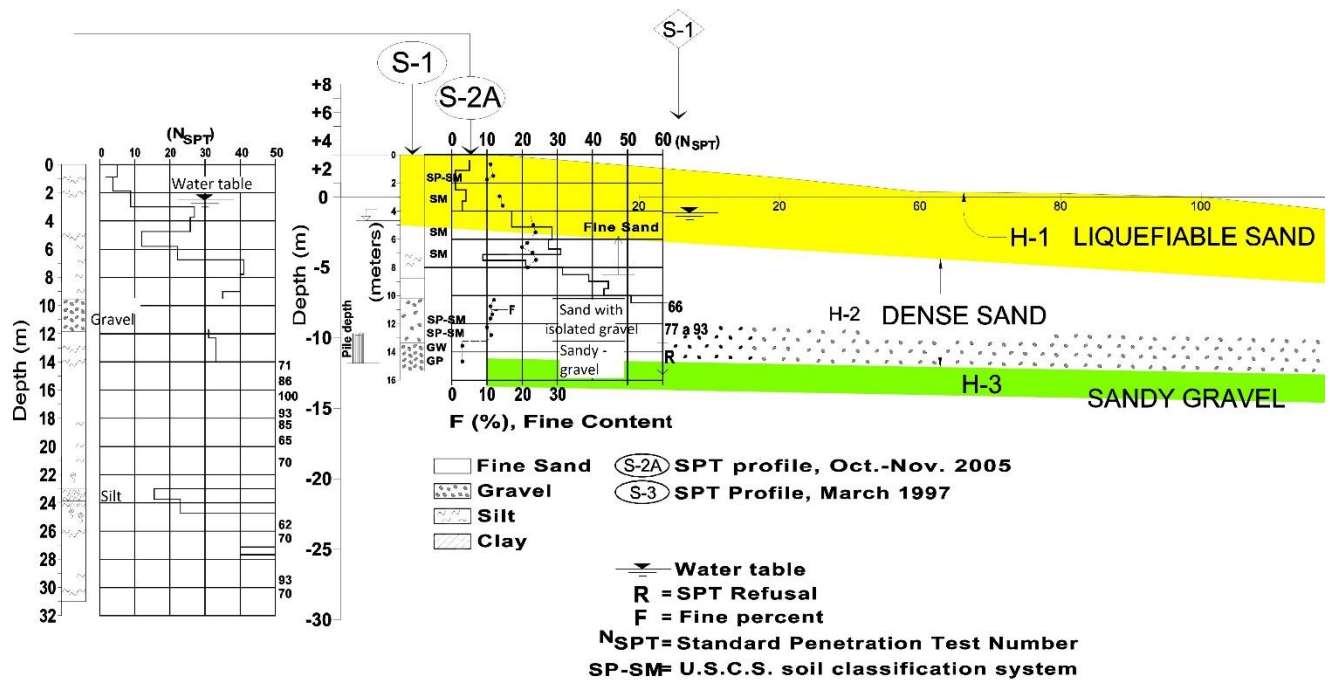
Figure 7. Subsurface information from the 1996 and 2005 investigations. The north side of the bridge is shown (modified from Petrus Consultores, 2006).

layer up to a depth of 4 m to 6 m was susceptible to liquefaction (shown in Figures 7 and 8). According to this soil exploration, the upper sand layer has a variable non-plastic fines content between 1% and 25%. As a result of this, it was recommended to use piles that reach the dense gravelly sand at about 15 m below the surface, and thus mitigate liquefaction-induced foundation failure and/or large post-liquefaction settlements of the foundations.

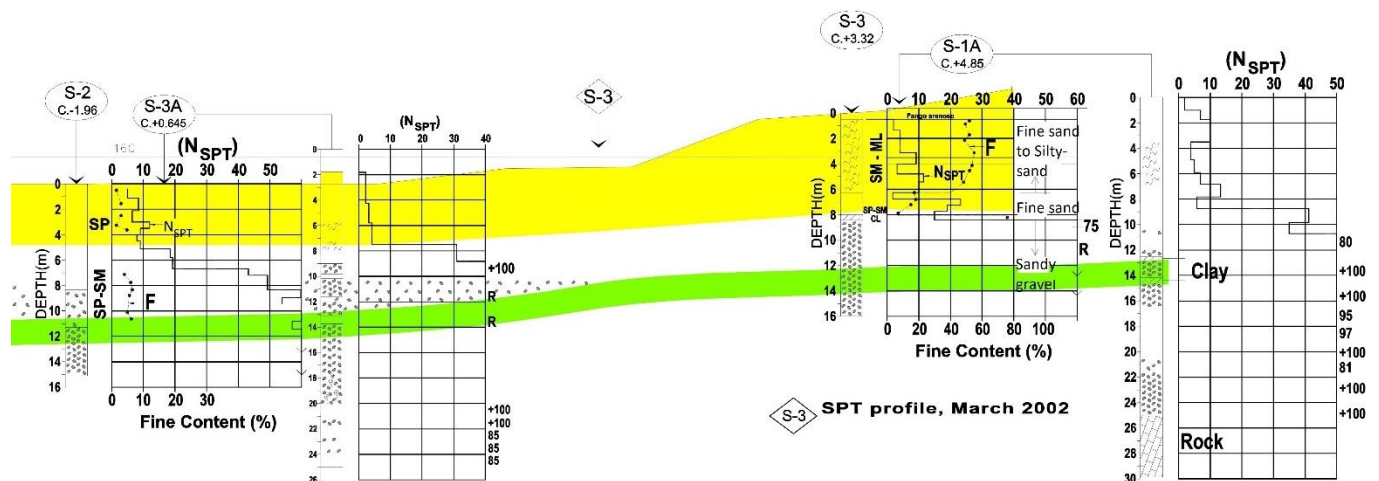
Figure 8. Subsurface information from the 1996 and 2005 investigations. The south side of the bridge is shown (modified from Petrus Consultores, 2006).

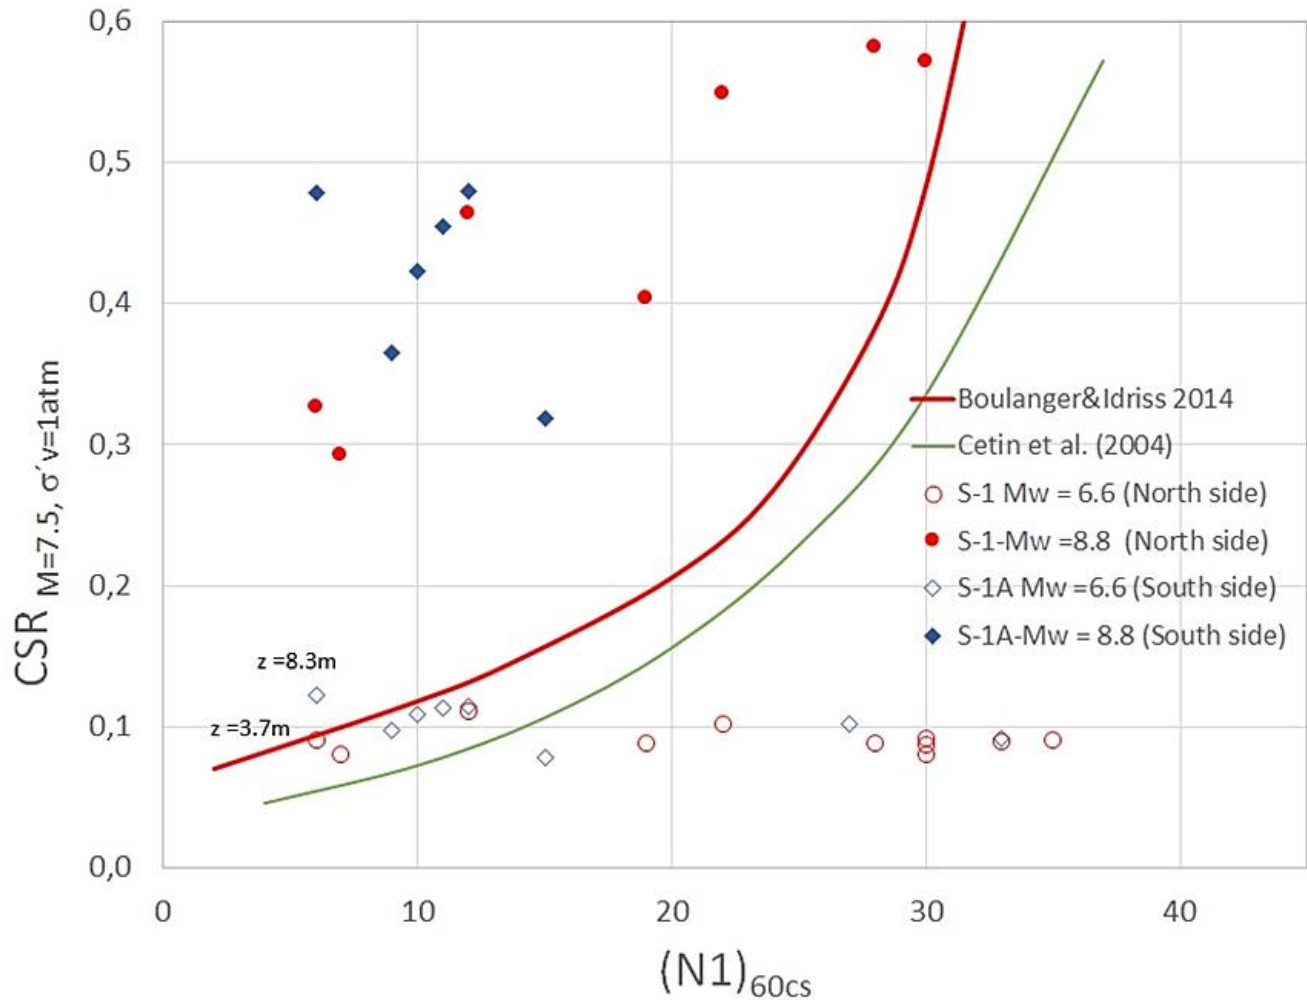
Figure 9. Liquefaction analysis with information prior to the 2010 earthquake.

Figure 9 shows the result of the liquefaction analysis using procedures (Cetin et al., 2004 and Boulanger and Idriss, 2014) with the original SPT data. Soil exploration S-1A was performed in the south side of the bridge, and soil exploration S-1 was performed in the north side. The NSPT blow count in both places are evaluated for the M_w 8.8 2010 and M_w 6.6 2019 earthquakes. Both soil explorations were located in places where the liquefaction manifestation was observed at the surface for the 2010 earthquake and no manifestation was observed for the 2019 earthquake. The evaluation for the 2010 earthquake using a PGA value of 0.44 g indicates potential liquefaction in both places (S-1 and S-1A) from depths just below the water table and down to a depth of 9 m. (Boroschek et al., 2012) proposed an attenuation relation for horizontal accelerations using the database of Chilean accelerograms located on different types of soils and recorded during earthquakes that occurred between 1985 and 2010. In Figure 10, this curve is shown together with another proposed by Zhao et al. (2006) using data from crustal and slab strong earthquakes recorded on soils. In both cases, at the rupture distance estimated for 2010 at the Mataquito Bridge, the PGA value is close to the 0.44 g used in this analysis. For the 2019 earthquake, a value of PGA equal to 0.14g was used for liquefaction evaluation. In this case, there is a border line point for data obtained at 3.7m deep at the

north side, and liquefaction potential is deduced at a depth of 8.3m in the south side (see Figure 9). This last case is probably too deep to exhibit liquefaction manifestation even if liquefaction was triggered at that depth (Ishihara, 1985 and Youd et al., 1995). Evaluation using both original data seems to correlate with field observations for both earthquakes, especially when considering the Boulanger and Idriss (2014) method.

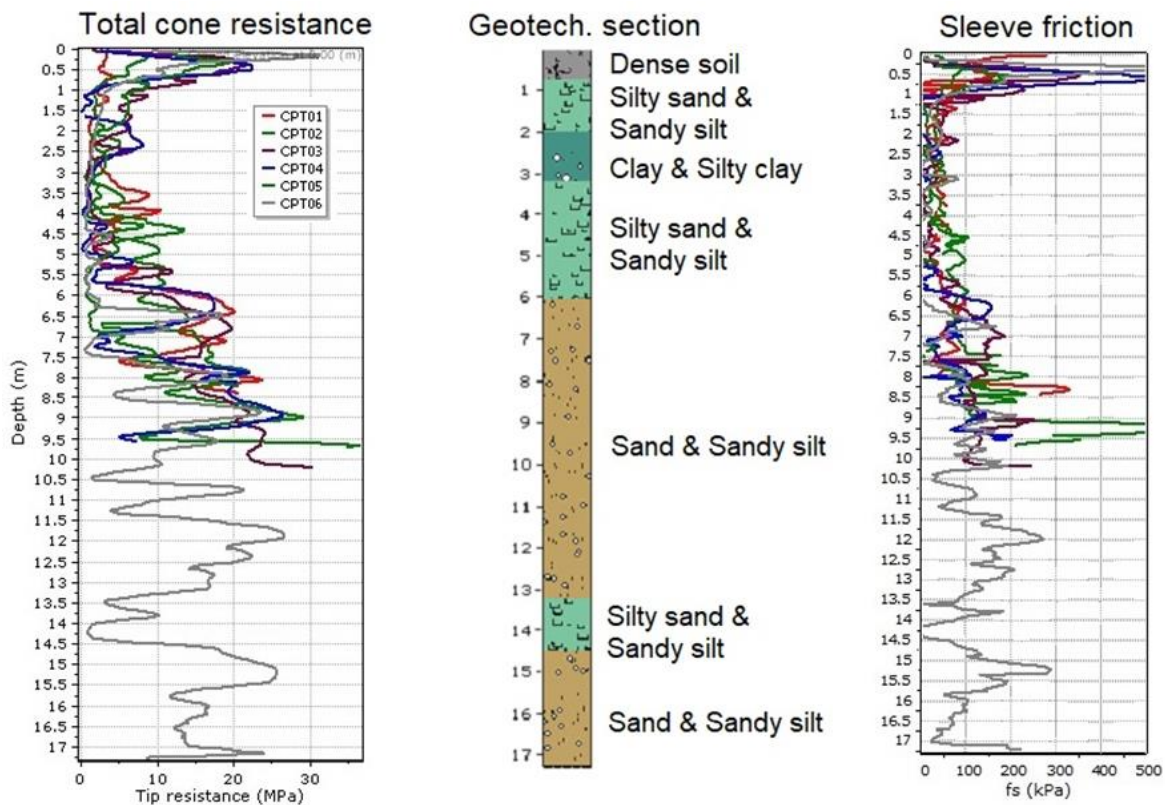
Figure 14. CPT soundings on the south side; the water table varies between 2 m to 5 m across the measured locations.

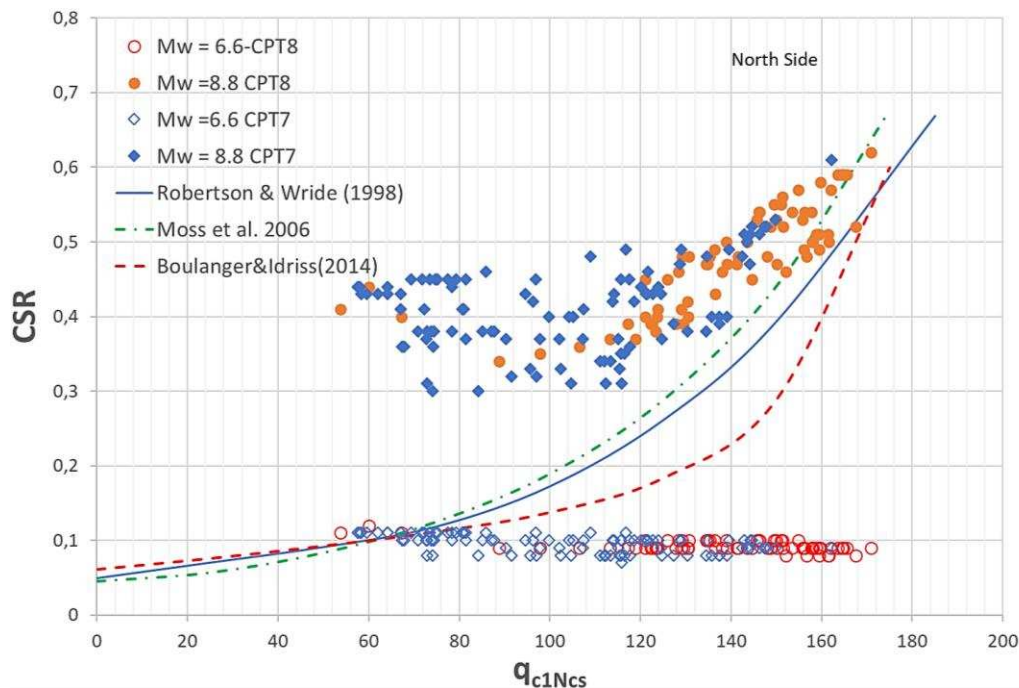
The liquefaction analysis using the CPT data and procedures Robertson and Wride (1997), Moss et al. (2006), and Boulanger and Idriss (2014) are shown in Figure 15. Boundary curves are deterministic or a 15% probability contour is used as deterministic. The analysis shown in this figure was performed for both earthquakes (M_w 8.8 and M_w 6.6), and used all CPT data until the gravel layer was reached. On the north side, the results agreed with what was observed in the field (see Figure 15). Liquefaction potential was deduced from the M_w 8.8 earthquake for almost any depth. Regarding the M_w 6.6, only a few points were on the liquefaction side, and these corresponded to depths between 7.3 m and 7.55 m, too deep to have a manifestation in surface of liquefaction (Ishihara, 1985, Youd et al., 1995).

Figure 15. Liquefaction analysis on the north side (CPTs 7 and 8) with three triggering relationships.

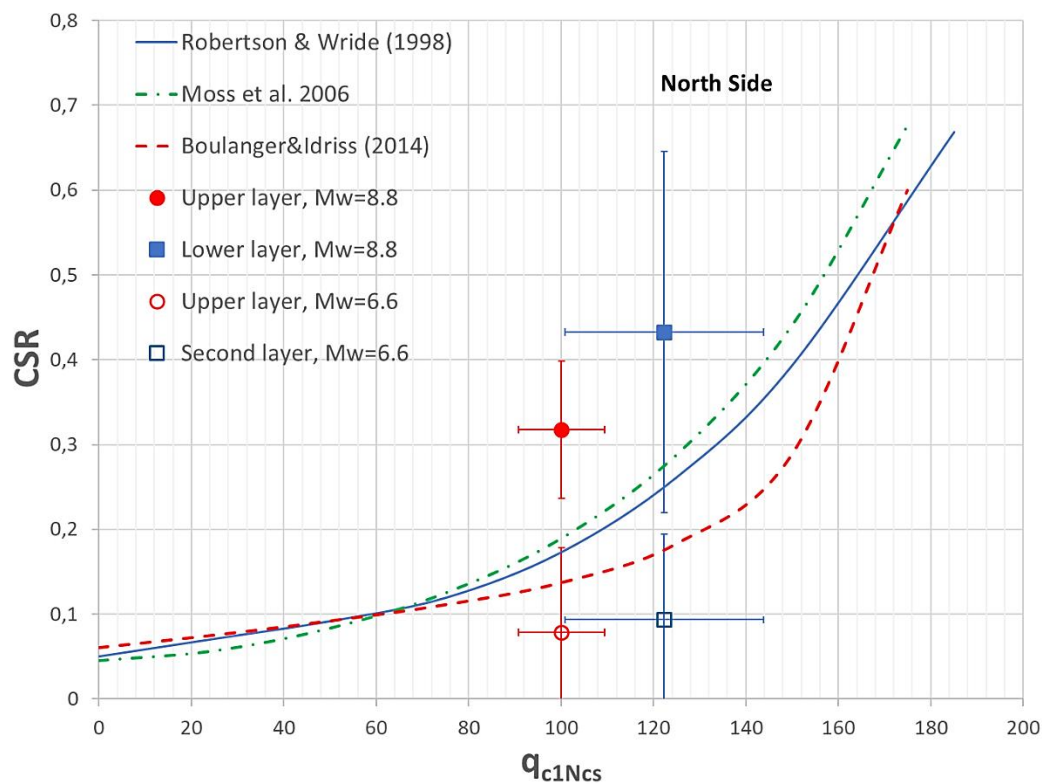
Figure 16 shows the average values for an upper layer (between 2.5 m and 3.5 m) and lower layer (between 3.5 m and 6.5 m). In addition to the mean values shown in Figure 16, the standard deviation for calculated values of CSR and q_{c1ncs} are also shown. The standard deviation of CSR was calculated following the methodology recommended by Cetin et al. (2018). As aforementioned, horizontal accelerations deduced from the attenuation relations and data from strong motion records relatively close to the Mataquito Bridge are consistent, and the coefficient of variation of maximum acceleration is assumed equal to 0.1. Ground water table standard deviation was assumed equal to 1 m. Moist and saturated unit weight were assumed to have a standard deviation equal to 0.5 kN/m3. Standard deviation of the participation factor (r_d) was calculated according to Cetin and Seed (2004). On the other hand, standard deviation of q_{c1Ncs} was calculated from the actual data from CPT sounding measurements in each critical layer considered for the analysis. The results are consistent with what was observed on the field: liquefaction occurred during the 2010 earthquake, and no effects happened during the 2019 earthquake. The Zhang et al. (2002) method was used to estimate, from CPT data, the vertical settlements due to liquefaction. In order to obtain vertical settlement similar to what was observed on the field (20 to 30 cm), it is necessary to consider that both layers liquefied. Similarly, it will be shown later that lateral spreading would also need both layers to liquefy in order for the models to match the observed horizontal displacement.

*Figure 16. Liquefaction analysis on the north side; average values for CPTs 7 and 8

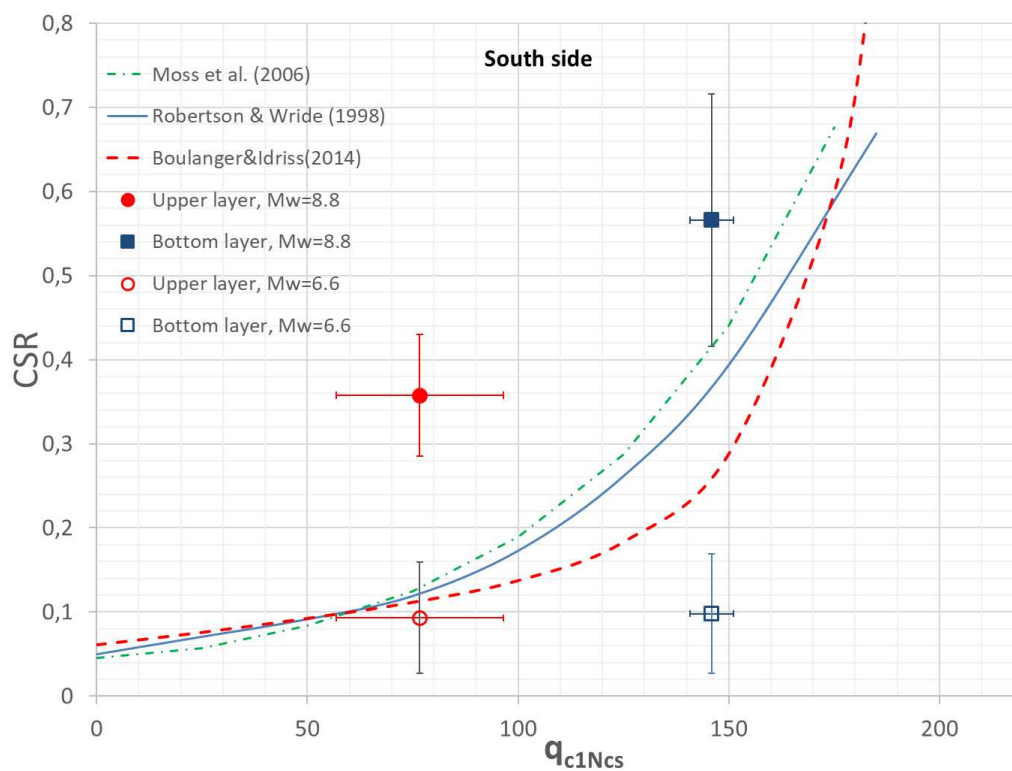
*Figure 17. Liquefaction analysis on the south side; average values for CPTs 1 to 3
along with plus/minus one standard deviation.*

The liquefaction analysis performed with data from CPTs 1 to 3 on the south side matches what was observed in the field. Special attention is given to the upper layer, as it is very close to the liquefaction triggering curve for the 2019 earthquake. Both Figures 16 and 17 show the standard deviation of CSR and q_{c1Ncs}, as previously explained.

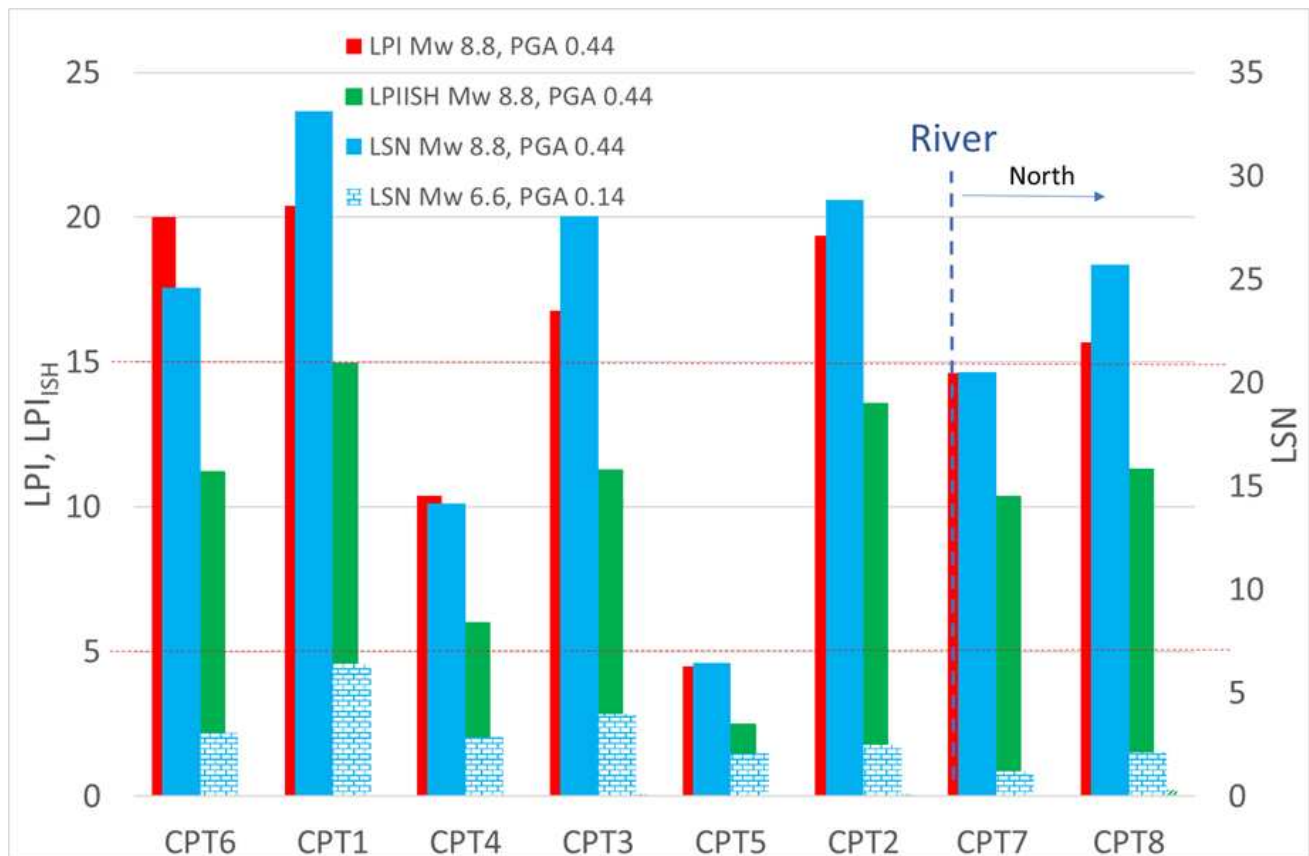
CPT data was also used to evaluate the surface manifestation, using an index such as: LPI, LPI$_{ISH}$, and LSN for all CPT soundings (Iwasaki et al., 1978, Maurer et al., 2015, Van Ballegooy et al., 2014). Figure 18 shows values of LSN, LPI, and LPI$_{ISH}$. Values of LPI and LPI$_{ISH}$ are very sensitive when passing from the 2010 to the 2019 earthquake. According to this case history, LPI of 10 showed the liquefaction manifestation on the surface, and LPI of 0.5 did not. Calculated values of LPI and LPI$_{ISH}$ for the 2019 earthquake were so low that they couldn't be observed in this figure. Similarly, values of LPI$_{ISH}$ showed that for LPI$_{ISH}$ of 6, there is liquefaction manifestation; for values lower than 0.2, however, liquefaction is not shown. On the other hand, LSN-calculated values showed that LSN above 15 liquefaction was observed—yet for values of LSN below 6.4, no liquefaction manifestation was observed.

Figure 18. Liquefaction manifestation indexes; LSN, LPI, and LPI$_{ISH}$.

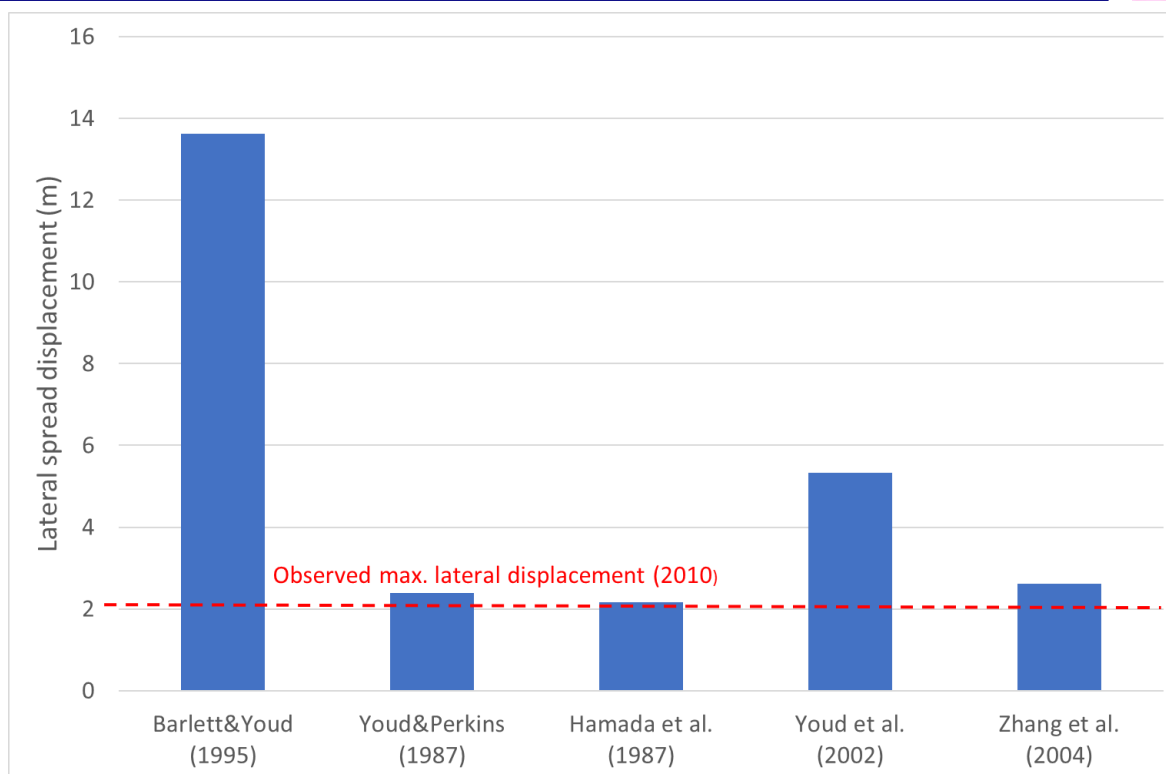
It is possible to observe that all methods (Zhang et al., 2002, Barlett and Youd, 1995, Youd et al., 1987, Hamada et al., 1987, Youd et al., 2002), with the exception of Barlett and Youd (1995) that was superseded by Youd et al. (2002), adequately predict the observed lateral displacement. This is consistent with what was mentioned by Youd et al. (2002), that erroneous data estimates were used on Barlett and Youd (1995). That caused this model to over-predict lateral spreading. Upper and lower layers were necessarily considered by these models to predict the observed displacement on the field. This confirms what was also aforementioned in this work: both layers must have liquefied during the 2020 earthquake.

Figure 19. Calculated values of lateral displacement for different predictive models.
