# Coastal Road Slope Collapses Behind a Retaining Wall Due to Scour and Erosion

**ABSTRACT**: *The present study investigates the coastal road slope disasters that took place in December 2014 and in November 2021 in Hokkaido, Japan. The coastal disasters represent collapses behind the retaining walls under high wave conditions. The results of the field investigations demonstrate that the extent of the damages was significantly larger in the 2014 disaster than in the 2021 disaster, and this difference was closely related with the presence and absence of overtopping. Based on the estimated offshore waves, a series of hydraulic wave flume experiments were conducted so as to gain insights into the disaster mechanisms. The combined field and experimental results show that the collapses were the consequence of coupled surface erosion, scour, and internal erosion beneath and behind the retaining walls. The overtopping enlarged the extent of the collapses. The paper also discusses an effective countermeasure meant to suppress such coastal road slope disasters behind retaining walls.*

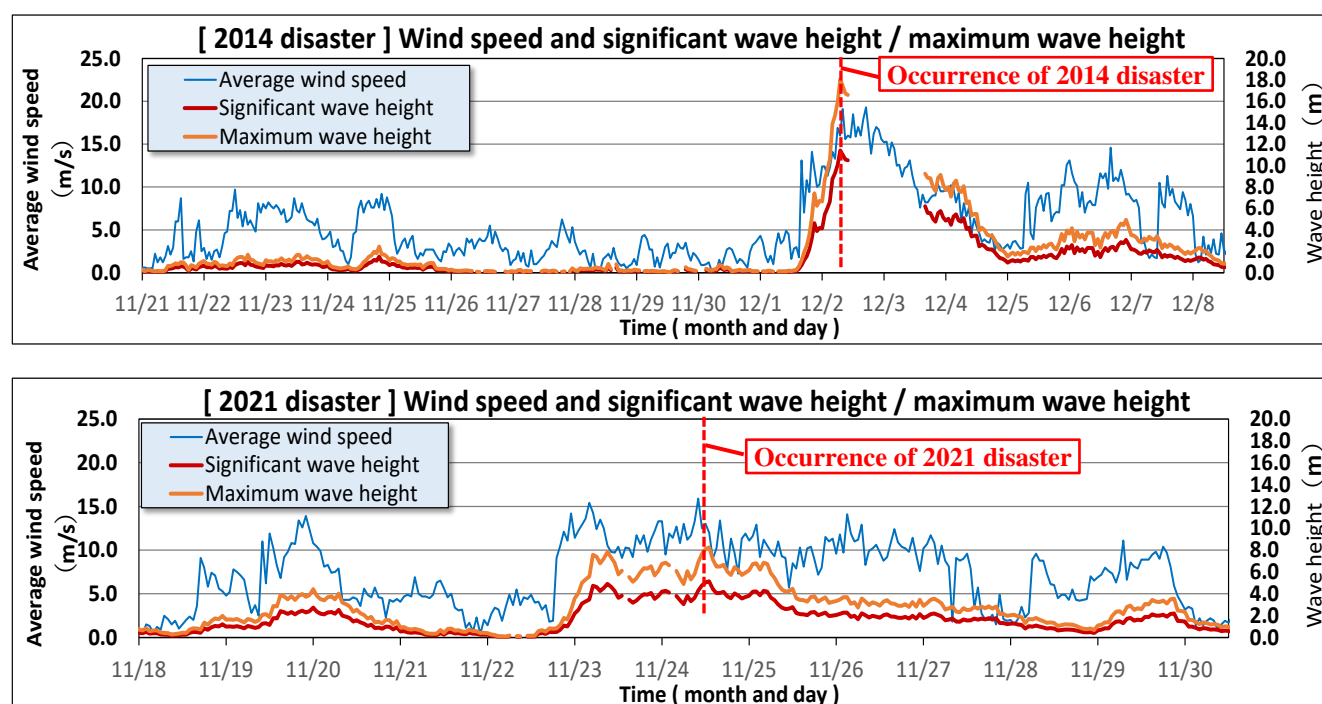
*Figure 1. Time histories of significant and maximum wave heights and average wind speeds at/around the times of the 2014 and 2021 disasters.*

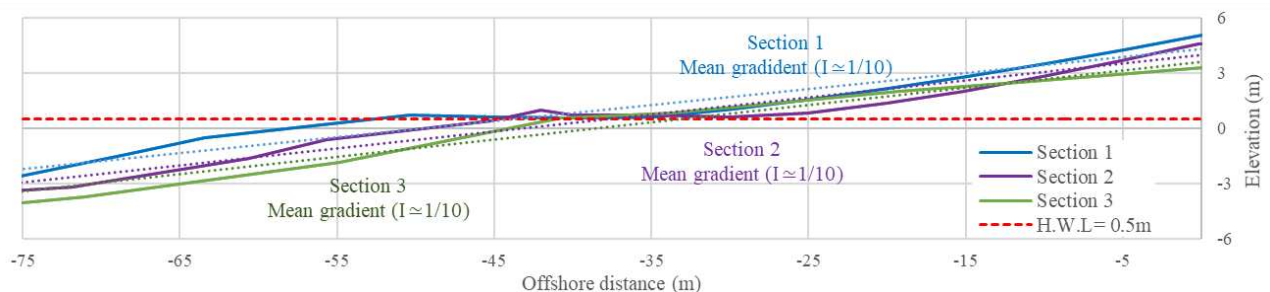
The measured results of foreshore slopes are shown in Fig. 3, together with the approximate curve for each profile measurement. The foreshore sand was coarse sand with a median grain diameter $d_{50}$ = 1.24 mm. With reference to Fig. 2, the morphological measurements were performed in Sections 1 and 2, which corresponded to the cross-shore transects adjacent to the site of the 2014 disaster, in October 2019, five years after the 2014 event. The morphological measurements were also performed in Section 3, which corresponded to the cross-shore transect just on the site of the 2021 disaster, in September 2021, before the 2021 event. This means that the measurements denote those at normal times. One can see in Fig. 3 that berms were formed near the high-water levels (H.W.L.). While the morphological heights were different from each other, the mean foreshore gradients were essentially the same at 1/10. These results, together with the above field evidence at the times of the disasters, demonstrate that the foreshore sands underwent surface erosion and deposition recurrently, bringing the morphological states into essentially the same foreshore gradients at normal times.

*Figure 3. Foreshore slope profiles at normal times. The solid lines represent measured results and the dotted lines denote the approximate curves. Sections 1, 2, and 3 correspond to those shown in Fig. 2(a).*

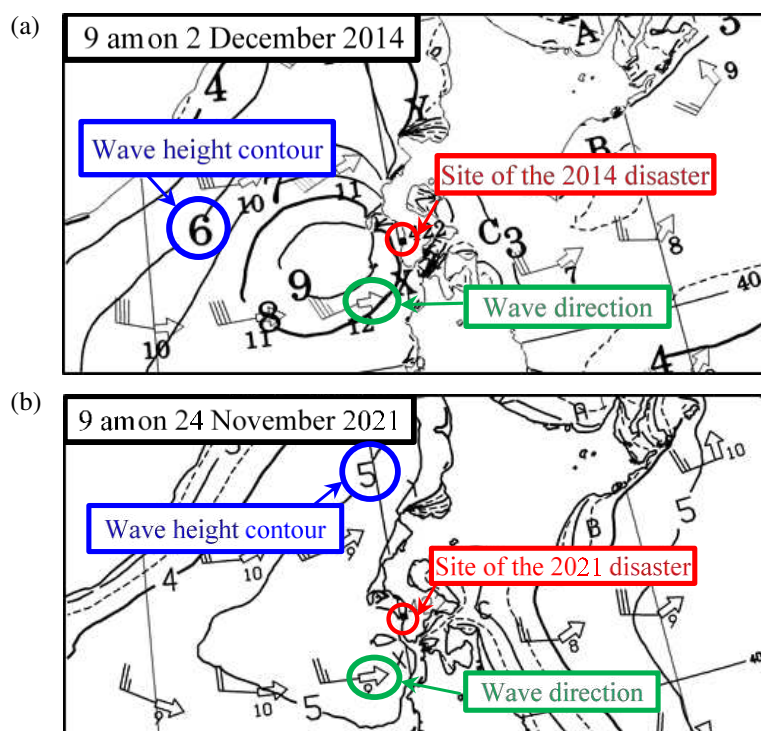
The coastal wave maps at the times of the disasters are shown in Fig. 4. For both the 2014 and 2021 disasters, waves were essentially east waves. The fact that the site of the disasters—namely, the coastal road and the foreshores—were located in the north-south direction demonstrates that the waves were propagating essentially orthogonally toward the coast. The wave conditions at the times of the disasters were numerically estimated using a third-generation wave model for coastal regions called SWAN (Simulation Waves Nearshore: Booij et al., 1999; Ris et al., 1999; SWAN Team, 2006). The calculation was conducted based on the input conditions that involved wind speeds, water depths, and bathymetry. The wind information was provided by the Japan Meteorological Agency (Grid Point Value of Meso Scale Model: GPV-MSM), and the water depth/bathymetry data were based on the General Bathymetric Chart of the Oceans (GEBCO, 2020). As the calculation domains (Fig. 5), Domain 1 covered seas surrounding Japan with the longitudes from 120.00° to 149.625° and the latitudes from 22.40° to 49.050°. Domain 2 covered a nationwide region with the longitudes from 127.125° to 143.375° and the latitudes from 33.60° to 47.45°, which included the site of the disasters and the nearby Setana Port. The lattice spacing was 0.1875° in longitude and 0.1500° in latitude for Domain 1, and 0.0625° in longitude and 0.05° in latitude for Domain 2.

*Figure 4. Coastal wave maps at the times of the disasters: (a) December 2014, (b) November 2021.*

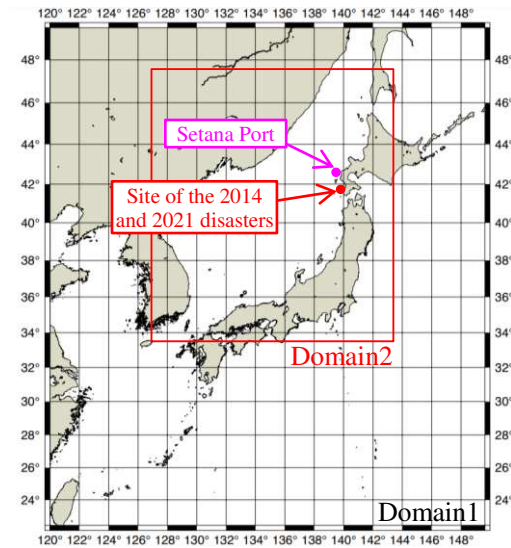
Figure 5. Calculation regions of offshore waves for the 2014 and 2021 disasters using a third-generation wave model (SWAN).

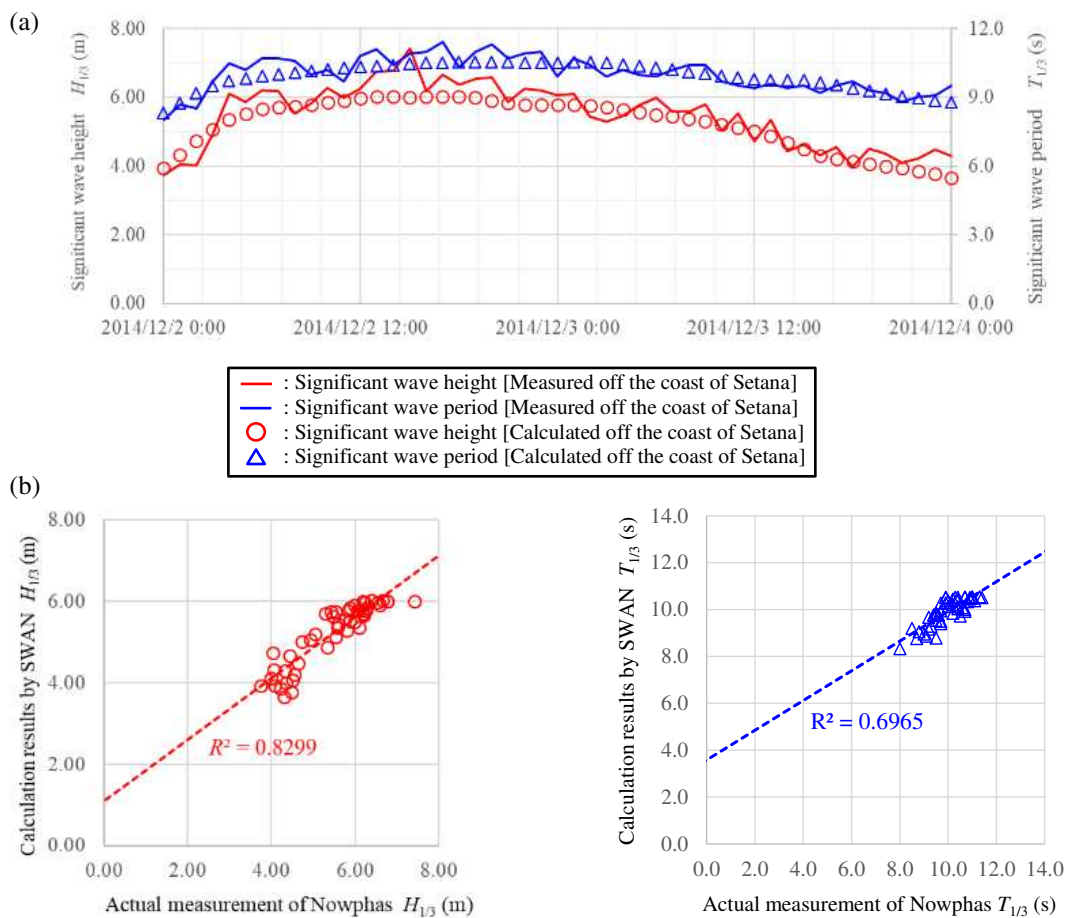
The calculated significant wave heights and significant wave periods are compared with the measured results off the coast of Setana Port in Fig. 6. The measurements were based on a national wave monitoring system, NOWPHAS (Nationwide Ocean Wave information network for Ports and HArbourS). One can see in Fig. 6 that there is a reasonably good agreement between the results of the calculations and measurements. The calculated and measured significant wave heights and significant wave periods are also well correlated with each other (Fig. 6). Based on the confirmation of the predictive accuracy, the offshore waves for the site of the 2014 disaster were estimated (Fig. 7). It is important here to note that the severe wave conditions at the time of the 2014 disaster resulted in the lack of measurements off the coast near the disaster site. In Fig. 7, a five-year probability wave and a one-year probability wave are also shown for comparison. One can see that the maximum significant wave heights reached over 6 m with the corresponding significant wave periods over 12 s. These values essentially corresponded to the five-year probability wave with the significant wave height $H_{1/3} = 6.7$ m and significant wave period $T_{1/3} = 12.9$ s. The estimated offshore waves for the site of the 2021 disaster are shown in Fig. 8, and are generally in good agreement with the measured results. The 2021 offshore waves wholly corresponded to the one-year probability wave with the significant wave height $H_{1/3} = 4.6$ m and significant wave period $T_{1/3} = 10.7$ s. Overall, the above results indicate that the offshore waves at the time of the 2014 disaster reached the five-year probability wave, whereas the offshore waves at the

Figure 6. Calculaed and measured results of significant wave heights and significant wave periods off the coast of Setana: (a) Time histories, and (b) Correlations.

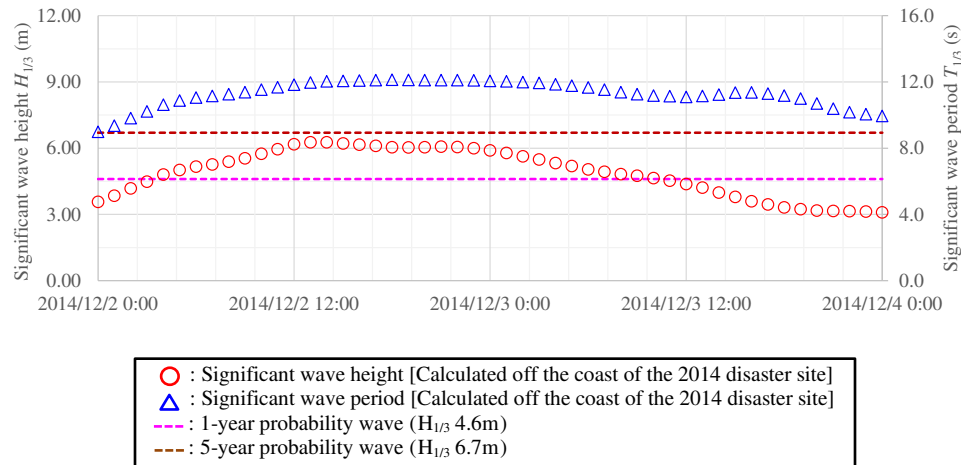
time of the 2021 disaster were essentially the one-year probability wave. This information was used for setting the external forces, namely, the input offshore waves for the hydraulic wave flume experiments as described below.

*Figure 7. Estimated significant wave heights and significant wave periods off the coast of the 2014 disaster site. The 1-year probability wave and 5-year probability wave are also shown for comparison.*

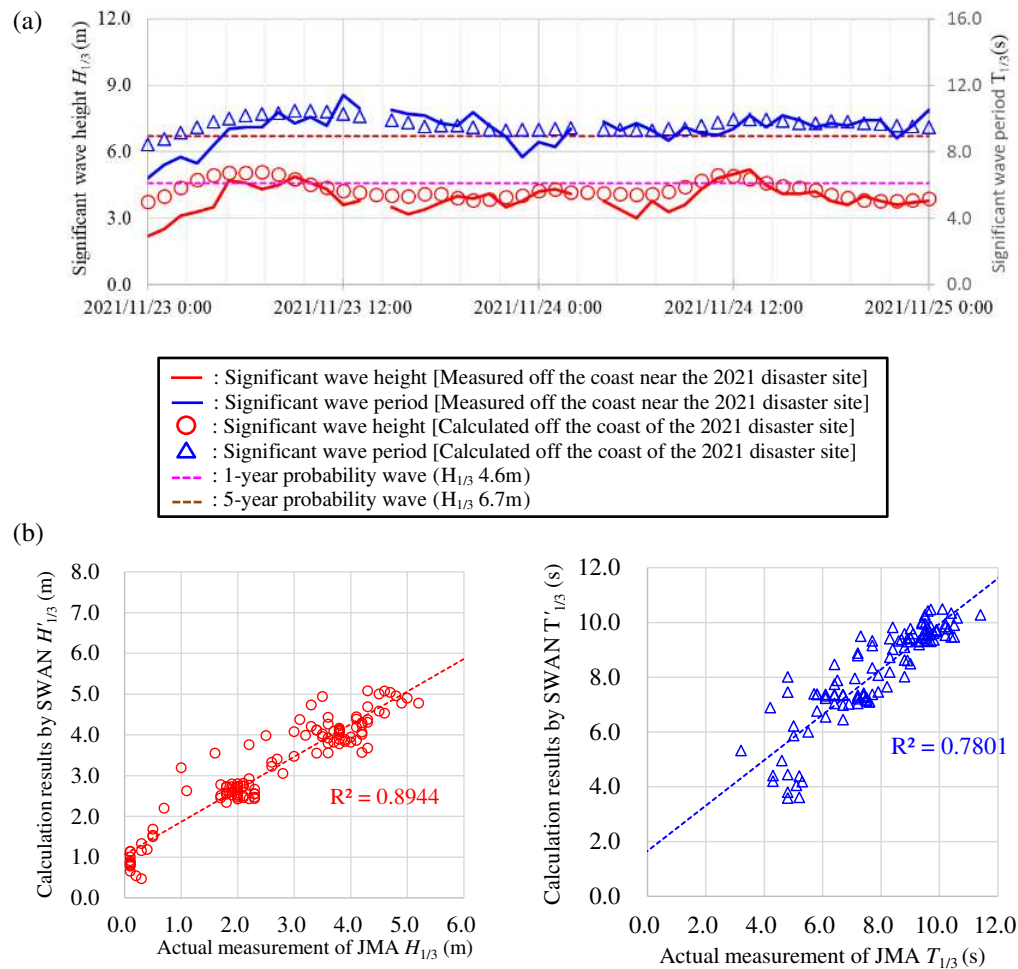
*Figure 8. Calculated and measured results of significant wave heights and significant wave periods off the coast of 2021 disaster site: (a) Time histories, and (b) Correlations.*

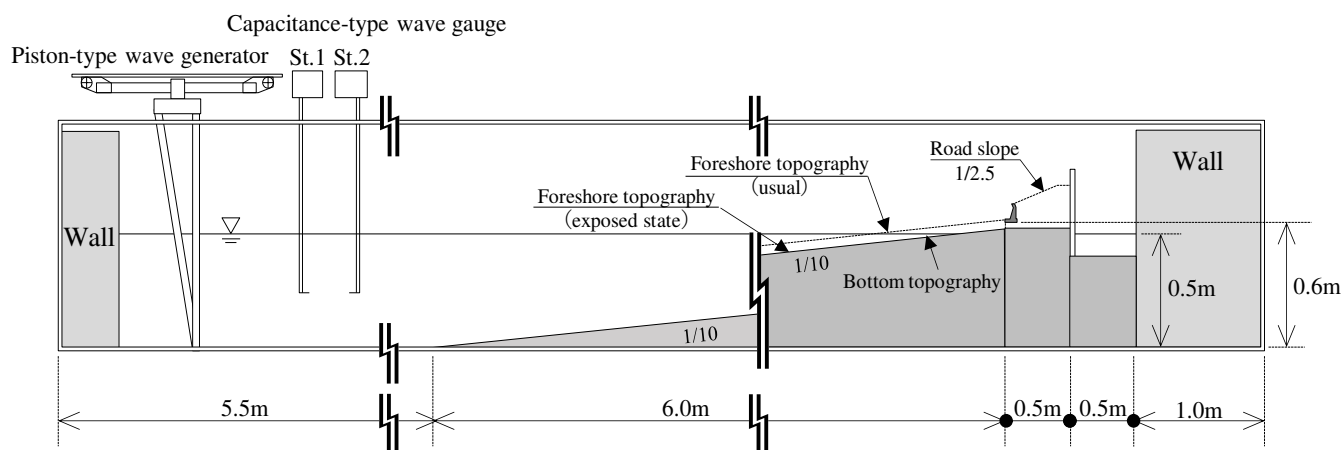
The experiments were conducted on a two-dimensional cross-section using a wave flume at the National Institute of Technology, Hakodate College, in Hokkaido, Japan. The wave channel is 13.5 m long, 0.9 m high, and 0.5 m wide and has a piston-type wave-maker at the left end of the channel (Fig. 9). The scale of the experiments was 1/50th with reference to the foreshores and retaining walls at the site of the 2014 and 2021 disasters described above. On the basis of the Froude similarity law, the five-year probability wave ($H_{1/3}$ = 6.7 m, $T_{1/3}$ = 12.9 s) and the one-year probability wave ($H_{1/3}$ = 4.6 m, $T_{1/3}$ = 10.7 s) were converted to irregular waves with the offshore significant wave heights of 13.4 cm (6.7 m/50) and 9.2 cm (4.6 m/50) and the offshore significant wave periods of 1.82 s ($12.9/\sqrt{50}$) and 1.51 s ($10.7/\sqrt{50}$)) respectively, using the Bretschneider-Mitsuyasu (BM) spectrum that is widely known to represent fully-grown wind waves (Bretschneider, 1968; Mitsuyasu, 1970). The coastal bottom slope gradient was set equal to 1/10 and the coastal road slope gradient behind the top of the retaining wall was set equal to 1/2.5 in light of the field. The sand used was silica sand with a median grain diameter $d_{50}$ = 0.42 mm. This was determined with reference to the measured permeability coefficient $k_w$ = 0.038 cm/s that was $1/\sqrt{50}$ -scale of the measured permeability coefficient $k_w$ = 0.267 cm/s of the foreshore sand ($d_{50}$ = 1.24 mm) in the field.

*Figure 9. Schematic diagram of a two-dimensional wave flume at National Institute of Technology, Hakodate College, in Hokkaido, Japan, and the experimental setup for the 2014 and 2021 disasters.*

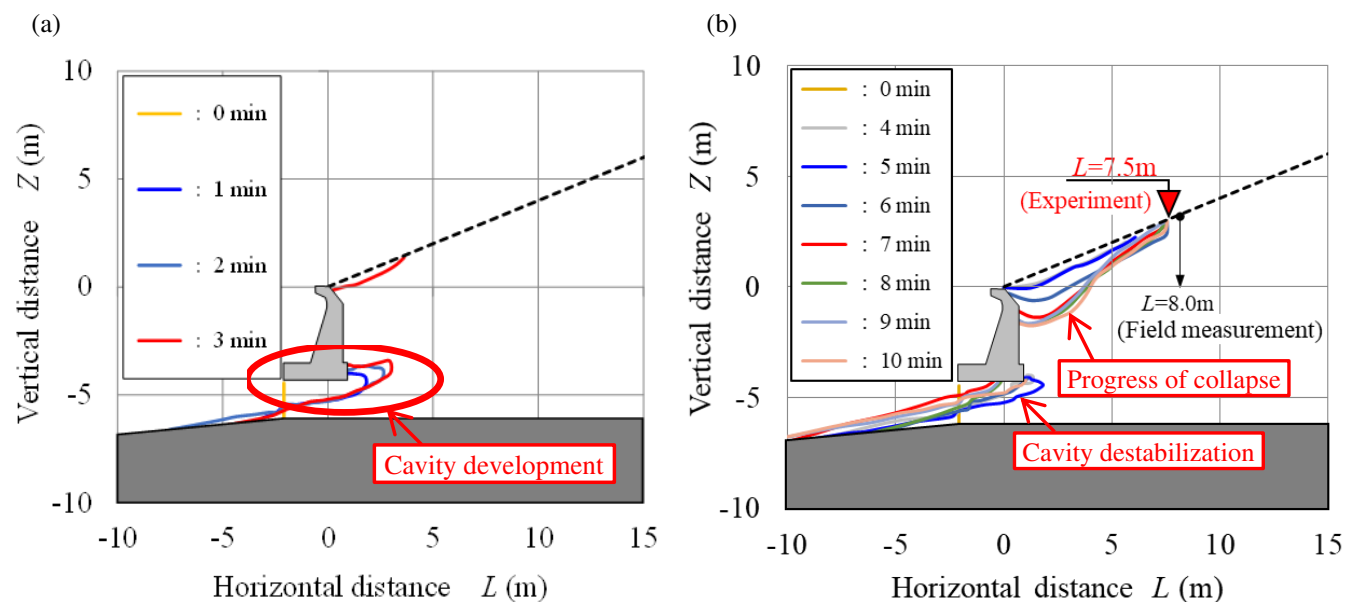
The results of the first series of the wave flume experiment for the 2014 disaster are shown in Fig. 10. At the start of the experiment, the base of the retaining wall was already exposed. The five-year probability wave gave rise to the occurrence of internal erosion beneath the base of the retaining wall. This was accompanied by the formation of a cavity, and the cavity developed towards the back of the retaining wall. Meanwhile, the overtopping induced by the five-year probability wave caused erosion of the slope surface behind the top of the wall. The continued action of the five-year probability wave also resulted in the progress of collapse behind the retaining wall in association with the destabilization of the cavities formed

Figure 10. Results of the wave flume experiment for the 2014 disaster. Progress of internal erosion and collapse beneath/behind the retaning wall at: (a) 0 to 3 minutes, and (b) 4 to 10 minutes after the start of the experiment. Contours of deformations on a prototype scale.

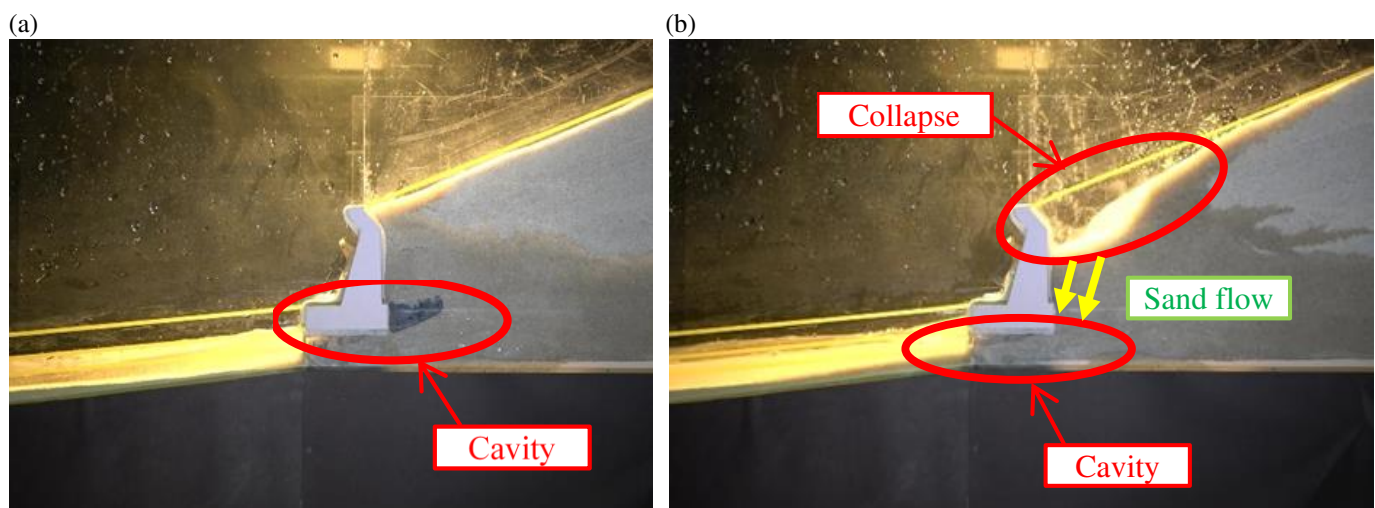
behind and beneath the retaining wall. The extent of the collapse was equal to 7.5 m on a prototype scale, which was consistent with that of 8 m as a result of the field measurement for the 2014 disaster, as mentioned above. Such progress of internal erosion and collapse beneath and behind the retaining wall can be more directly seen from the photographs shown in Fig. 11. Here, one can see the concurrent cavity occurrence, sand flow, and collapse surrounding the retaining wall.

Figure 11. Results of the wave flume experiment for the 2014 disaster. Progress of internal erosion and collapse beneath/behind the retaning wall at: (a) 0 to 3 minutes, and (b) 4 to 10 minutes after the start of the experiment. Photographs.

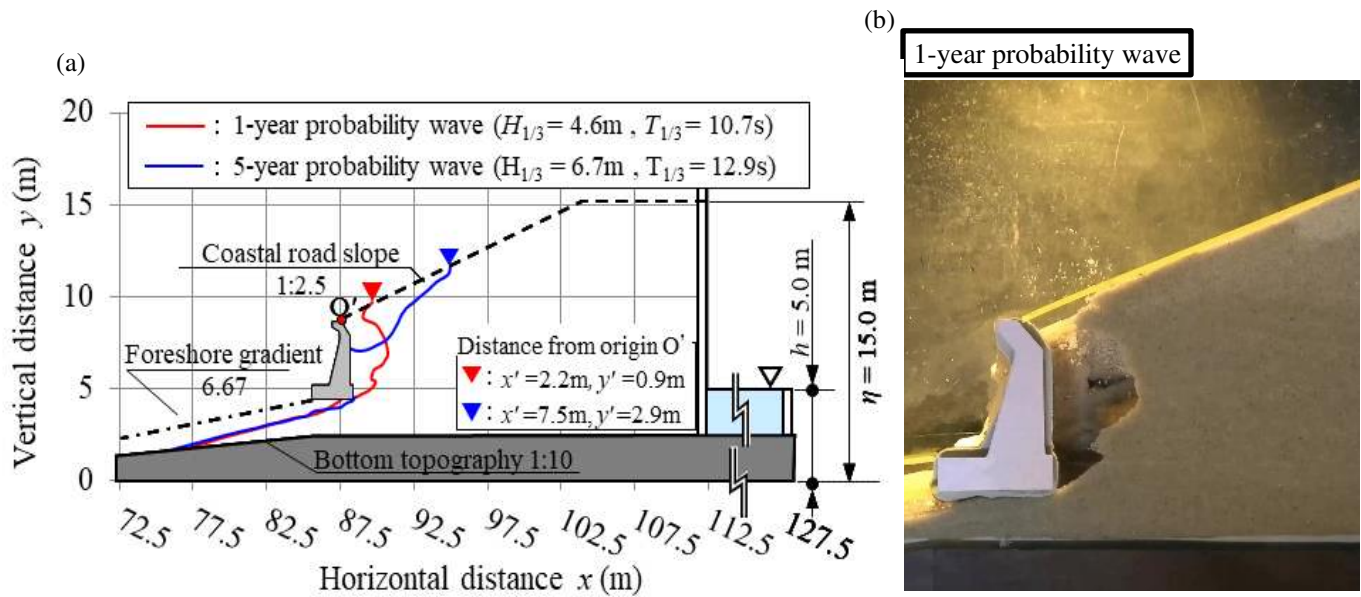
The results of the second series of the wave flume experiment for the 2021 disaster are shown in Fig. 12. Fig. 12(a) shows deformations as a consequence of the one-year probability wave. The results indicate that the foreshore sands were lost due to surface erosion and scour in front of the base of the retaining wall. Under the continued action of the one-year probability wave, the internal erosion progressed beneath and behind the retaining wall, and collapse occurred. The extent of the collapse, however, was significantly smaller than the extent of collapse under the five-year probability wave that accompanied overtopping (Fig. 12(a)). Fig. 12(b) shows the situation of collapse in the absence of overtopping under the one-year probability wave.

*Figure 12. Results of the wave flume experiment for the 2021 disaster: (a) Comparison of deformations on a prototype scale beneath/behind the retaning walls under 1-year and 5-year probability waves, and (b) Collapse behind the retaining wall under 1-year probability waves.*

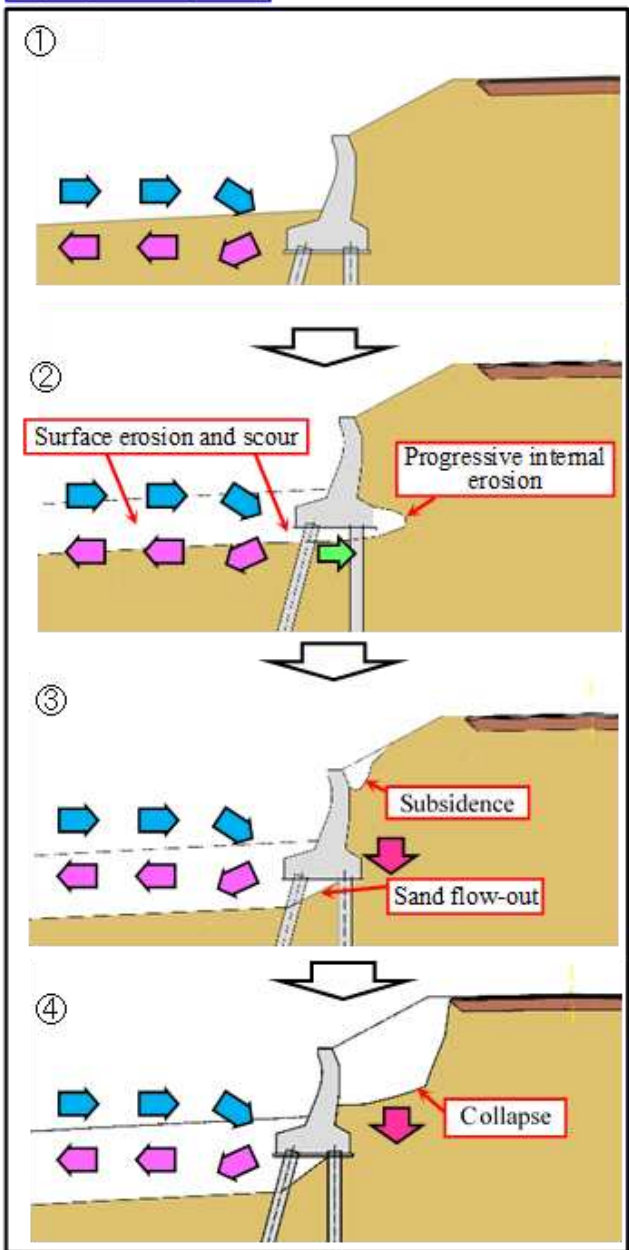
The processes and mechanisms for the 2014 and 2021 disasters based on the field, numerical, and experimental investigations described above can be schematically shown in Fig. 13. For the 2014 disaster, the five-year probability wave produced wave overtopping. The wave-induced runup and return flow, i.e., swash and backwash, acted on the foreshore sands and the weak erodible bedrock. These caused surface erosion and scour in front of the base of the retaining wall. The continued severe wave action then gave rise to the occurrence of progressive internal erosion, accompanied by the formation of cavities beneath and behind the retaining wall. In the meantime, the wave overtopping/overflow led to erosion of the road slope surface behind the top of the wall. Here, the overflow represents infiltration that reduces suction in the ground, which has been shown to destabilize cavities formed by the wave-induced internal erosion (Kudai et a., 2021), and the overflow promotes flow-out of granular materials beneath a foundation of coastal structures (Sassa et al., 2016). Hence, the coupled severe wave action and overflow brought about subsidence and sand flow-out that resulted in a large collapse behind the retaining wall.

In contrast, the 2021 disaster stemmed from the one-year probability wave that did not produce wave overtopping. Nevertheless, the wave-induced runup and return flow, i.e., swash and backwash, were severe enough to cause surface erosion and scour in front of the base of the retaining wall, which gave rise to progressive internal erosion beneath and behind the retaining wall. The continued wave actions involving swash and backwash destabilized the cavities formed, leading to subsidence and sand flow-out. As a consequence, collapse occurred behind the retaining wall. Overall, both the 2014 and 2021 disasters share the same basic mechanisms: namely, the coupled surface erosion, scour, and internal erosion beneath and behind the retaining wall, which led to collapse. The existence of the overtopping flow enlarged the extent of collapse in the 2014 disaster compared to the 2021 disaster.

*Figure 13. Sketches based on the field, numerical, and experimental investigations, showing the processes and mechanisms of the 2014 and 2021 disasters.*

The above results and discussion indicate that the 2014 and 2021 disasters stemmed from the wave-induced internal erosion beneath and behind the retaining wall. This means that the deterrence of the internal erosion beneath the base of the retaining wall may serve as an effective countermeasure to prevent the occurrence of future collapse behind the retaining wall. This can be achieved by applying an appropriately designed filter, which has been shown to have a sufficient deterrent effect under strong hydraulic forcing at coasts (Kudai et al., 2021). Deterring the wave-induced internal erosion beneath the base of the retaining wall should thus be a viable measure, which could be conducted in conjunction with a protection work to suppress the influence of overtopping on the coastal road slope surface behind the retaining wall.
