# Preliminary Field Assessment of Sinkhole Damage in Pokhara, Nepal

**ABSTRACT:** Since November 2013, numerous sinkholes have been forming in the Armala area of Pokhara Valley, Central Nepal, posing serious threat to local residents. In order to provide measures aimed at reducing sinkhole risk, investigations into the cause and features of the sinkholes are crucial. This paper presents early research results based on two damage surveys conducted in June 2014 and November 2014 in the Armala area. Comparison of photos, taken in the two surveys, clearly indicates not only the formation of new sinkholes, but also the re-activation of filled sinkholes. By means of dynamic cone penetration tests and surface wave method investigations, qualitative characterization of the soil profile was attained, and shallow weak soil layers which are believed to be the location for future sinkholes could be identified. On the basis of the field investigation results, possible sinkhole formation mechanisms are identified for the Armala area. Furthermore, results of a reconnaissance survey conducted in the Armala area in early May 2015 (following the 2015 Gorkha Nepal Earthquake, which occurred on April

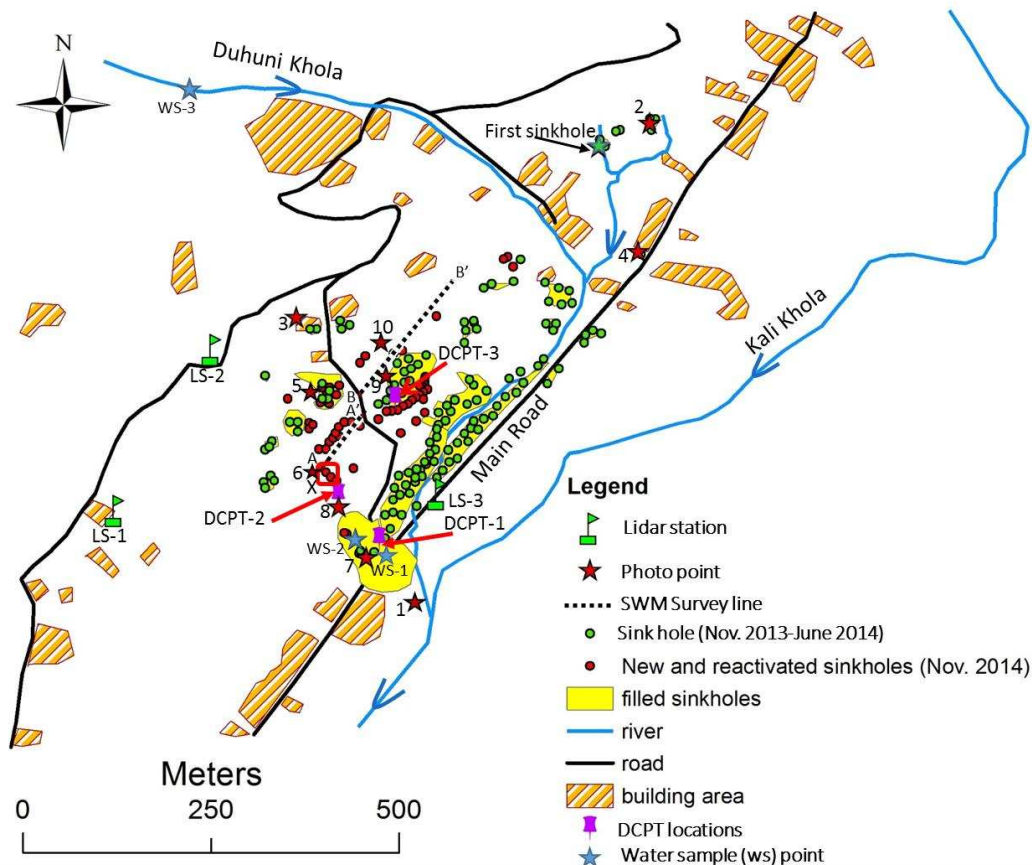
Figure 2. Detailed map of the sinkhole damaged area in Armala.

A detailed map of the study area reporting the location of sinkholes observed in June and November 2014, photo points and field investigations are shown in Figure 2. Topographically, the study area is a low-elevated zone as shown by the bird's eye view presented in Figure 3. This 3D image was obtained by overlapping LiDAR scanning carried out at three different locations (i.e. LS-1, LS-2 and LS-3 reported in Figure 2). There is a very gentle slope in the south-east direction, while a steep slope can be noticed in the north-west part. The black zones enclosed within circles are interconnected sinkholes as observed in November 2014.

During the June 2014 survey, the trace of a number of sinkholes previously formed since November 2013 could be typically observed in both sides of the Duhuni Khola (green dots in Figure 2). All the sinkholes were completely back filled, except for the sinkholes at photo points 7 and 8 (see also Figures 10 and 11). Originally, they had a diameter of about 10m and a depth of about 7 m. However, at the time of the survey, the upper part was already partially filled by sediments, and the measured depth was less than 4 m.

During the November 2014 survey, a number of sinkholes of recent formation (known to have formed in August 2014) were mostly observed in the west side of the surveyed area. In the map shown in Figure 2, it can be seen that the new sinkholes (shown as red dots) are concentrated on the western side of the old sinkholes. Some of the new sinkholes may be old sinkholes re-activated during the rainy season in 2014.

Immediately after the occurrence of the sinkholes, a wide area affected by the cave-in was backfilled by using gravelly soil retrieved from nearby quarries, which is identified by a yellow color filled area in Figure 2. Though, at the time of the first damage survey in June 2014, most of the sinkholes had been fully backfilled (Figure 7a corresponding to photo point 5), the photos taken in November 2014 at the same location clearly show that the backfilling was not an adequate solution as most of the former sinkholes were re-activated (Figure 7b) likely in August 2014 during the peak rainy season in Pokhara Valley.

Among many, sinkholes N1, N2 and N3 in the area X shown in Figure 2 were found to be of particular interest. They were developed in a delimited area of approximately  $10 \text{ m} \times 20 \text{ m}$ , as shown in the schematic map shown in Figure 8. They have a circular pattern and diameters ranging from 4.6 m (N3) to 6.8 m (N1). Their depth measured at the top of the collapsed soil varied from 2.2 m (N1, N3) to a maximum of 3.5 m (N2). According to witnesses, N1 was the first sinkhole to be formed. A few days later, N2 caved-in and finally N3 developed. This progressive formation of several sinkholes along a straight line (moving along the uphill direction from N1 to N3) may suggest that the collapse of N1 caused the complete disruption of underground water flow. Consequently, water started to erode the soil just adjacent to N1 until a new cave-in (N2) was formed. In a similar way, N3 was later developed. The same pattern of sinkhole formation occurred often since November 2013. Most of the newly developed sinkholes are located on the upstream side of the underground water flow.

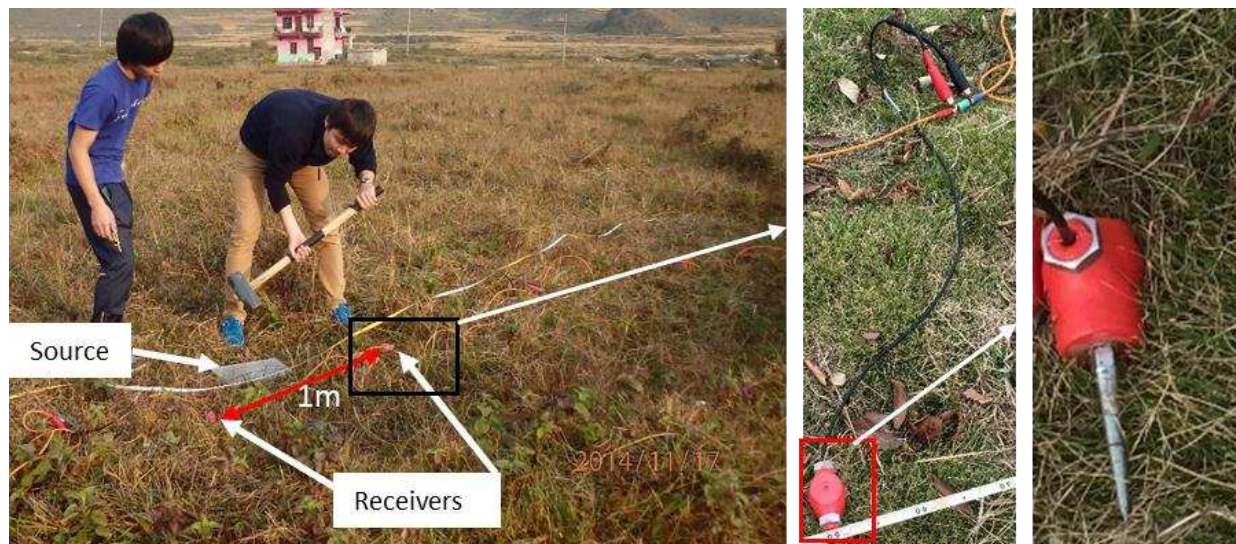
Figure 14. Surface wave method used in this investigation.

SWM surveys were performed along the two sections A-A' and B-B' shown in Figure 2 and Figure 3. The total length of the survey was 263 m (i.e. 95 m along the section A-A' and 168 m along the section B-B'). The testing conditions consisted of 24 vertical-component geo-phones (Figure 14) placed at 1m interval while ensuring good contact with soil. A 5 kg hammer was used to generate surface waves by impacting vertically on a rubber plate. The source was also positioned at 1m interval, to be precise at 0.5 m between two subsequent geophones.

After finishing one 24 m profile, the subsequent measurement was made with at least 3 geophones overlapping. The nearest source to the receiver offset was 0.5 m. An OYO MCSEIS-SW was used for data acquisition. Figure 14 shows the typical surface wave method alignment used in this investigation.
