Remediation of The Pissouri Landslide in Cyprus

ABSTRACT: During the winter of 2001-2002, a landslide of 80.000 m³ was activated and moved downslope at the Northeast outskirts of the Pissouri village in Cyprus (Limassol prefecture), displacing a section of a country road that was crossing the upper part of the sliding mass and destroying three newly built residences. This paper presents the geologic and hydrogeologic regime of the landslide and its implication on the landslide's mobilization. Geotechnical site investigation and post failure monitoring, in conjunction with slope stability back analysis formed the basis for the study of the slide and subsequently guided the remediation strategy. Various possible interventions to stabilize the slope and allow the safe reconstruction of the displaced road have been investigated and compared considering both economic and environmental criteria. The performance of the remediation measures has been studied in terms of stability safety, using numerical models previously calibrated via back analyses. Observations made during the execution of the stabilization works provided additional data verifying and supplementing the original design.

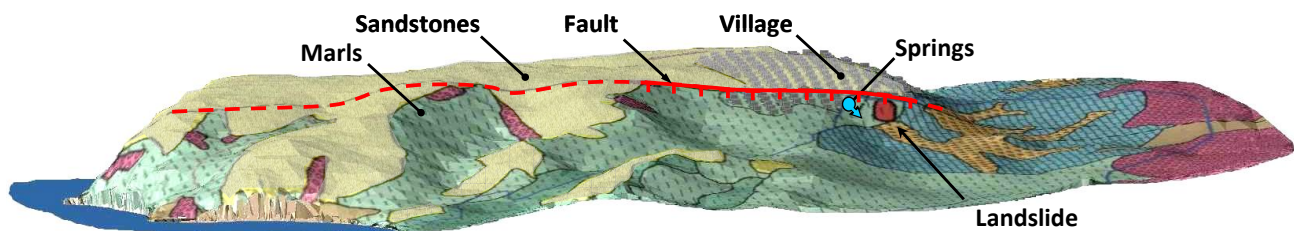
Figure 9. Hydrogeologic setting of the Pissouri area. Geological units (after Stow et al., 1995) are projected on the distorted relief of the Pissouri hill (exaggerated vertical scale H/V 2:1). Location of the landslide and the springs with respect to the major hydrogeologic units are also noted.

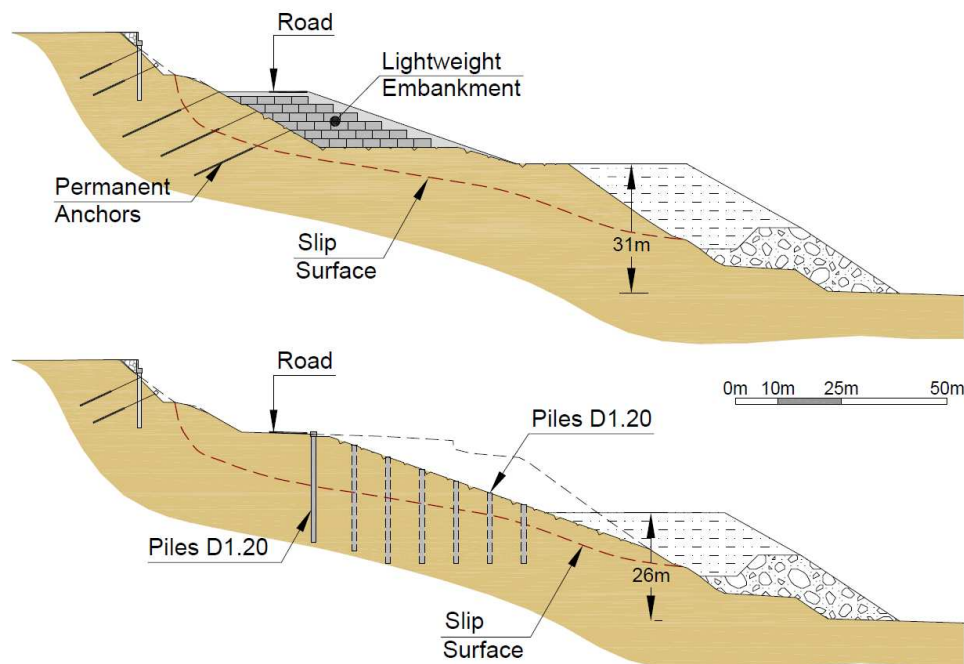
Figure 15. Landslide remediation - Alternative design solutions.

In order to develop a robust remediation strategy and to meet the value engineering requirements set by the district administration, alternative stabilization strategies were considered, coherent design options were developed, and subsequently evaluated in terms of economy, constructability and environmental compatibility. A wide spectrum of alternatives was investigated. An initial thought to completely abandon the site and deviate the road did not prove to be feasible. Stabilization of the slide solely by a high and massive toe stabilizing buttress proved also impracticable. Consequently the construction of a modest toe buttress and the simultaneous reduction of ground weight at the upper part of the sliding mass via ground removal and its replacement by lightweight material (EPS geofoam) was the first option developed. A second option involved the construction of a medium sized toe buttress, the trimming of the upper part of the sliding mass to remove as much of its weight as possible and the dowelling of the remaining soil mass, by means of large diameter bored concrete piles. Outline design of the two alternatives are presented in figure 15.

The last option proved to be more robust, reliable, cost effective, and better fit to the constructability requirements, since it required materials, equipment and expertise available locally on the island. It was also found that it had a smaller impact to the landscape and the environment in general. After deciding to adopt this solution, the design was further developed, the construction procedure was studied more thoroughly and every construction stage was checked by means of detailed stability calculations. The layout of the adopted solution is presented in figure 16. The lower part of the landslide is stabilized first by means of a toe buttress fill resting on a drainage blanket, to allow for unobstructed drainage of the natural ground behind it. For the existing gullies running along the two sides of the sliding mass, erosion protection works (lining of the stream courses with gabions) were foreseen to protect the native soils and the toe buttress. Bored piles 1.20 m in diameter were placed in a staggered, 12x12 m pattern further up on the trimmed slope, to dowel the existing slide surface, but also to prevent shallower slides on pre-sheared surfaces from being mobilized, especially during the anticipated development of perched water tables during the more intense rainfall events anticipated. Along the downslope borderline of the road, a row of bored piles, 1.20 m in diameter at 3.0 m spacing, was designed, to reduce the amount of fill necessary for resetting the road pavement at its initial elevation and to ensure the integrity of the road pavement from ground movements. Sewage pipes running under the road pavement were carefully constructed to ensure that no leakage would escape and infiltrate within the sliding mass. The back scarp area which was left by the landslide movement as a degrading steep slope was protected and stabilized by means of a permanent anchored wall. This intervention fulfilled also the requirement to protect the buildings situated on the upslope crest. Groundwater within the remaining sliding mass was decided to be controlled by constructing a trench drain at the back scarp area of the landslide, which would collect the water seeping from the uphill area and discharge it towards the neighbouring gullies.
