Lessons Learned from Dike Failures in Recent Decades

ABSTRACT: *The paper describes five different dike failures that occurred in recent decades. The case histories were located on different rivers and involved different loading conditions. The observed failure mechanisms involved erosion and stability problems. The types of erosion observed were both internal erosion due to extreme groundwater flow and external erosion caused by the river flow and wave action. The case involving instability was caused by uplift, i.e., increased hydraulic head led to a sharp reduction in maximum shear strength between subsoil layers. Two cases demonstrate the importance of dike management and maintenance. Despite the variations in the loading conditions and failure mechanisms, all the cases show that the strength of a dike depends not only on the material used to build the dike but also on the strength of the subsoil.*

Lessons Learned from Dike Failures in Recent Decades. International Journal of Geoenvironment Case histories, Vol.4, Issue 3, p.203-229. doi: 10.4417/IJGCH-04-03-04

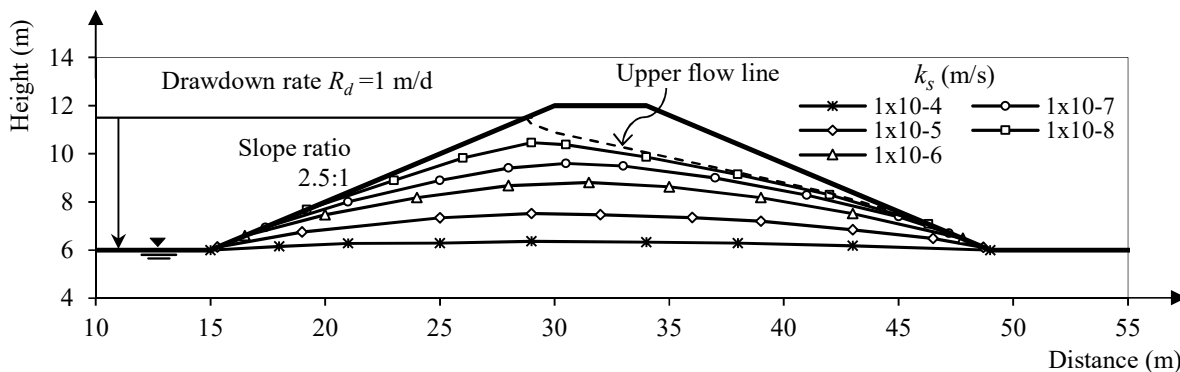
Figure 7. Phreatic surfaces (desaturation lines) at the end of the water drawdown stage in a dike with variable hydraulic conductivities k_s , (López-Acosta et al. 2015)

These analyses evaluated several homogeneous and isotropic dikes with a 2.5(H):1(V) slope and total dewatering head of 5.5 m for different hydraulic conductivities. Figure 7 shows the upper flow line for the initial steady-state condition and desaturation lines at the end of water drawdown in dikes with different hydraulic conductivities k_s for the transient-state condition and assuming a constant drawdown rate of $R_d = 1$ m/d. As can be seen from this figure, where $k_s = 1 \times 10^{-8}$ m/s, the desaturation line remains practically in the same position as the upper flow line, which is associated with the *fully rapid drawdown mode*. In this case, it can be assumed that the soil behaves undrained. For $k_s = 1 \times 10^{-4}$ m/s, the desaturation line inside the dike drops down almost in line with the reservoir water level, which is associated with the *fully slow drawdown mode*. In this case, it can be assumed that the soil behaves drained. It can also be assumed that the desaturation lines between these two extreme modes represent the *transient drawdown mode* in which a curvilinear water line is generated in the soil structure, the position of which depends on the drawdown rate and the constitutive material properties. The remaining pore pressure in the dike is therefore transient, it varies as a function of time, but also with the soil's ability to retain water. Several authors have recognised the three water drawdown modes described here (examples being Lane & Griffiths, 2000 and Berilgen, 2007).

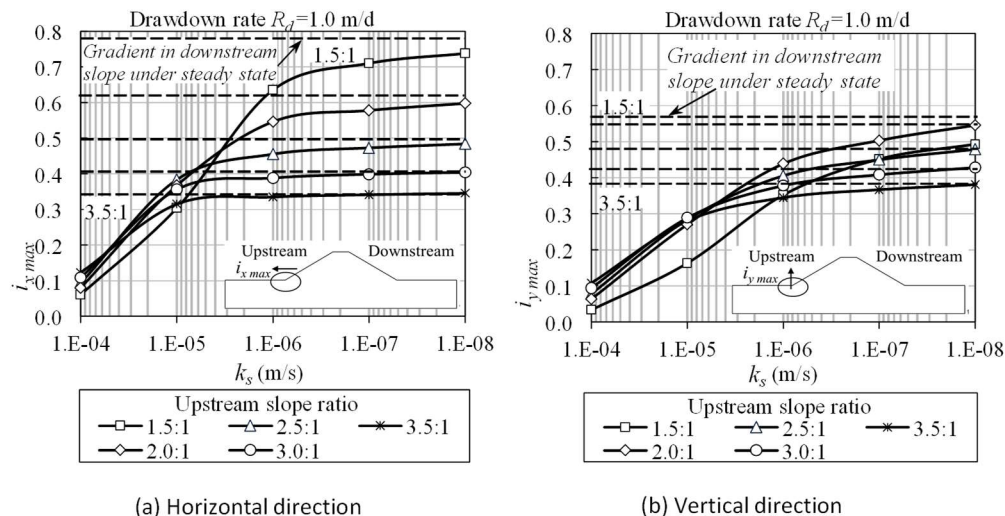
Figure 9. Effect of the slope ratio (H:V) on exit hydraulic gradients in dikes for different hydraulic conductivities k_s , (López-Acosta et al. 2015)

- Under a steady-state flow, the exit hydraulic gradients in the downstream slope remain constant for all k_s permeabilities studied.
- Changes in the slope ratio of dikes have a more significant effect on the magnitude of the exit hydraulic gradients than changes in the drawdown rate. It was observed that steeper slopes generate greater values for exit gradients.

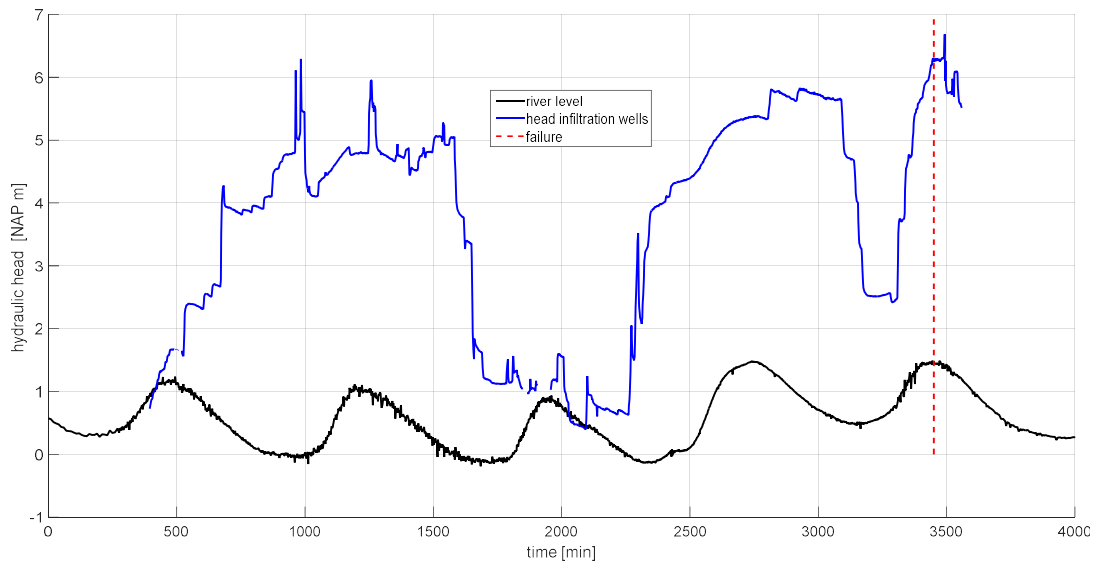
Figure 32. River level and hydraulic head in infiltration wells during the test

The test began at 06.00 on 26 November 2000, $t = 0$ in the graphs below. Figure 32 shows the river level and the average head in the nine infiltration wells. Infiltration started at $t = 370$ min, 6 hours after the start of the test. Initially, the hydraulic head in the wells followed the fluctuations in the river level. It should be noted that the test site is close to the sea and that the tidal wave has a pronounced influence on the water level in front of the dike. Although drinking water was used for infiltration, the infiltration wells clogged up after 26 hours, $t = 1580$ min, reducing well capacity. Due to maintenance, required to regain the full pumping capacity, the hydraulic head was seen to fall between $t = 1580$ and 2260 min, a period of 11.3 hours (Figure 32). Maintenance was also needed between $t = 3090$ and 3308 min, a period of 3.6 hours. Failure was observed at $t = 3450$ min, approximately 2.5 days after the start of the test, in the form of large longitudinal cracks in the dike body accompanied by major subsoil deformation (see Figures 33 and 34). The difference in height at the location of the cracks increased to more than 1.0 m (Figure 27b).

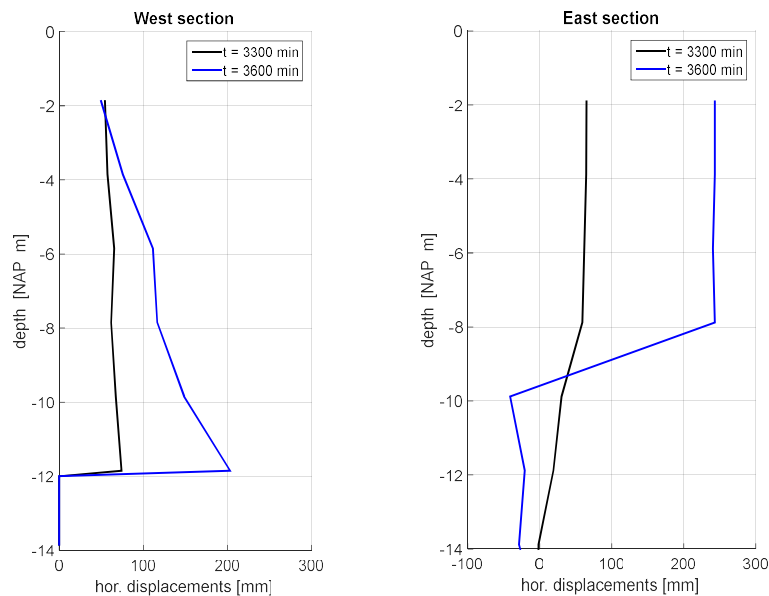
Figure 33. Horizontal displacement at the toe (both polder-side west respectively east of the central section as shown in Figure 27a)

Figure 33 shows the horizontal displacements measured at the toe in the eastern and western sections at $t = 3300$ min (55 h) and $t = 3600$ min (60 hours). Note that there was no inclinometer in the central section. The maximum displacement was found at the transition between the Pleistocene and Holocene layers, which was not at the same depth in both sections. Figure 34 shows the development of the maximum displacement for both sections. In the western section, horizontal displacements started to develop as soon as infiltration began. At approximately $t = 1500$ min, infiltration was suspended temporarily and no further deformation was observed until $t = 2500$ min, when infiltration resumed. Soon after, horizontal displacement developed in the eastern section as well. Infiltration was suspended for a second time, and horizontal displacement stopped again. Soon after infiltration resumed, displacement accelerated until the dike failed at $t = 3450$ min (57.5 hours) after the start of the test.

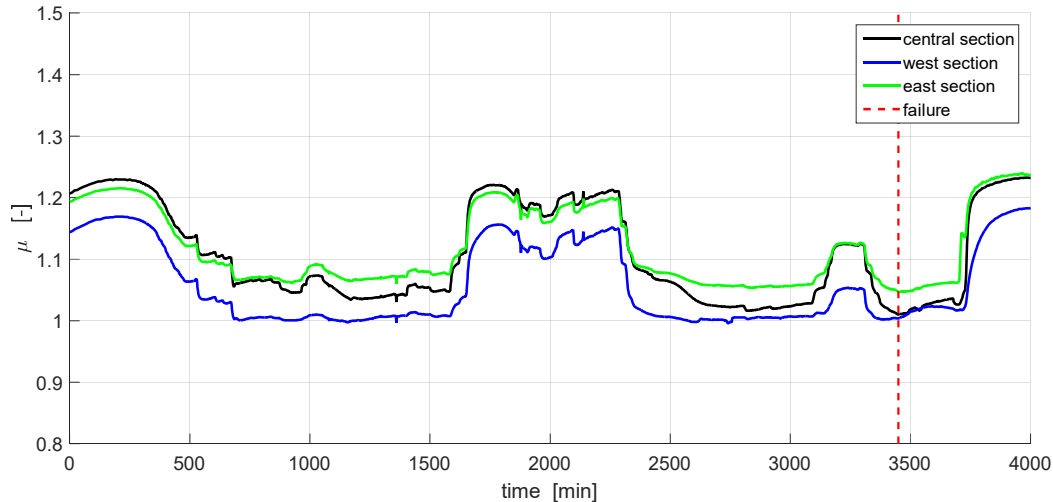
Figure 37. Ratio of total overburden pressure to pore pressure, μ , during the test

To check on the uplift conditions during the test, the ratio, μ , of the weight of the Holocene layer to pore pressure in the Pleistocene sand layer was determined for each of the transducers in the Pleistocene sand layer. Figure 37 shows the ratio, μ , during the test for the transducers placed at 46 m from the crest of the dike in the central, eastern and western sections. Initially, $\mu = 1.2$. When infiltration began, this value reduced, as expected. Due to differences in the subsoil layer, μ varied for the different sections, with the lowest value in the western section, where the value remained approximately 1. In the central and eastern sections, μ seemed to reduce slightly during the test. This corresponds to the slight increase in infiltration pressure during the test, as shown in Figure 35. The value did not drop significantly below 1.0. This could be explained by the pumping capacity, which does not allow for any further increase in pore pressure in the sand layer at the toe of the dike. It can also be hypothesized that when the pore pressure in the sand layer starts to exceed the weight of the clay and peat layers above it, a gap is created which is filled with pore water from the sand layer until a new equilibrium is attained. When pumping capacity is further increased, the gap may be widened, maintaining the equilibrium in vertical forces. In this hypothesis, $\mu = 1.0$ could be a physical boundary that will have prevented any further decline in the μ value in the western section during the test. It should be noted that, at larger distances from the dike, the Pleistocene hydraulic head decreased, causing an increase in μ . Close to the dike, μ is affected by the weight of the dike body.
