# Geological Engineering Reconnaissance of Damage Caused by the October 15, 2006 Hawaii Earthquakes

**Edmund W. Medley**, Senior Consultant, Geosyntec Consultants Inc., Oakland, CA, USA, Email: [emedley@geosyntec.com](mailto:emedley@geosyntec.com)

**ABSTRACT:** *Two strong earthquakes shook the Island of Hawaii, Hawaii on the morning of October 15, 2006. Peak Ground Accelerations reached 1.2g, and earthquake felt intensity of MMI VIII. Earthquake damage of public and private property totaled about \$200 million, with no fatalities. Geological engineering reconnaissance of earthquake damage resulting from the earthquakes focused on the apparent relationships between the observed geology and the damage. Some roadway embankments failed causing temporary closure of Island highways. Landslides were common at steep coastal cliffs. Liquefaction and lateral spreading occurred in coralline fill at Kawaihae Harbor. There were extensive road cut failures, in which the performance of road cuts in soil slopes was generally better than that of rock slopes. Where a'a clinker underlay massive a'a basalt blocks in road cut slopes, the loose clinker dislodged thereby undermining the blocks, and ca

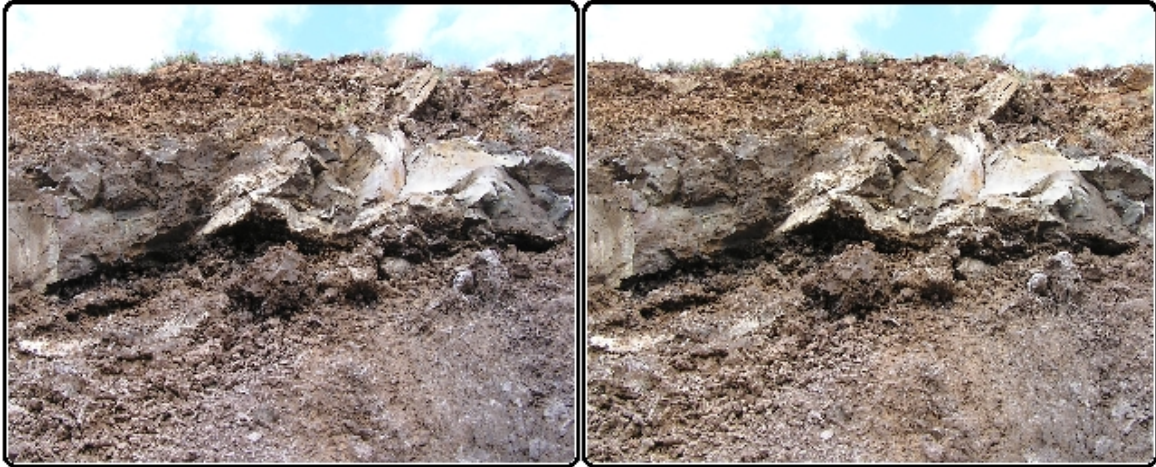
*Figure 13. Location 25, near Kohala Ranch Estates, Hwy 270. 3-D stereo pair version of Figure 12. Road cut in mixed massive a'a and clinker.*

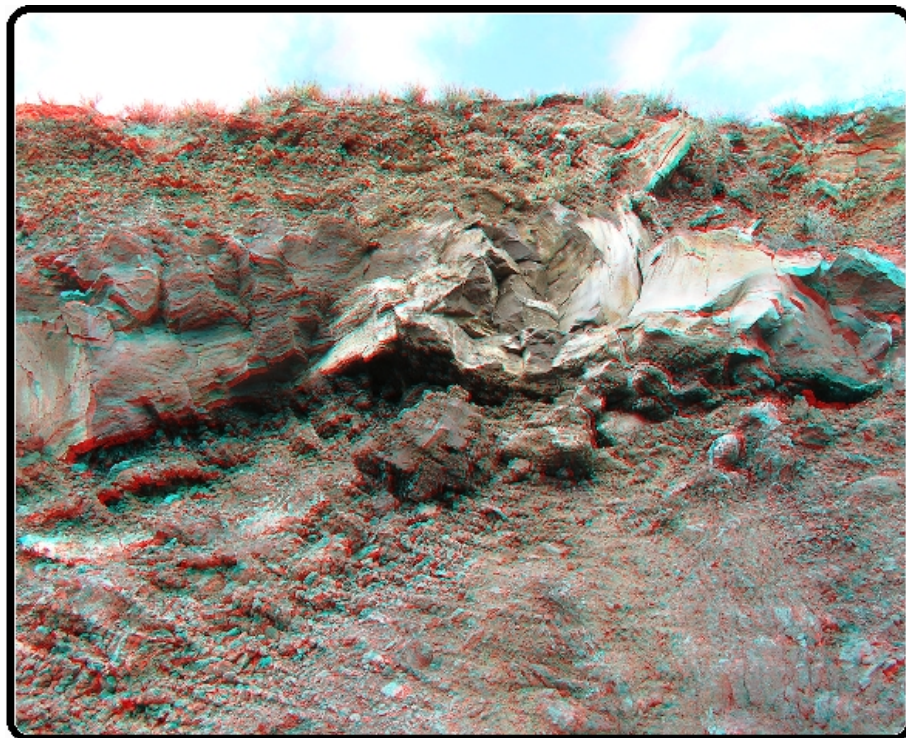
*Figure 14. Location 2, near Kohala Ranch Estates, Hwy 270. Anaglyph 3-D image version of Figure 12. Road cut in mixed massive a'a and clinker.*

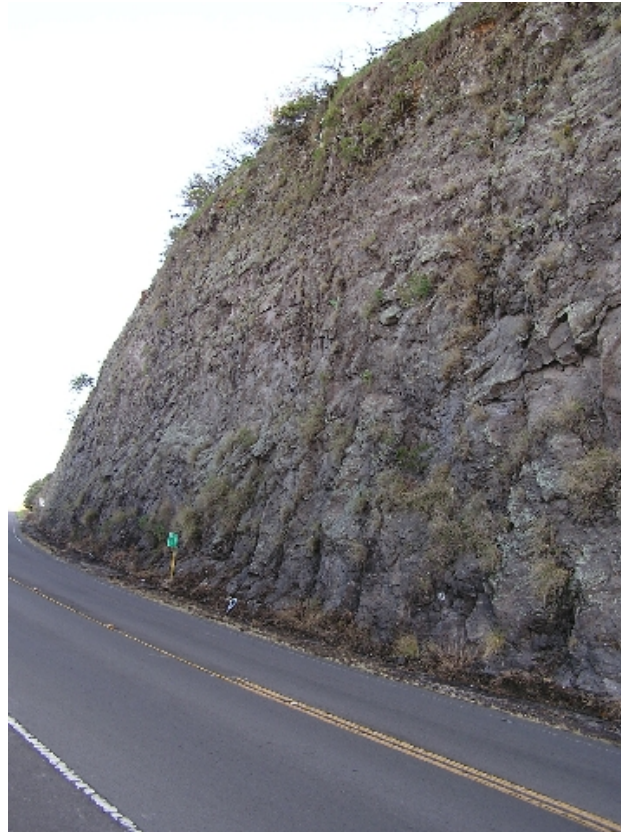
*Figure 21. Location 13, Milepost 8, Hwy 250. Stable steep and high road cut.*

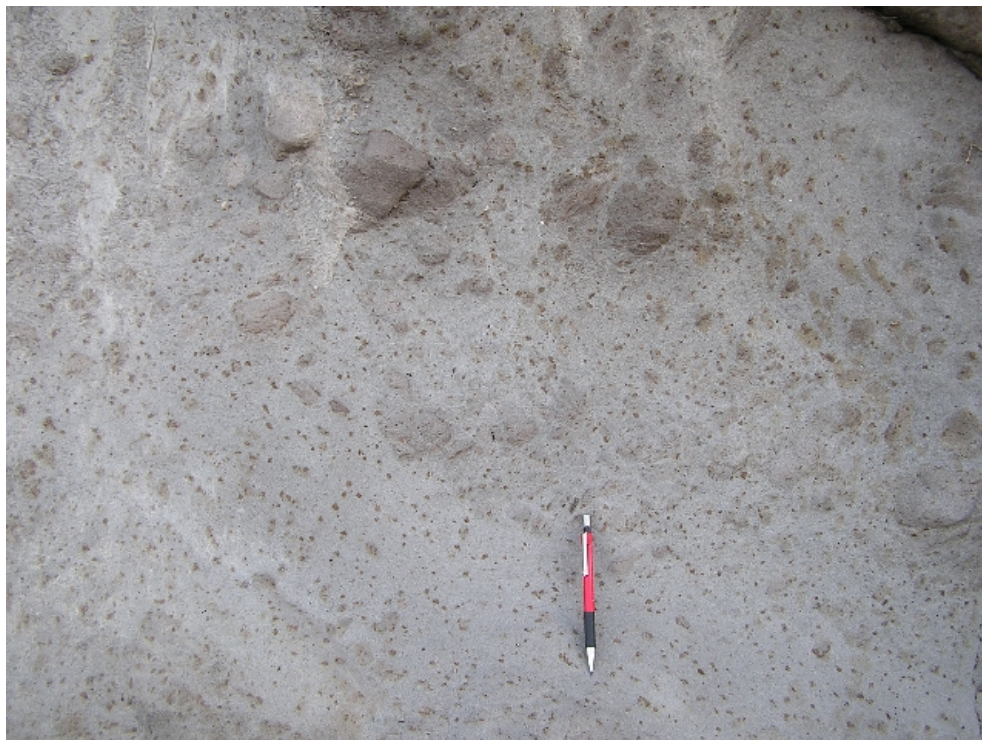
*Figure 22. Location 13, Milepost 8, Hwy 250. Road cut in a pyroclastic assemblage of ash and other volcanic debris.*

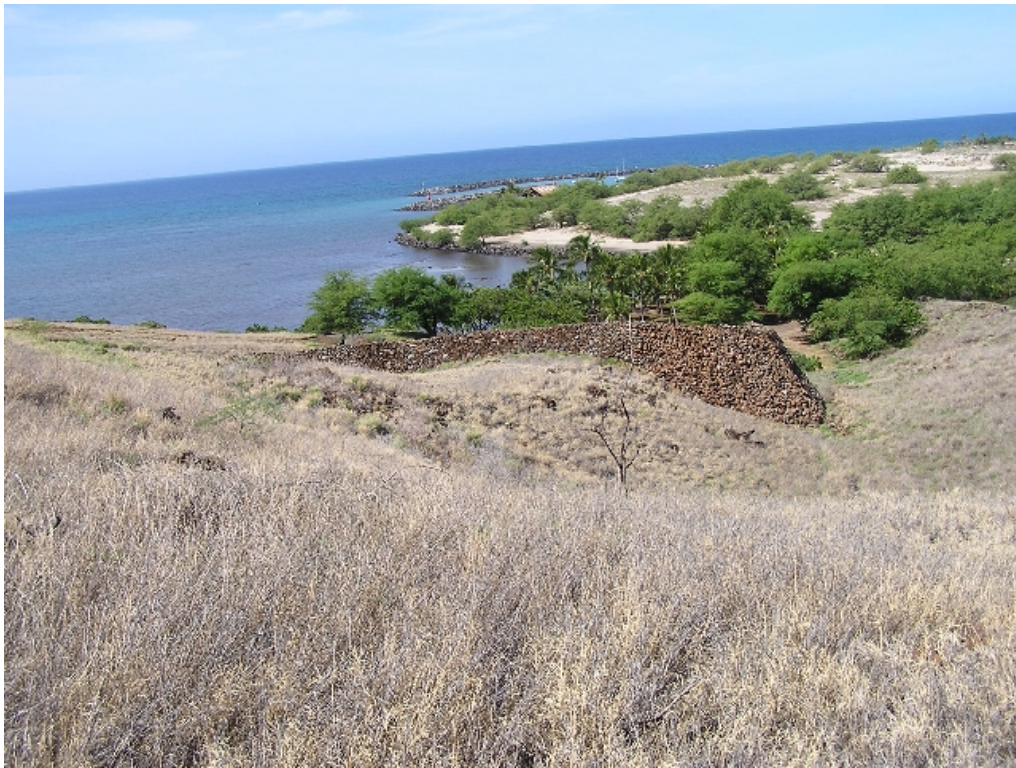
*Figure 47. Location 29. View of part of rear of Mailekini heiau as seen from Pu'ukoholā heiau.*

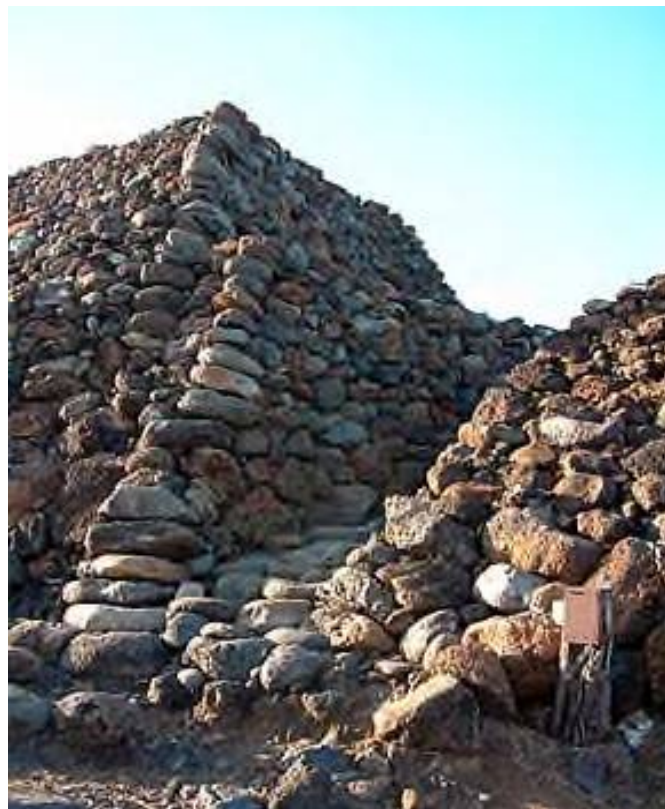
The heiaus were badly damaged by the earthquakes. The hill top location of the heiaus may have focused seismic shaking, although no details about site response are available. The worst damage at the Pu'ukoholā Heiau was to high retaining walls bounding the sole access passage (Figure 48 and Figure 49). At the Mailekini heiau, much of the interior face of the east wall slumped and raveled (Figure 50 and Figure 51).

*Figure 48. Pre-earthquake view of entrance passageway into Pu'ukoholā (Location 29)  
(Medley and Zekkos, 2007; original photo from [www.pacificworlds.com/kawaihae](http://www.pacificworlds.com/kawaihae)).*

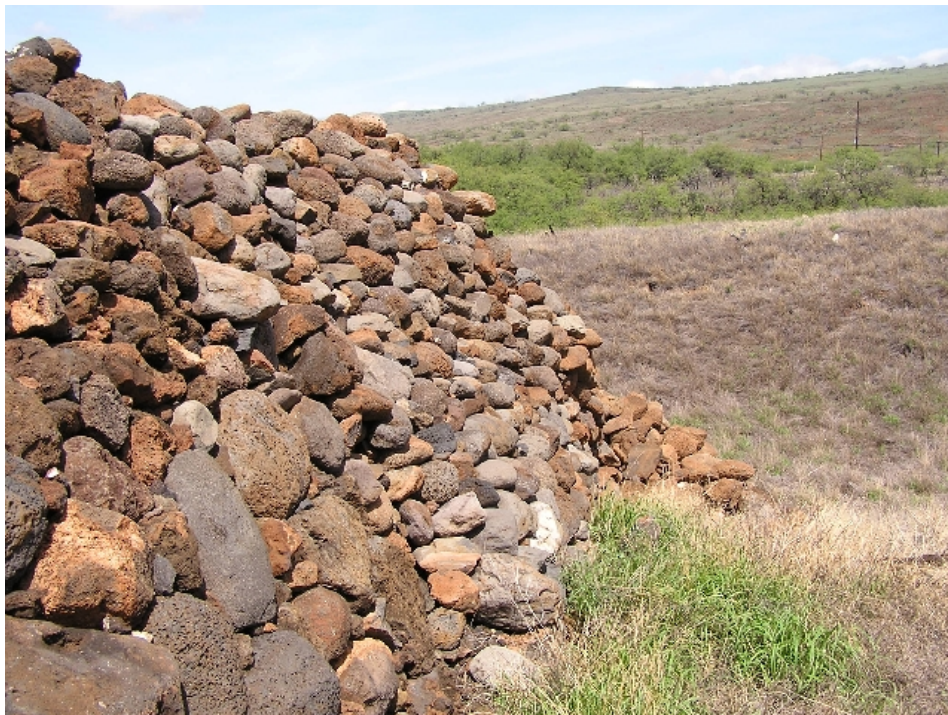
figure 58 and stereo Figure 59). The slumps apparently occurred in much the same fashion as sketched in Figure 60. The angle of repose for the slumps was about 30 degrees, with run-outs extending to more than 5 m from the original toes of the walls (Figure 52 and Figure 56).

*Figure 52. Location 29, NE corner Mailekini heiau. In foreground: typical intact face inclined at about 50 degrees. In background, toe of raveled face shown in Figure 56.*
