Geological Engineering Reconnaissance of Damage Caused by the October 15, 2006 Hawaii Earthquakes

Edmund W. Medley, Senior Consultant, Geosyntec Consultants Inc., Oakland, CA, USA, Email: emedley@geosyntec.com

KEYWORDS: Geological Engineering, Hawaii, Earthquake Damage, Rock Mass, Basalts, Rock Block Structures

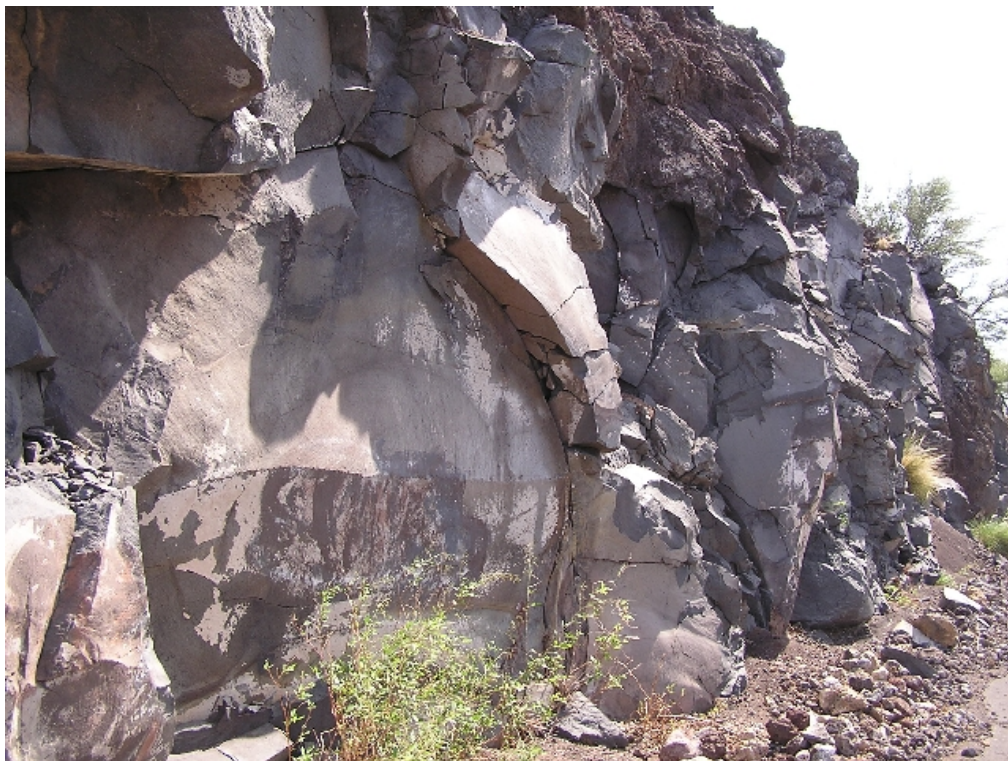
Figure 10. Location 32, road cut at Hwy 11. Massive basalt in a'a flow.

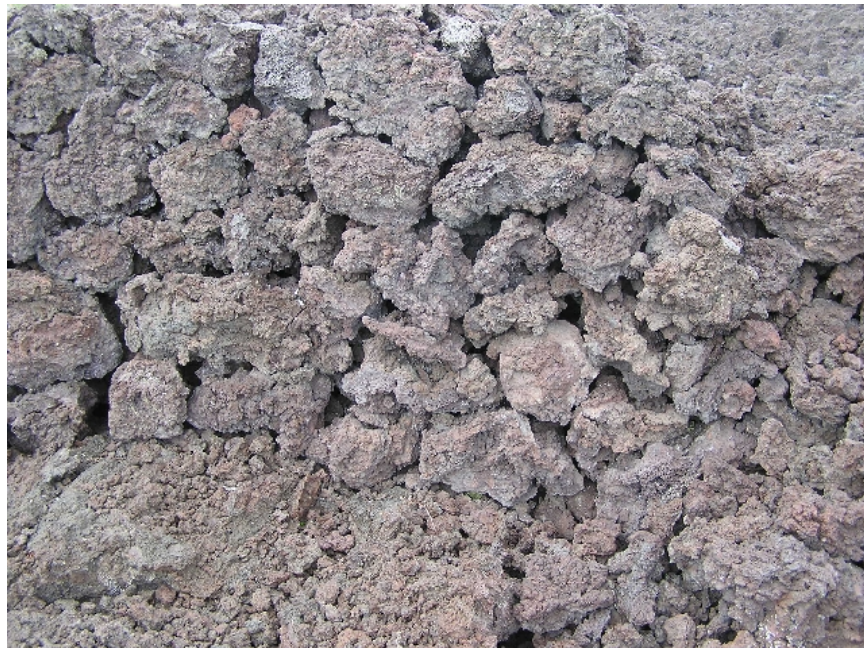
Figure 40. Location 11, Saddle Road (Hwy 200). Stacked rock wall of a 'a clinker.

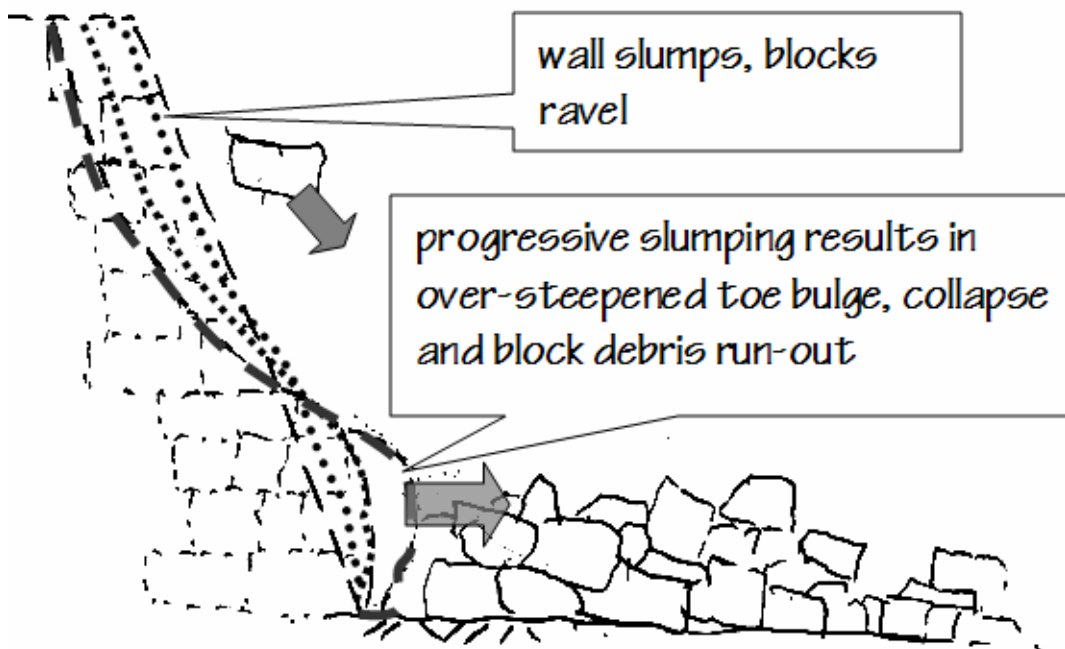
figure 58 and stereo Figure 59). The slumps apparently occurred in much the same fashion as sketched in Figure 60. The angle of repose for the slumps was about 30 degrees, with run-outs extending to more than 5 m from the original toes of the walls (Figure 52 and Figure 56).

Figure 60. Raveling, bulging and slumping of the face of a rock block edifice (Medley and Zekkos, 2007).
