Geological Engineering Reconnaissance of Damage Caused by the October 15, 2006 Hawaii Earthquakes

Edmund W. Medley, Senior Consultant, Geosyntec Consultants Inc., Oakland, CA, USA, Email: emedley@geosyntec.com

ABSTRACT: Two strong earthquakes shook the Island of Hawaii, Hawaii on the morning of October 15, 2006. Peak Ground Accelerations reached 1.2g, and earthquake felt intensity of MMI VIII. Earthquake damage of public and private property totaled about \$200 million, with no fatalities. Geological engineering reconnaissance of earthquake damage resulting from the earthquakes focused on the apparent relationships between the observed geology and the damage. Some roadway embankments failed causing temporary closure of Island highways. Landslides were common at steep coastal cliffs. Liquefaction and lateral spreading occurred in coralline fill at Kawaihae Harbor. There were extensive road cut failures, in which the performance of road cuts in soil slopes was generally better than that of rock slopes. Where a'a clinker underlay massive a'a basalt blocks in road cut slopes, the loose clinker dislodged thereby undermining the blocks, and causing failures that blocked important roads

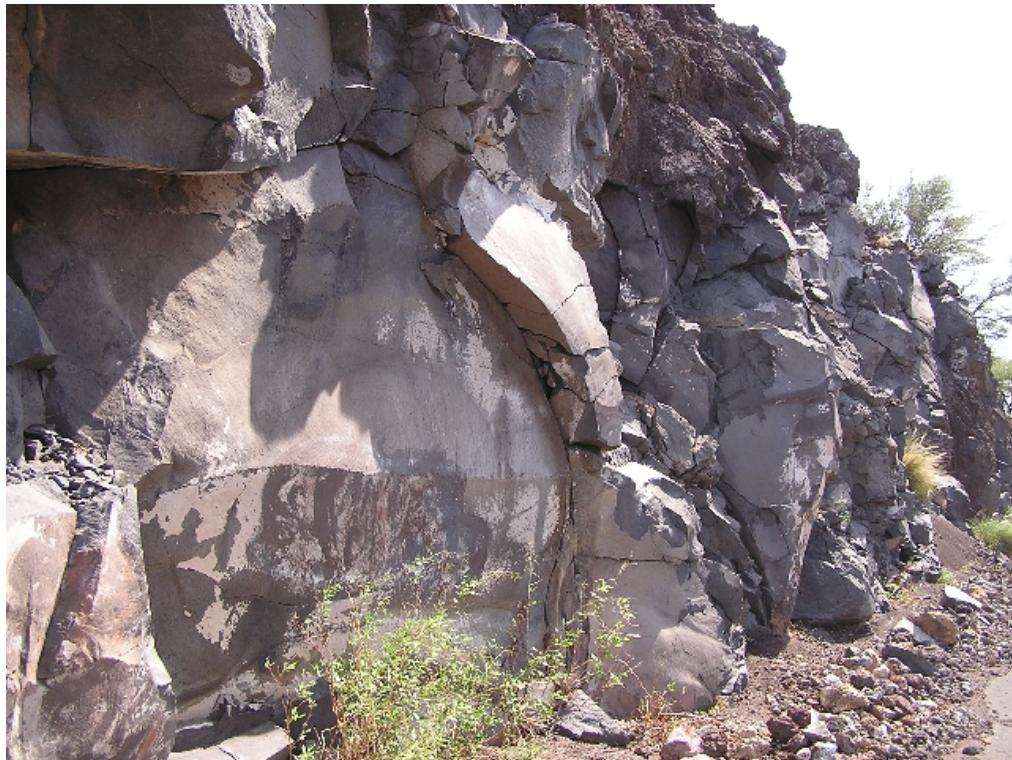
Figure 10. Location 32, road cut at Hwy 11. Massive basalt in a'a flow.

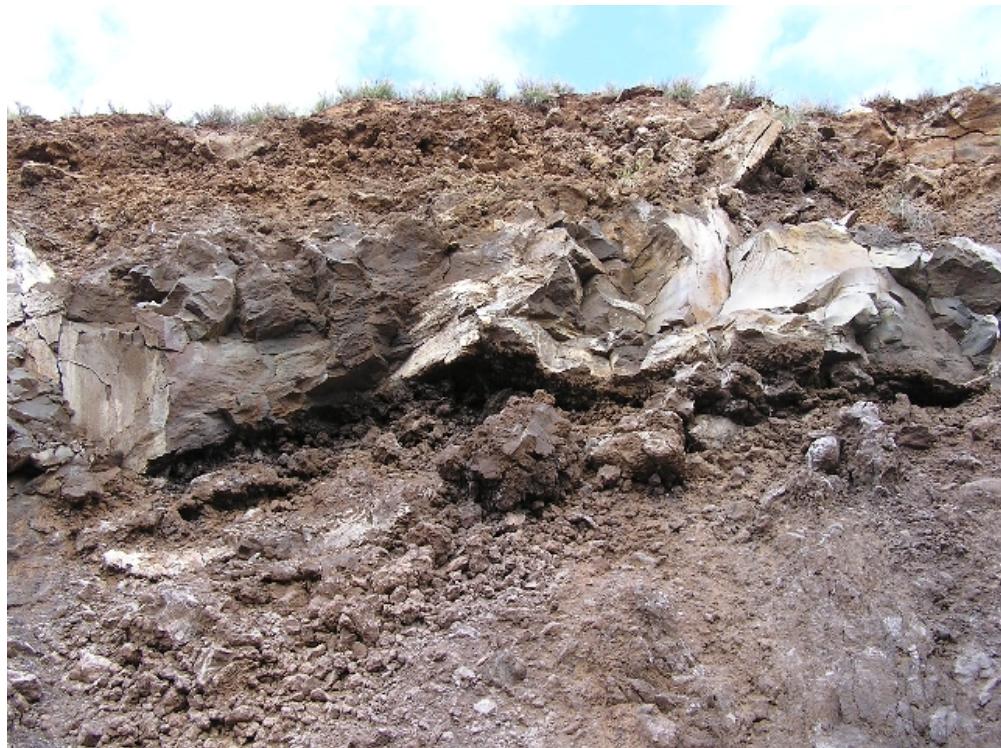
Figure 12. Location 2, near Kohala Ranch Estates, Hwy 270. View from road of excavation in mixed massive a'a and clinker. See stereo 3-D photographs of Figure 13 and Figure 14.

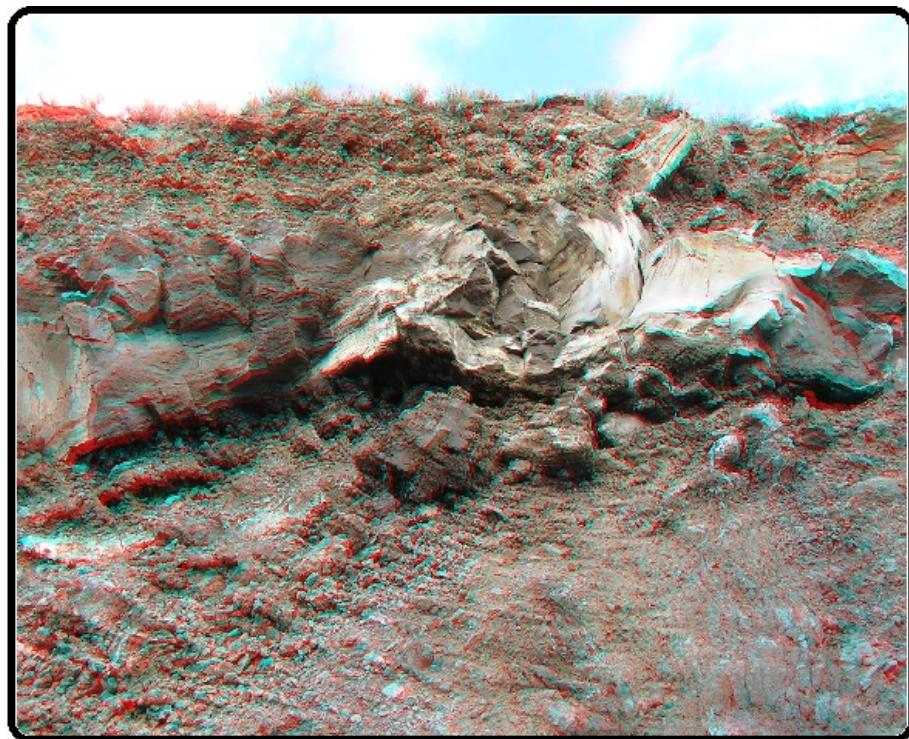
Figure 14. Location 2, near Kohala Ranch Estates, Hwy 270. Anaglyph 3-D image version of Figure 12. Road cut in mixed massive a'a and clinker.

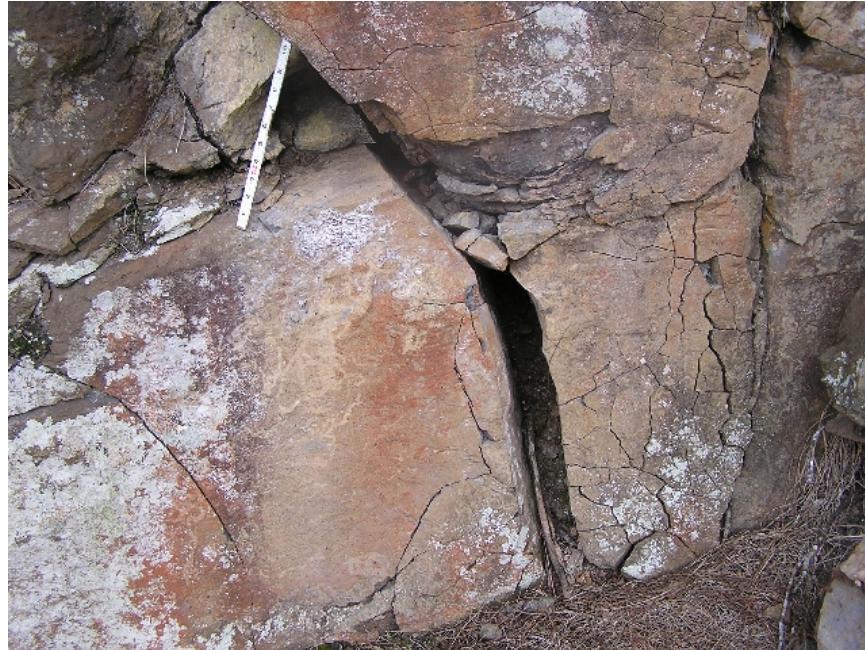
Figure 29. Location 9, Hwy 19 near Honoka'a. Wide fracture likely not caused by earthquake- note debris and tree root.

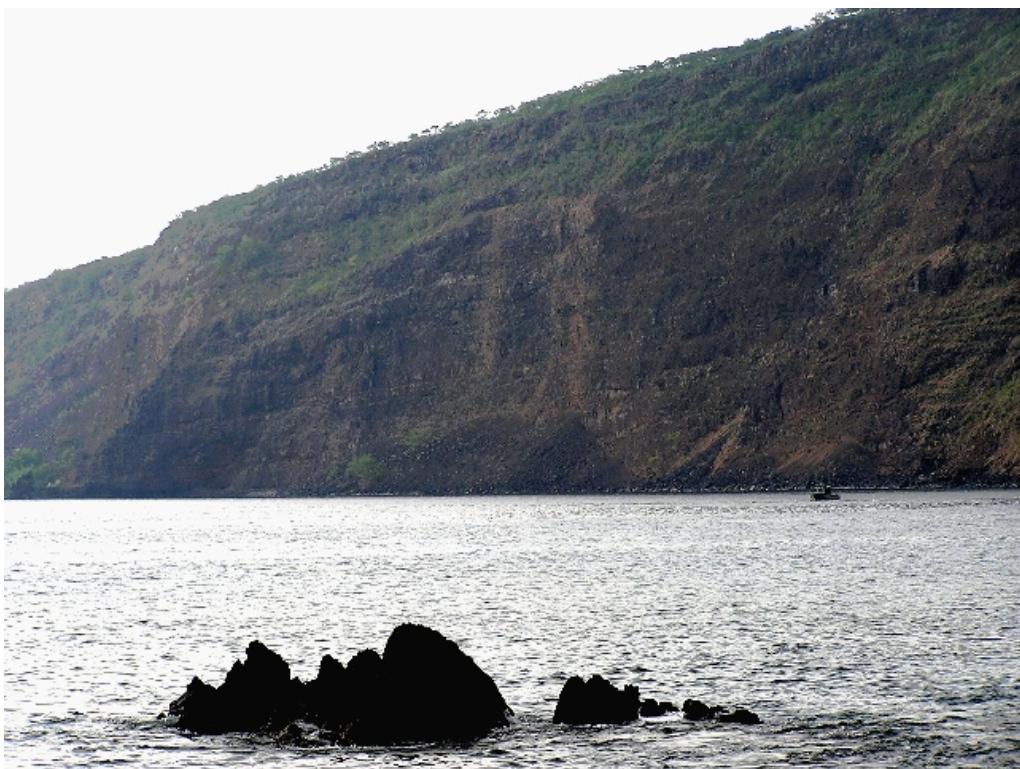
Figure 36. Location 36, Napo 'opo 'o, facing the Pali Kapu o Keōua, a fault/mega-landslide scarp.

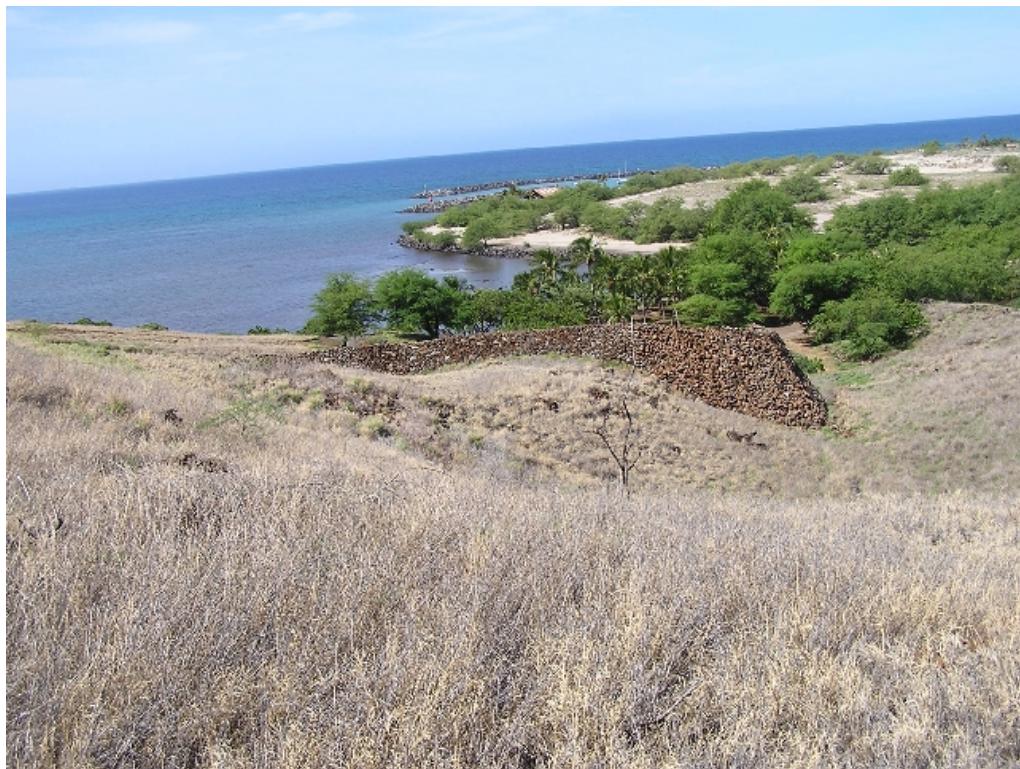
The heiaus were badly damaged by the earthquakes. The hill top location of the heiaus may have focused seismic shaking, although no details about site response are available. The worst damage at the Pu'ukoholā Heiau was to high retaining walls bounding the sole access passage (Figure 48 and Figure 49). At the Mailekini heiau, much of the interior face of the east wall slumped and raveled (Figure 50 and Figure 51).

Figure 47. Location 29. View of part of rear of Mailekini heiau as seen from Pu'ukoholā heiau.

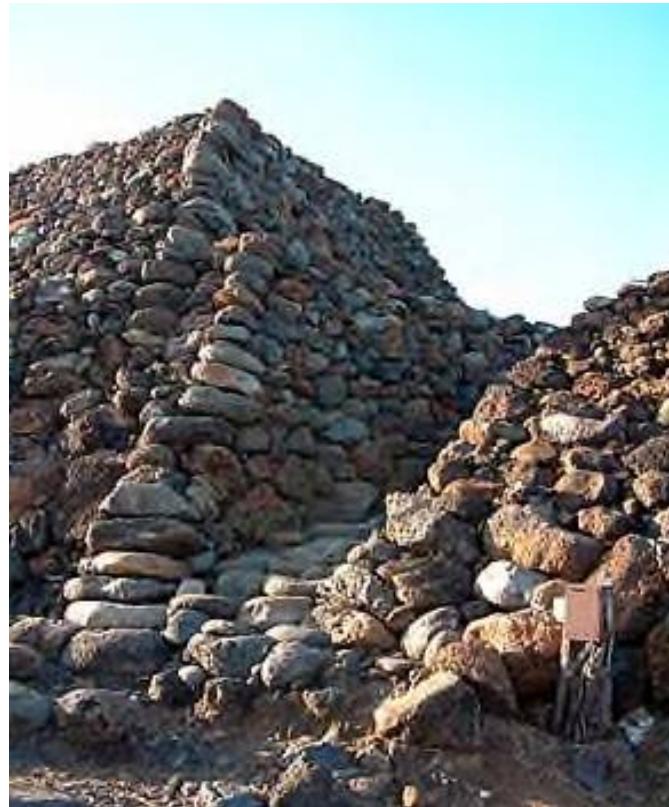
Figure 48. Pre-earthquake view of entrance passageway into Pu'ukoholā (Location 29) (Medley and Zekkos, 2007; original photo from www.pacificworlds.com/kawaihae).

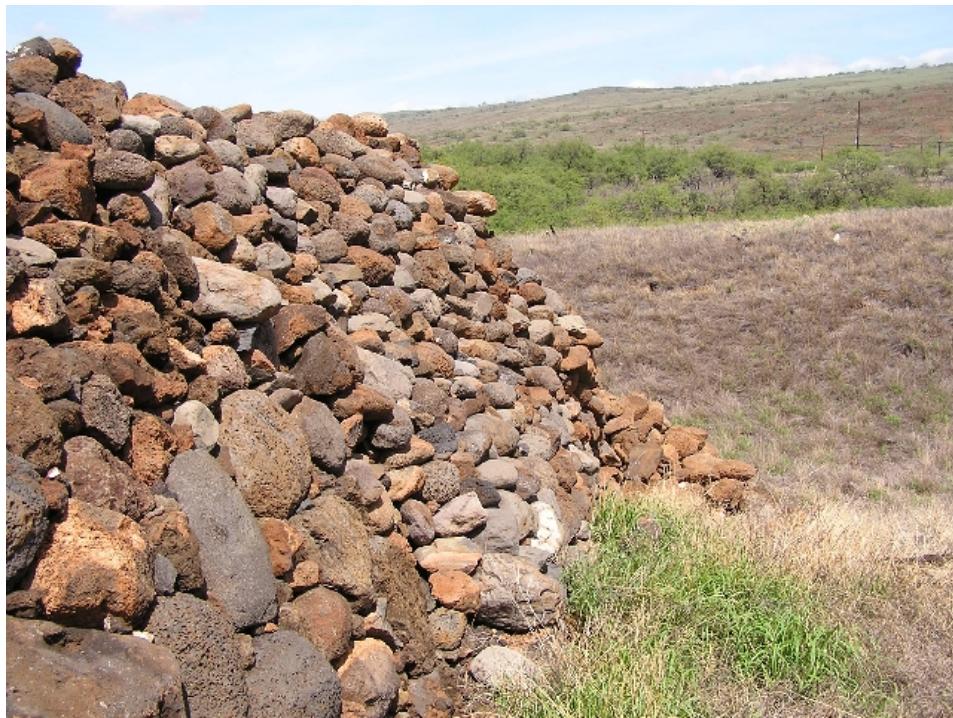
At the Mailekini and Pu'ukoholā heiaus damage in the form of slumps and raveling of the wall was observed that seemed to roughly match the behaviors described by Medley and Zekkos (2007). Many wall bulges were observed at originally steep wall faces (40 to 50 degree inclinations, Figure 52) resulting in further steepening of the wall faces near the bottom of the edifices (Figure 53; stereo Figure 54 and stereo Figure 55) although it is likely that some bulging had occurred before the earthquakes. Many wall bulges were observed where the slopes approached vertical (Figure 53), which suggests vulnerabilities to increased rock face instability and eventual collapse from future earthquakes or creep deformation. Some slumps and raveling of the wall faces occurred where the bulges over-steepened and collapsed (Figure 56, Figure 57; stereo

figure 58 and stereo Figure 59). The slumps apparently occurred in much the same fashion as sketched in Figure 60. The angle of repose for the slumps was about 30 degrees, with run-outs extending to more than 5 m from the original toes of the walls (Figure 52 and Figure 56).

Figure 52. Location 29, NE corner Mailekini heiau. In foreground: typical intact face inclined at about 50 degrees. In background, toe of raveled face shown in Figure 56.
