## Lack of Maintenance Compromises Tunnel Structural Safety

**ABSTRACT:** *The Chekka tunnels represent a critical section of the Northern Lebanon Highway. The approximately 350-m long twin tunnels are the most important tunnels in the country. They are used by regular and freight traffic and are a vital link to the capital, Beirut. The tunnels were completed in the early 1970s on the eve of the Lebanon civil war. Given the state of affairs in the country for about two decades of strife, the tunnels were not maintained nor did they undergo any regular inspection. This unique condition of near-abandonment continued up until recently, when the first signs of distress were documented. These consisted of severe and extensive cracking, particularly in the portal approach of the southbound tunnel, along with significant deterioration of the tunnel lining and radial section joints. The danger to traffic and, potentially, to the structure itself was evident. In this paper, the results of an extensive site inspection and evaluation program are presented. The underlying causes of the observed damage are analyzed and discussed using a modeling approach of the progressive loading conditions.

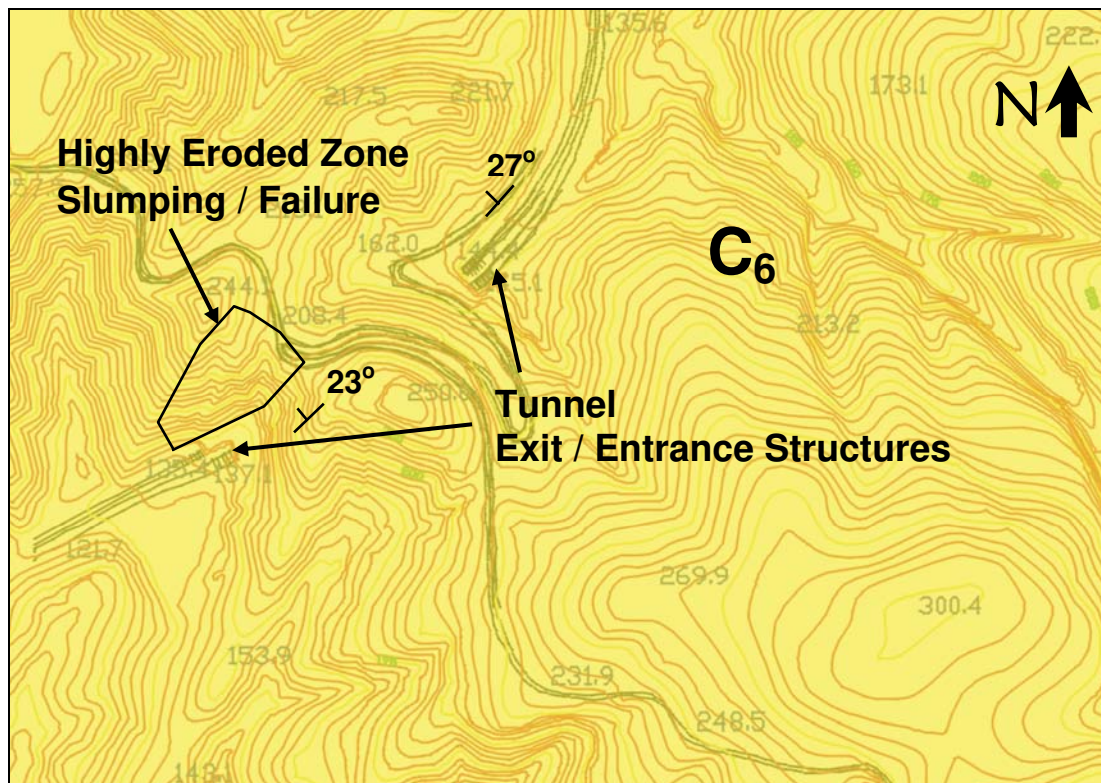
Based on the topographic and geological surveys, it is clear that the prevailing strata are prone to erosion and mass wasting, and that significant slopes are evident in the vicinity of the tunnels with adverse dips identified towards the tunnel exit and entrance points.

Figure 5. Geology of Area: The Only Outcropping Unit is the Chekka Formation C6.

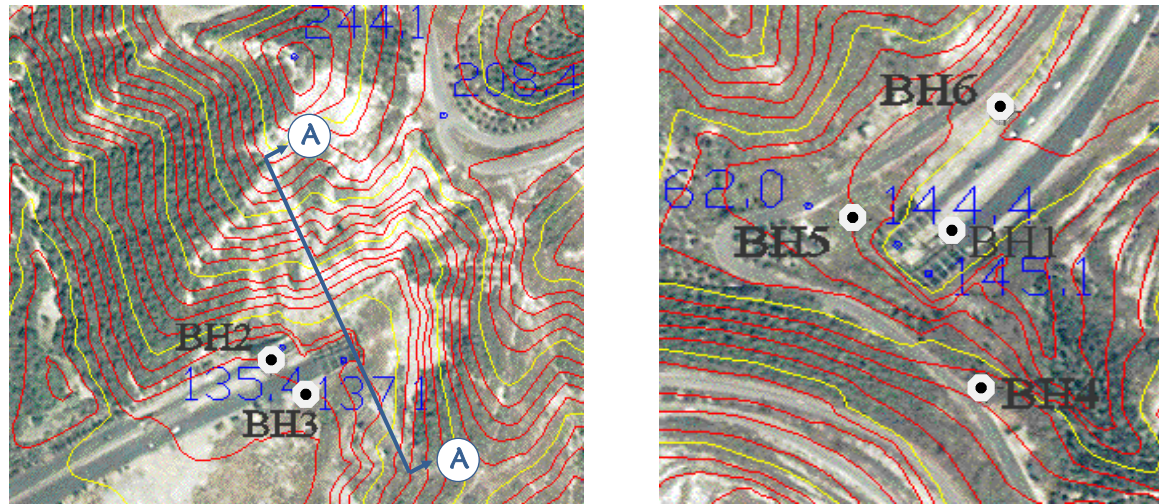
A total of six boreholes, approximately 10 m deep, were drilled in addition to a number of shallow pits. The locations of the boreholes were restricted to accessible areas and are indicated in Fig. 7. The exploration pits complemented the boreholes and were located primarily above the southern entrance/exit points.

Figure 7. Location of Exploration Boreholes BH-1 Through BH-6.

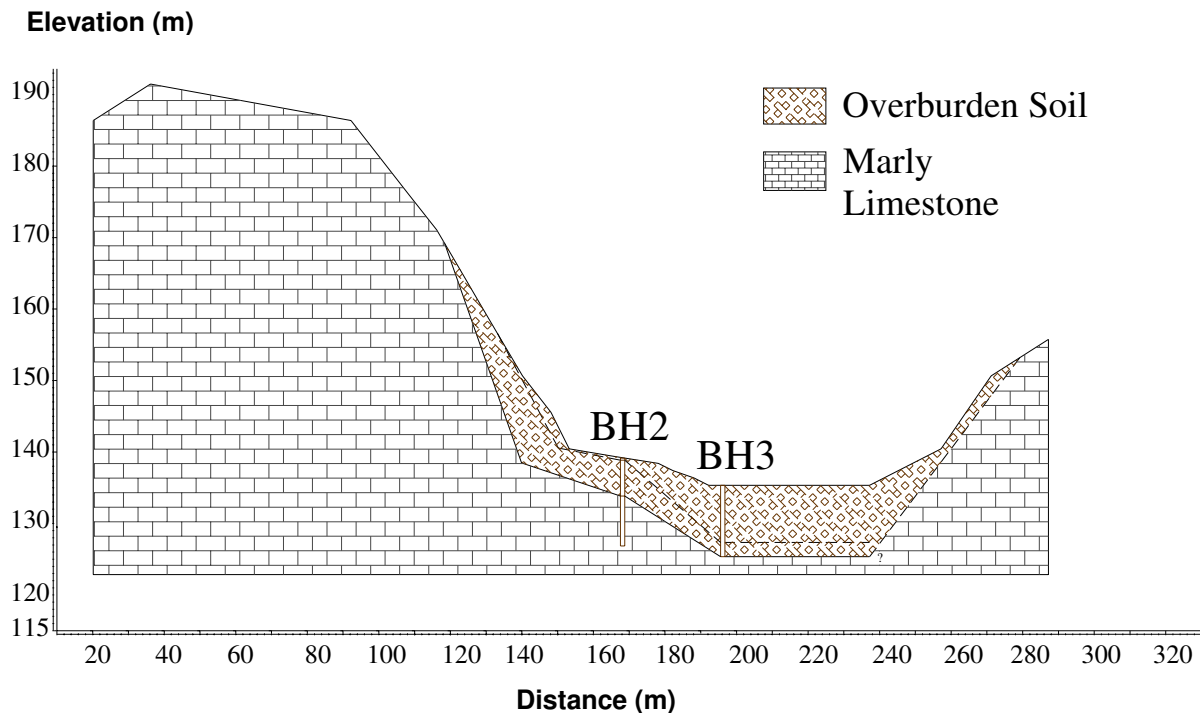
Figure 8. Transverse Section Across South tunnel (A-A in Fig. 7). Tunnel Portal Between Two Hills.

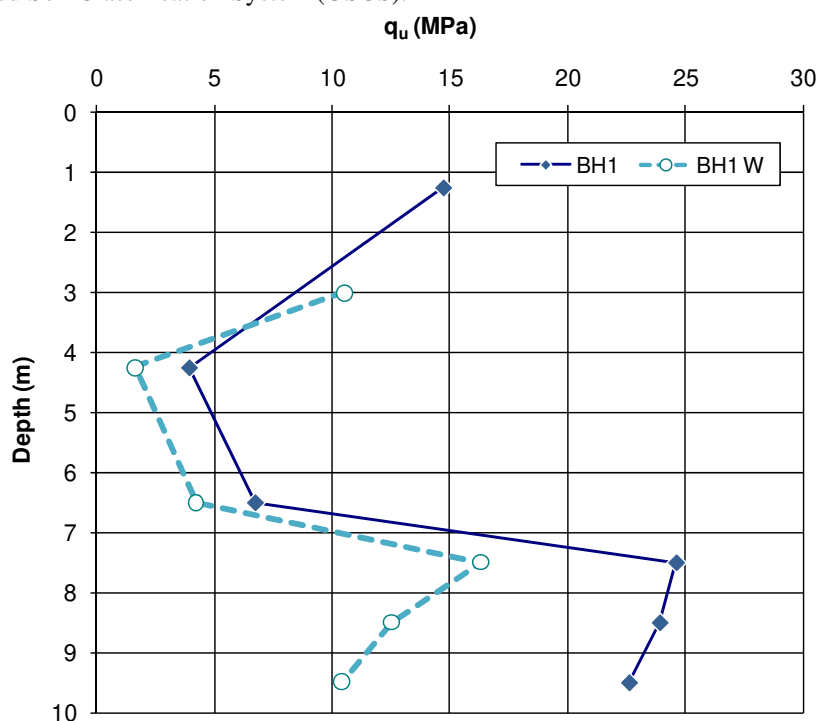
Unconfined compression tests were conducted on rock cores according to ASTM D2166. Some of the samples were submerged in water for 48 hours prior to testing in order to explore the effect of increased water content on the strength of the marlstone/rock samples. The elastic deformation modulus values obtained from the laboratory tests on the cores extracted from the material above the southbound tunnel cross-section are relatively low (from about 5800 to 15000 kPa), which was expected given their higher degree of weathering. The results of the unconfined compression tests showed a significant decrease in strength for the wetted samples. The average unconfined compression strength values from samples from BH-1 and BH-5 for the marly limestone layers are shown in Table 1. The unconfined compressive strengths above the southbound tunnel cross-section suggested an average value of  $q_u \sim 19.5$  MPa for the natural condition samples, and a value of  $q_u \sim 7.0$  MPa for the wetted samples. Typical results from BH1 samples are presented in Fig. 9.

Figure 9. Unconfined Compressive Strength Results From BH1: Natural Water Content and Wetted Samples (w).

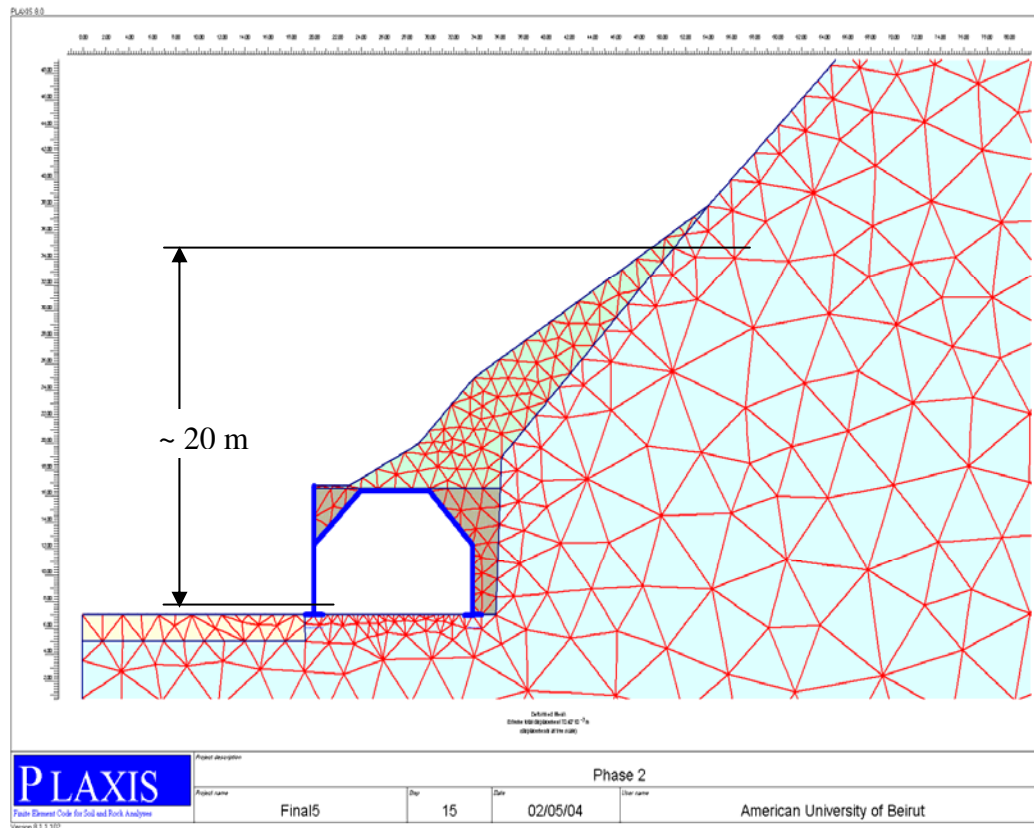
Fig.11 is a detail view of the finite element mesh near the tunnel portal, showing the soil and rock strata as described in Table 2. The intact rock is shown in light blue, while the slumping soil mass is green. The olive green color represents the engineered backfill soil at the end of construction. It is important to note here that the slumping soil mass was only activated for Stage 2.

Figure 11. Finite Element Model Showing the Various Strata and the Loading Sequences – Stages 1 and 2.
