# Reconstruction of Konstantinovsky Palace in a Suburb of Saint Petersburg

**ABSTRACT:** *This article describes a complex approach to the condition survey and design executed as part of the remedial works on Konstantinovsky palace in the suburb of Strelna (Saint Petersburg)--one of the most beautiful historic monuments of 18th century Russia. The palace was almost completely destroyed in the 1940s. In 2000 the decision was made to reconstruct the palace, and the project for palace reconstruction was developed. The project was completed in 2003. The following important stages of the project are discussed in this paper: palace condition survey and site investigations, analyses of the palace retaining structures, design project of palace reconstruction, and phases of the remedial works.*

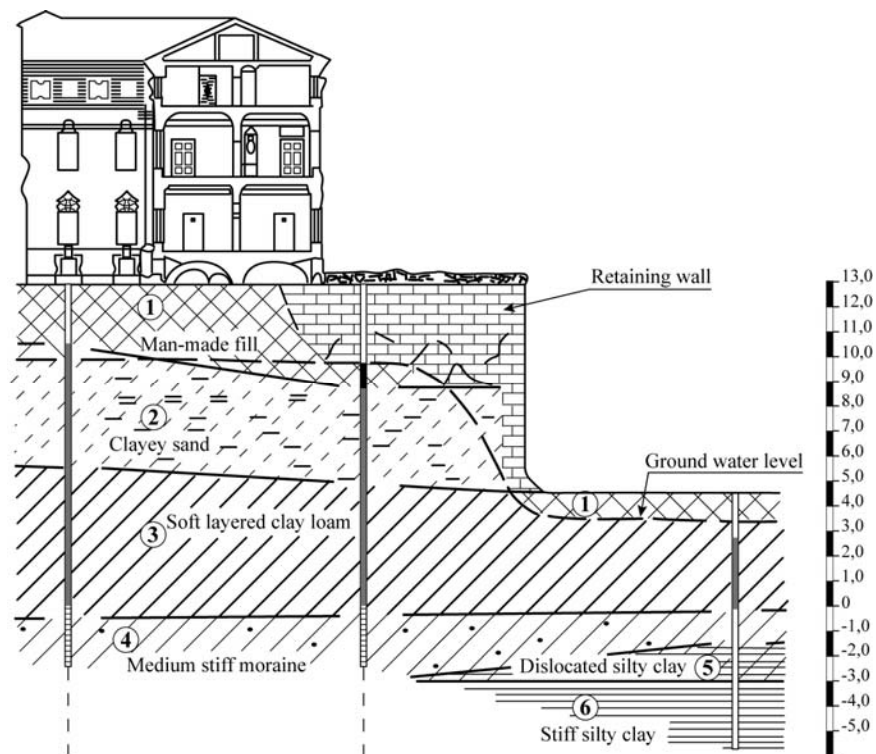
Figure 8. Cross-section of the palace and subsoil profile: 1. Made-up fill, 2. Clayey sand, 3. Soft varved clay loam, 4. Medium-stiff moraine clay loam, 5. Dislocated stiff Cambrian silty clay, 6. Stiff silty Cambrian clay.

As attested by site investigation in the park, underneath 1 m of fill there is a 3-m layer of soft varved clay loam, underlain by medium stiff moraine clay loam (Fig. 8). Still deeper, at the level of around 14.0 m (absolute – 1.3 m), there are medium stiff and stiff deep Cambrian clays.
