Reconstruction of Konstantinovsky Palace in a Suburb of Saint Petersburg

ABSTRACT: *This article describes a complex approach to the condition survey and design executed as part of the remedial works on Konstantinovsky palace in the suburb of Strelna (Saint Petersburg)--one of the most beautiful historic monuments of 18th century Russia. The palace was almost completely destroyed in the 1940s. In 2000 the decision was made to reconstruct the palace, and the project for palace reconstruction was developed. The project was completed in 2003. The following important stages of the project are discussed in this paper: palace condition survey and site investigations, analyses of the palace retaining structures, design project of palace reconstruction, and phases of the remedial works.*

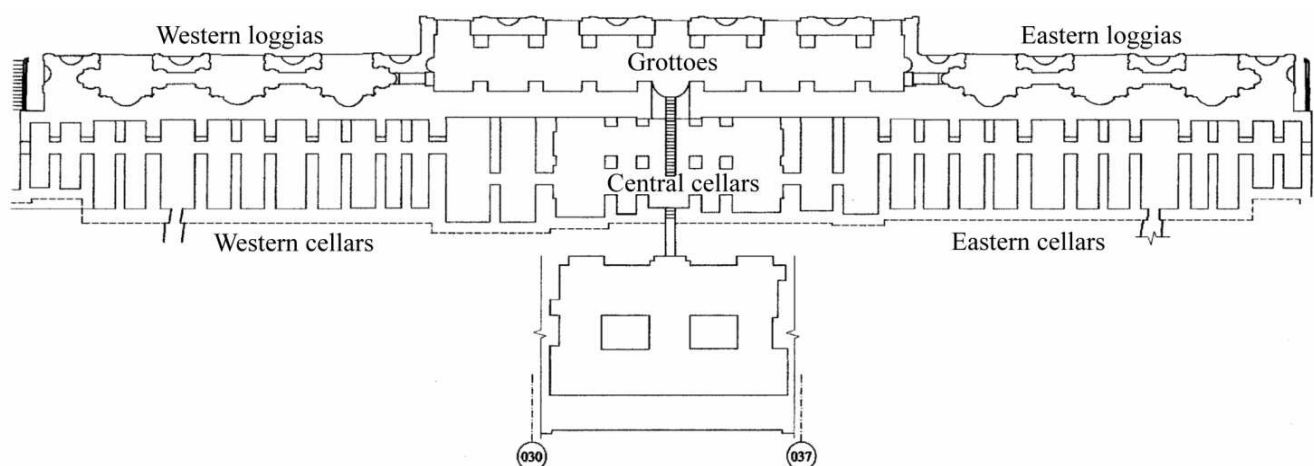
Figure 3. Plan of cellars, grottoes, and loggias of Konstantinovsky Palace.

Symmetrically on each part of the central grotto there are 3 loggias (see Fig. 3 and 4). The gable wall for both the grottoes and the loggias is the actual retaining wall. The loggias retaining wall contains half-sphere niches forming the volume of every loggia. In these locations the retaining wall is especially thin (around 1.5 m), but gradually increases up to 3.2 m elsewhere.

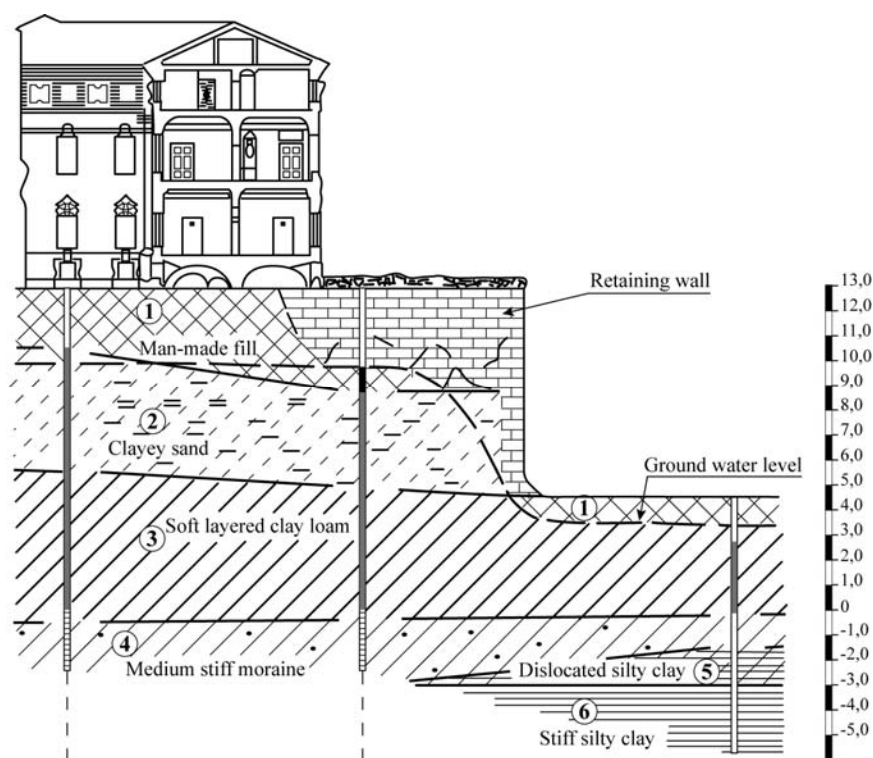
Figure 8. Cross-section of the palace and subsoil profile: 1. Made-up fill, 2. Clayey sand, 3. Soft varved clay loam, 4. Medium-stiff moraine clay loam, 5. Dislocated stiff Cambrian silty clay, 6. Stiff silty Cambrian clay.

As attested by site investigation in the park, underneath 1 m of fill there is a 3-m layer of soft varved clay loam, underlain by medium stiff moraine clay loam (Fig. 8). Still deeper, at the level of around 14.0 m (absolute – 1.3 m), there are medium stiff and stiff deep Cambrian clays.

not be entirely ruled out that the discovered brickwork is demonstrative of a bond between the courtyard foundations and the retaining structure. Above the clayey sand there is a layer of man-made ground about 3 m thick (Fig. 8, layer 1).

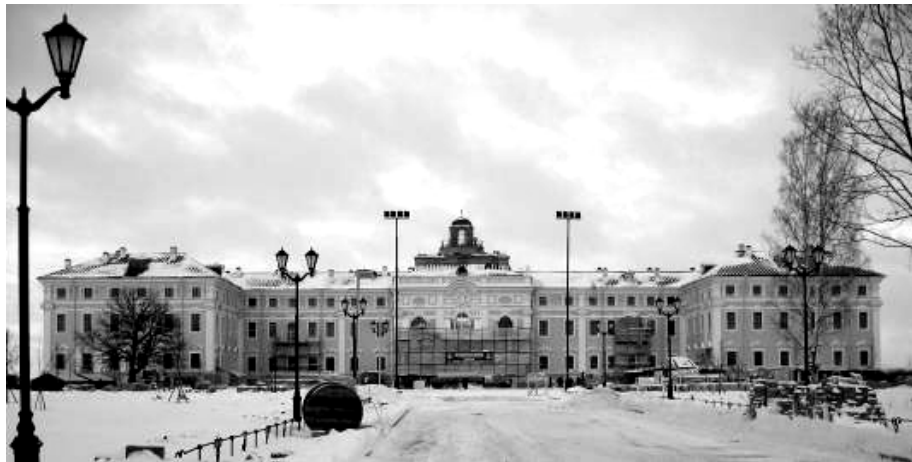
Figure 19. Konstantinovsky Palace, south façade. View of a final reconstruction stage (January 2003).

It took about 1.5 years to completely reconstruct Konstantinovsky Palace in Strelna (Fig. 19). The palace officially opened as the Congress Palace in 2003 during the tercentenary celebrations of Saint Petersburg (Fig. 20, 21).

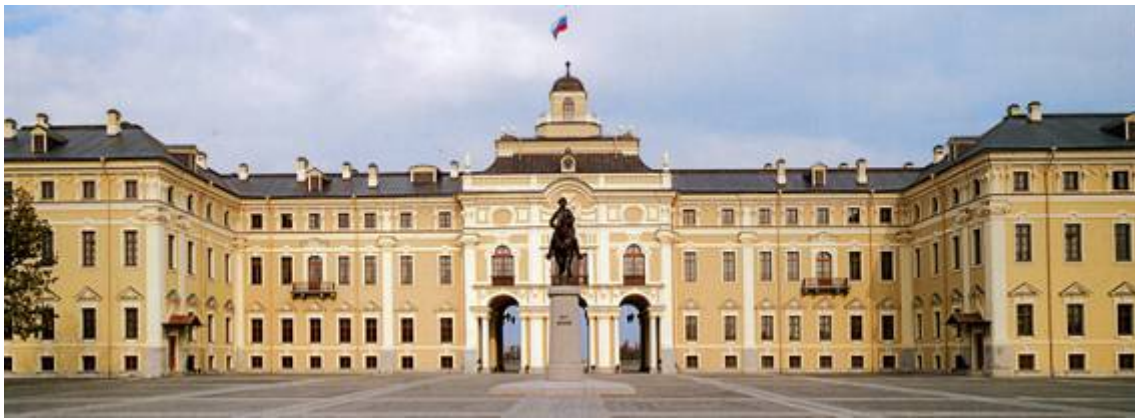
Figure 21. Konstantinovsky Palace, south façade. View after a final reconstruction stage (July 2003).
