Reconstruction of Konstantinovsky Palace in a Suburb of Saint Petersburg

ABSTRACT: *This article describes a complex approach to the condition survey and design executed as part of the remedial works on Konstantinovsky palace in the suburb of Strelna (Saint Petersburg)--one of the most beautiful historic monuments of 18th century Russia. The palace was almost completely destroyed in the 1940s. In 2000 the decision was made to reconstruct the palace, and the project for palace reconstruction was developed. The project was completed in 2003. The following important stages of the project are discussed in this paper: palace condition survey and site investigations, analyses of the palace retaining structures, design project of palace reconstruction, and phases of the remedial works.*

Reconstruction of Konstantinovsky Palace in a Suburb of Saint Petersburg. International Journal of Geoengineering Case histories, <http://casehistories.geoengineer.org>, Vol.1, Issue 3, p.189-205.

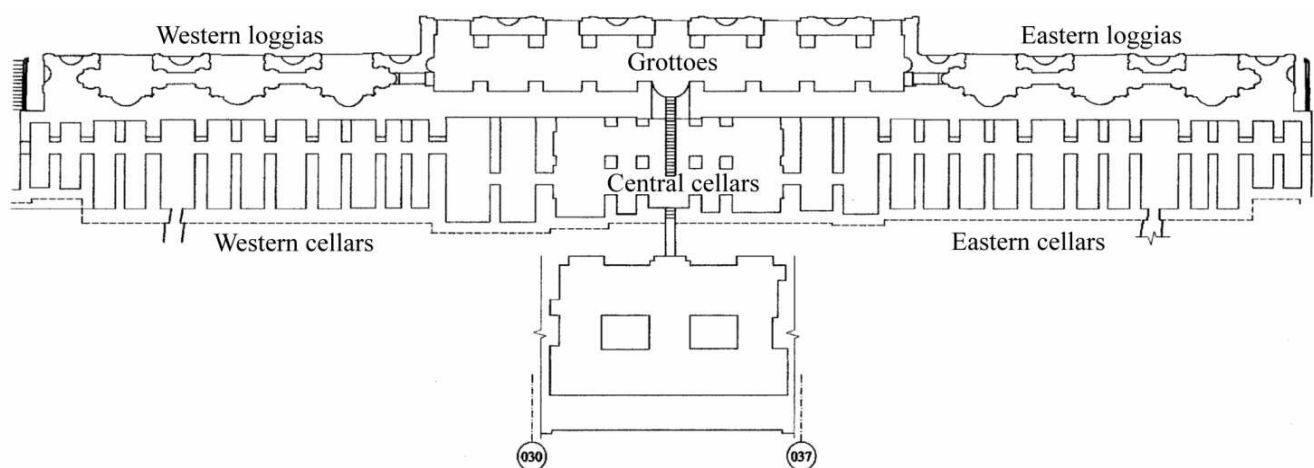
Figure 3. Plan of cellars, grottoes, and loggias of Konstantinovsky Palace.

Symmetrically on each part of the central grotto there are 3 loggias (see Fig. 3 and 4). The gable wall for both the grottoes and the loggias is the actual retaining wall. The loggias retaining wall contains half-sphere niches forming the volume of every loggia. In these locations the retaining wall is especially thin (around 1.5 m), but gradually increases up to 3.2 m elsewhere.

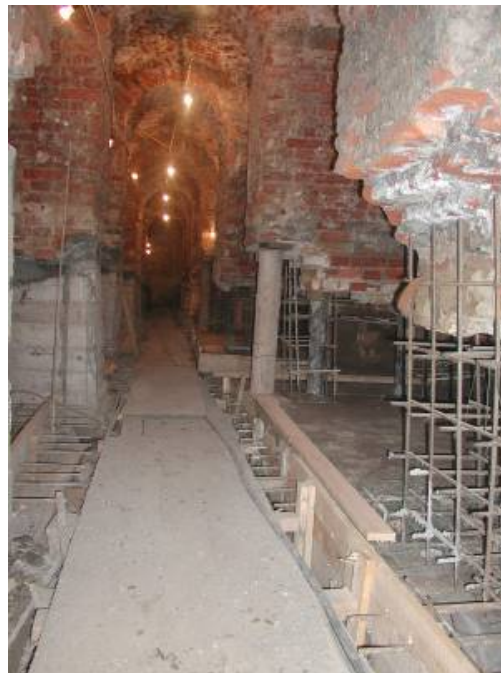
Figure 17. Deepening of the basements by 1.0-1.5 m.

3. The constructed strengthening option was successful even when faced with an unexpected challenge. The architects suddenly decided to provide front access to the palace from the Lower Park and furnish a vestibule underneath the terrace. To do this, all cellars had to be deepened by 1.0-1.5 m and the transverse brick walls were temporarily suspended on the thin underpinning piles (Fig. 16, 17, 18). Quality of the strengthening was attested by the fact that not one section of the brickwork was in any way displaced. It was therefore ascertained that the strengthening was successful.

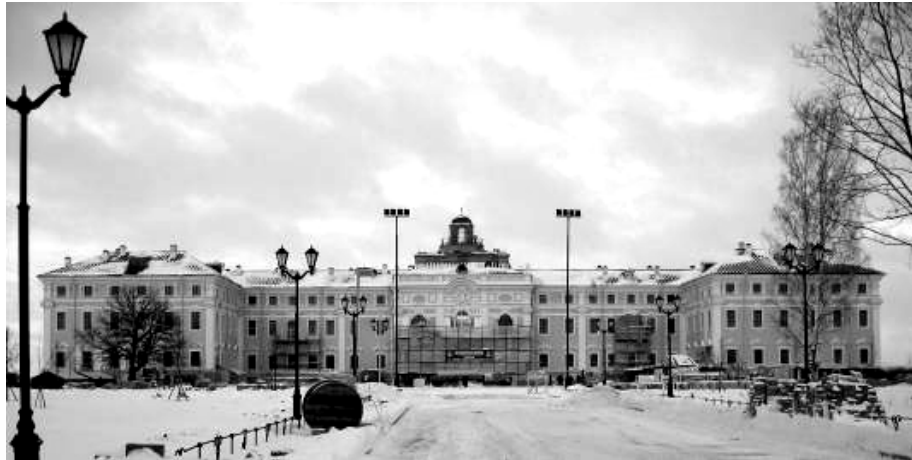
Figure 19. Konstantinovsky Palace, south façade. View of a final reconstruction stage (January 2003).

It took about 1.5 years to completely reconstruct Konstantinovsky Palace in Strelna (Fig. 19). The palace officially opened as the Congress Palace in 2003 during the tercentenary celebrations of Saint Petersburg (Fig. 20, 21).

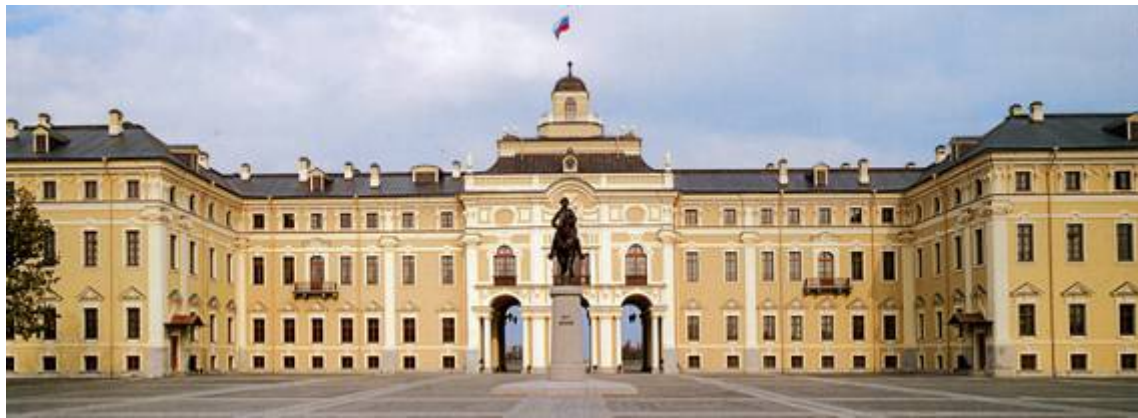
Figure 21. Konstantinovsky Palace, south façade. View after a final reconstruction stage (July 2003).
