# Reconstruction of Konstantinovsky Palace in a Suburb of Saint Petersburg

**ABSTRACT:** *This article describes a complex approach to the condition survey and design executed as part of the remedial works on Konstantinovsky palace in the suburb of Strelna (Saint Petersburg)--one of the most beautiful historic monuments of 18th century Russia. The palace was almost completely destroyed in the 1940s. In 2000 the decision was made to reconstruct the palace, and the project for palace reconstruction was developed. The project was completed in 2003. The following important stages of the project are discussed in this paper: palace condition survey and site investigations, analyses of the palace retaining structures, design project of palace reconstruction, and phases of the remedial works.*

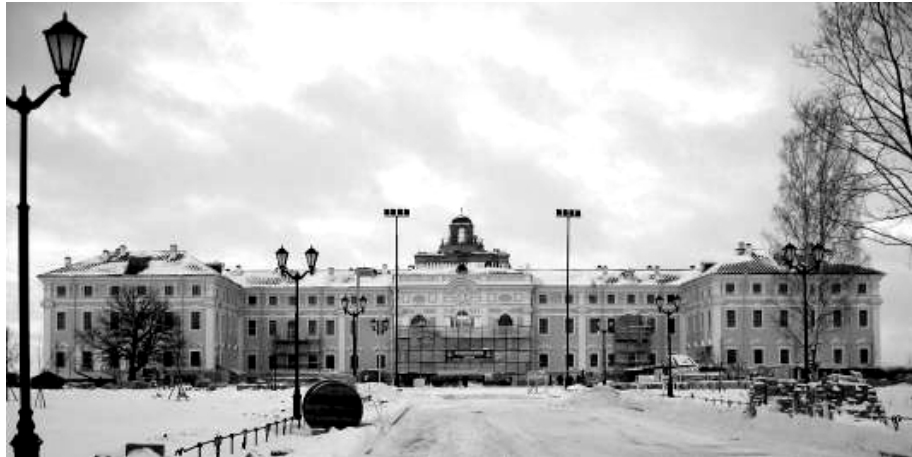
*Figure 19. Konstantinovsky Palace, south façade. View of a final reconstruction stage (January 2003).*

It took about 1.5 years to completely reconstruct Konstantinovsky Palace in Strelna (Fig. 19). The palace officially opened as the Congress Palace in 2003 during the tercentenary celebrations of Saint Petersburg (Fig. 20, 21).

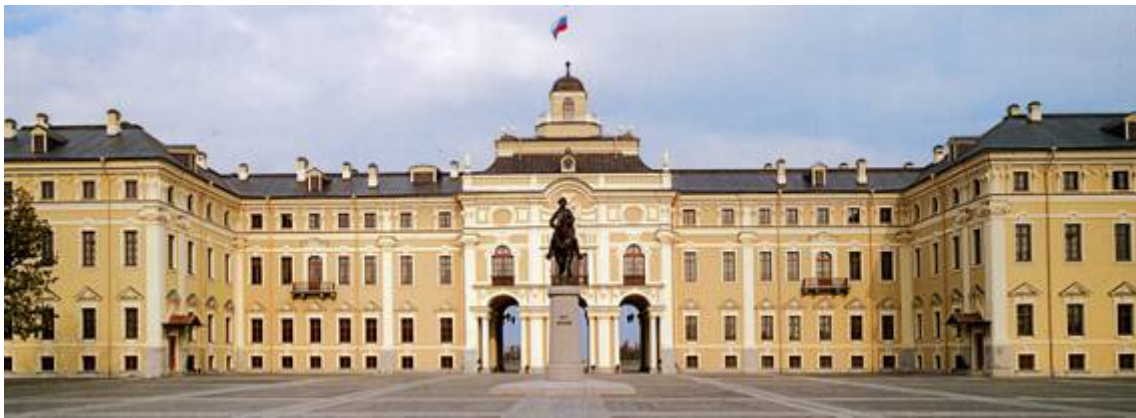
Figure 21. Konstantinovsky Palace, south façade. View after a final reconstruction stage (July 2003).
