Rockfall and Subsidence on Mumbai-Pune Expressway

ABSTRACT: Mumbai-Pune, India's first expressway, which crosses the mountainous and rugged Deccan Trap Province, suffered from a large amount of rockfall and major landslides in 2003 and 2004. A significant number of accidents and fatalities have occurred on the expressway as a result of such events. On the basis of frequency and magnitude of the recorded incidences of rockfall, seventeen critical areas of the road have been deemed in need of investigations and mitigation. One of the problematic areas that suffered from rockfall and subsidence is at km 41 on the expressway, adjacent to a tunnel (Adoshi). This location has been chosen for detailed study. This area extends for 500 m along the expressway, and the embankment has subsided by 2 to 3 m along the entire length. Based on the geological, geomorphologic and geotechnical investigations, causative factors for rockfall and subsidence at this location have been established. This paper presents the field investigations, probable causes, stability analysis and remedial measures for controlling the subsidence and rock fall.

Reference: Kumar, K., Prasad, P.S., Mathur, S., Kimothi, S.

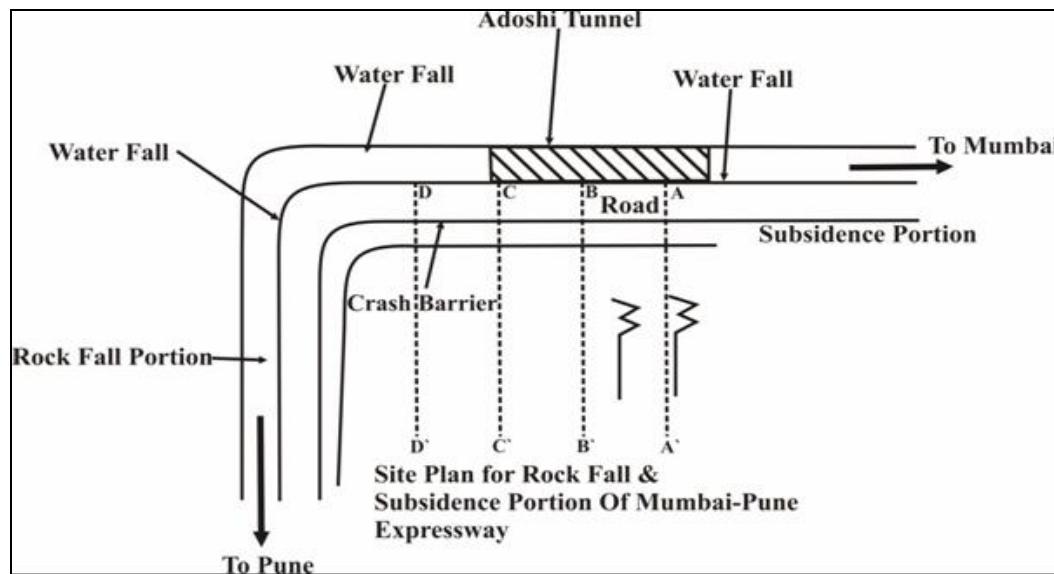
Figure 18. Location of crosss sections for stability analysis.

Soil samples were collected from the field. In-situ density of the embankment was measured using the core cutter method. The bulk density of the embankment is 17 kN/m^3 . The shear strength parameters of the embankment soil are $c'=3 \text{ kPa}$ and $\phi'=30^\circ$. The subsidence portion is around 500 m in length. The cross sections A – A, B – B, C – C and D – D were chosen for every 125 m as shown in Figure 18. Stability analysis of the embankment slope was analyzed by using GEO 4 software (Figure 19). The factor of safety of the embankment was analyzed using Bishop's and Peterson's methods. These results are presented in Table 1. The factor of safety at cross sections A – A and B – B is less than 1.25, which is considered critical by both the code of Indian standards and the US Army Corps of Engineers (IRC: 75, 1979 and EM 1110- 2-1902, 2003).
