Mississippi River Levee Failures: June 2008 Flood

ABSTRACT: *During the spring and summer of 2008, record rainfall in the Midwest United States led to severe flooding as water overtopped the levees bordering the Mississippi River and its tributaries. The erosion associated with the overtopping resulted in levee breaches in many places. After the flooding, a field reconnaissance team was sent to collect time-sensitive data and provide a comprehensive overview of the performance of the levees during the flooding.*

Reference: Bernhardt, M., Briaud, J.L., Kim, D., Leclair, M., Storesund, R., Lim, S.G., Bea, R.G., Rogers, J.D., (2011). *Mississippi River Levee Failures: June 2008 Flood*. International Journal of Geoengineering Case Histories, <http://casehistories.geoengineer.org>, Vol.2, Issue 3, p. 127-162. doi: 10.4417/IJGCH-02-02-03.

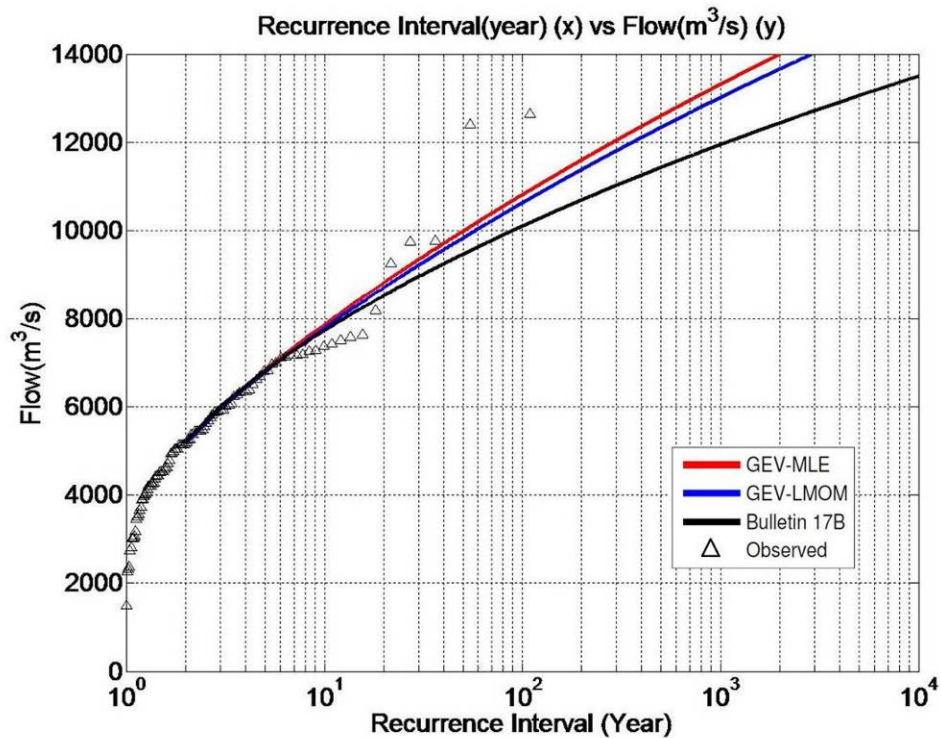
Figure 6. Observed flow peaks versus their recurrence intervals, gage 05474500.

The recurrence interval of the June 2008 flood based on the three different methods can be read on a fitted curve for the observed value of the flow, such as shown for gage 05474500 in Figure 6. To obtain the estimated recurrence intervals, a horizontal line is drawn from the data point with a flow value of 12,400 m³/s through the regression lines. Each intersection point represents the recurrence interval for that respective estimation method. The results for the 4 gages of Figure 5 are shown in Table 1. As can be seen from Table 1, the predicted recurrence interval for Gage 05474500 varies significantly

among the three methods due to the fact that the data is extrapolated to extreme values. It is clear however, that at this location the flood was very large and in the vicinity of a 1000-year flood.

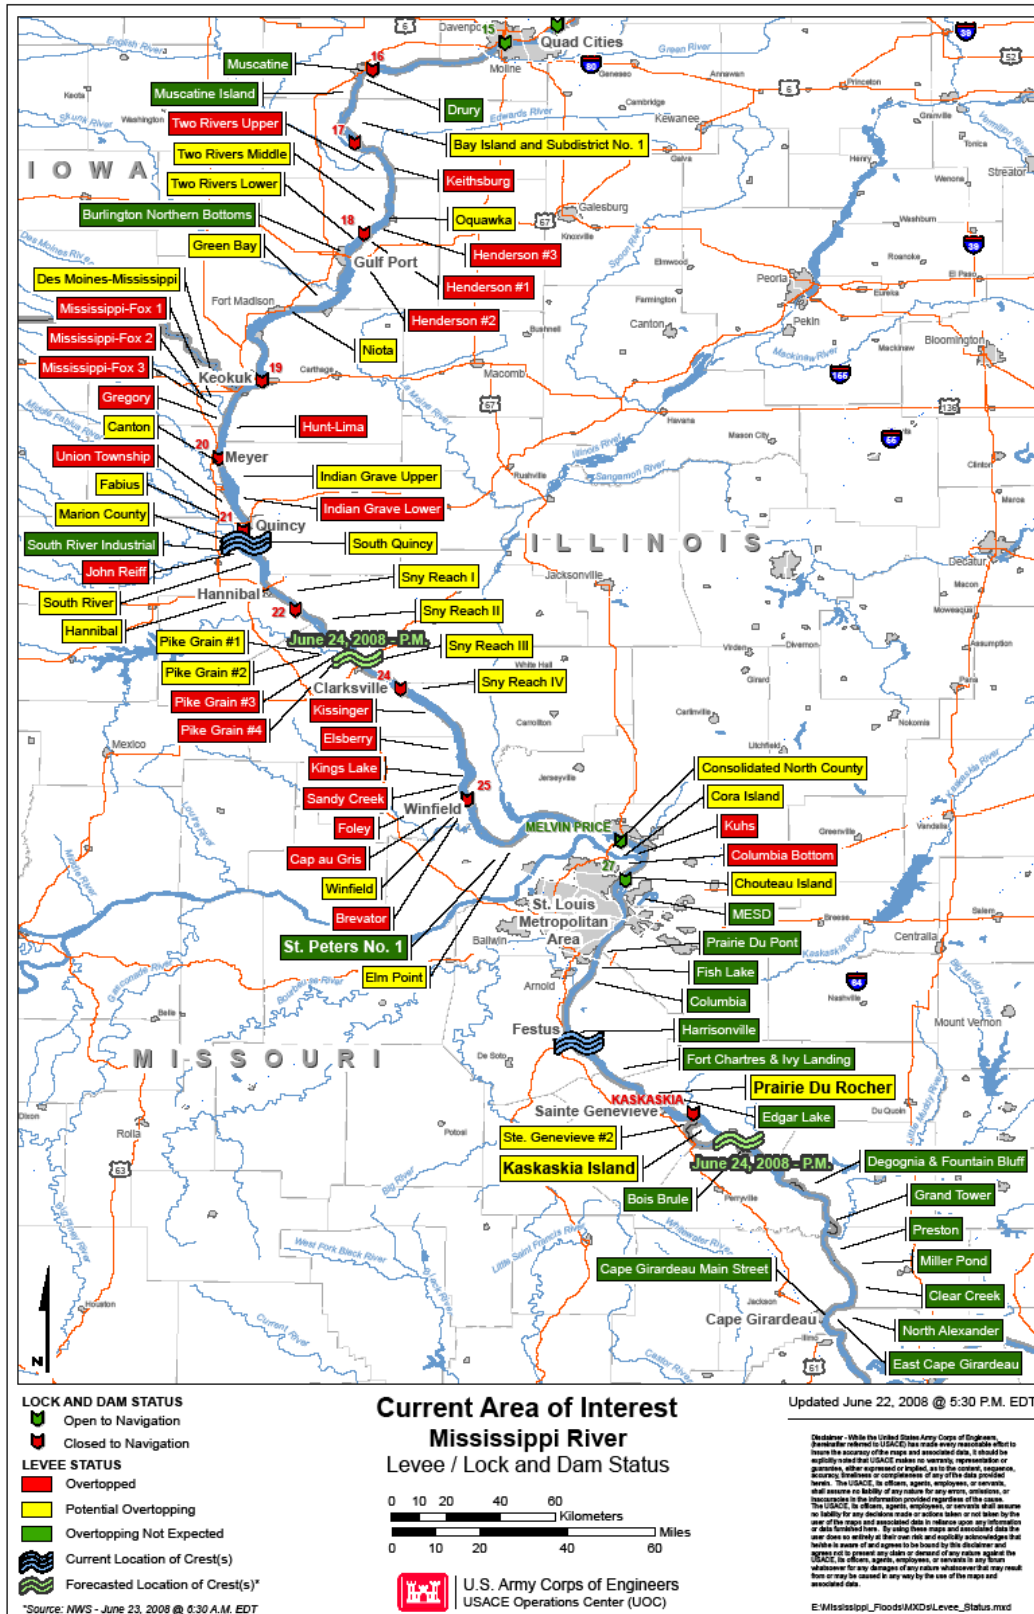
Figure 10. Overtopping status of Upper Mississippi River System (USACE 2008).

Figure 10 shows the US Army Corps of Engineers map of each particular levee system along the Upper Mississippi River System and the corresponding overtopping status during the flooding events as reported on 22 June 2008. The areas tagged in red had already been overtopped while the areas tagged in yellow show levee sections that were still in danger of being overtopped at that date.

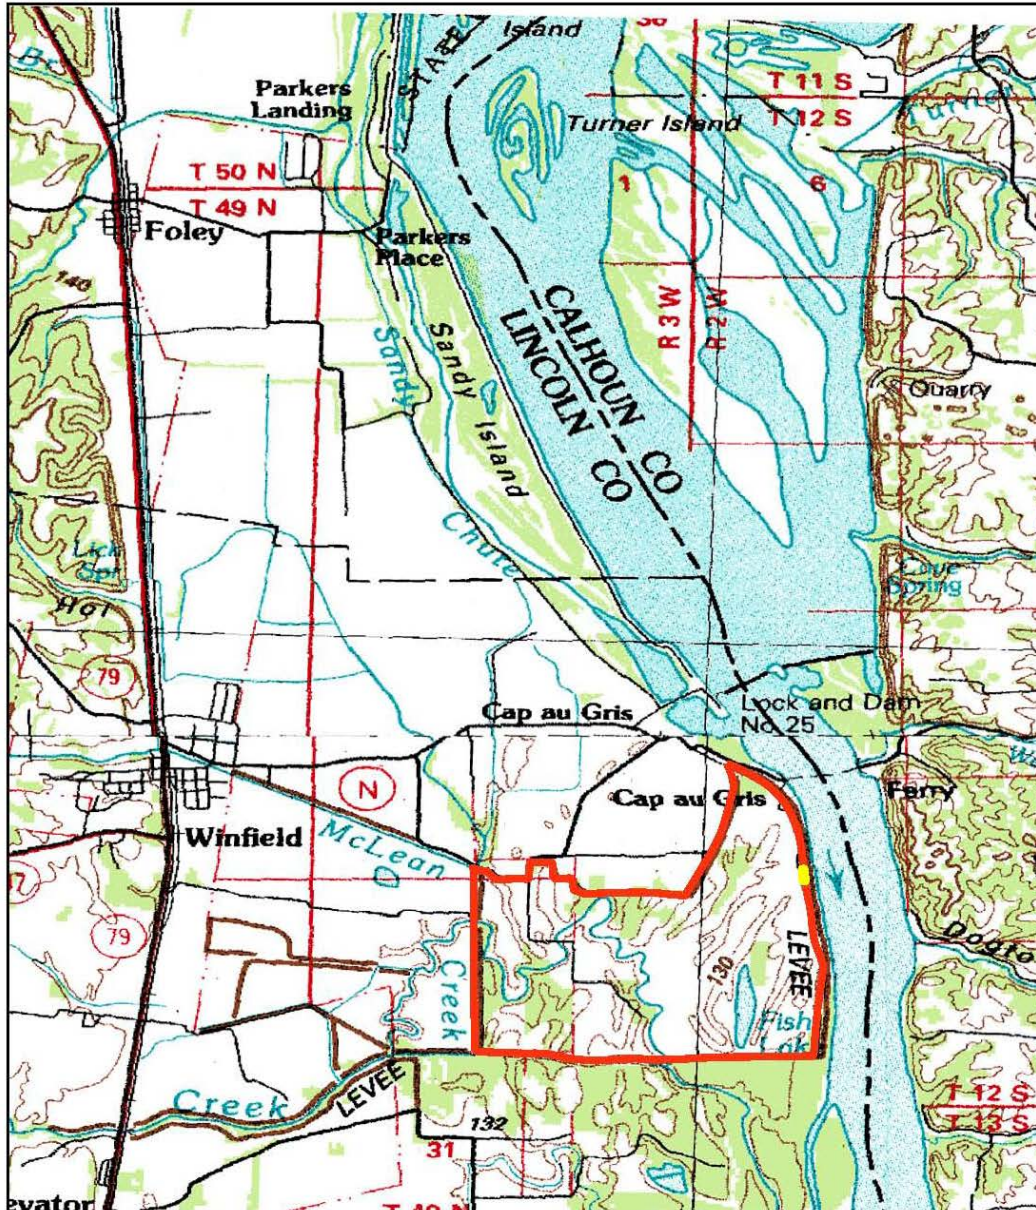
Figure 14. Winfield-Pin Oak levee system and levee breach (Storesund 2009).

The Winfield-Pin Oak levee is maintained by the Cap Au Gris Drainage and Levee District. This levee system is estimated to reduce the risk of flooding of approximately 493 ha up to a 14-year return period flood event on the Mississippi River (Figure 14). This area failed during the 1993 floods, however, the specific location of the breach (or breaches) was not documented (USGS 2006). This site was overtopped for an extended period beginning on June 18th, 2008.

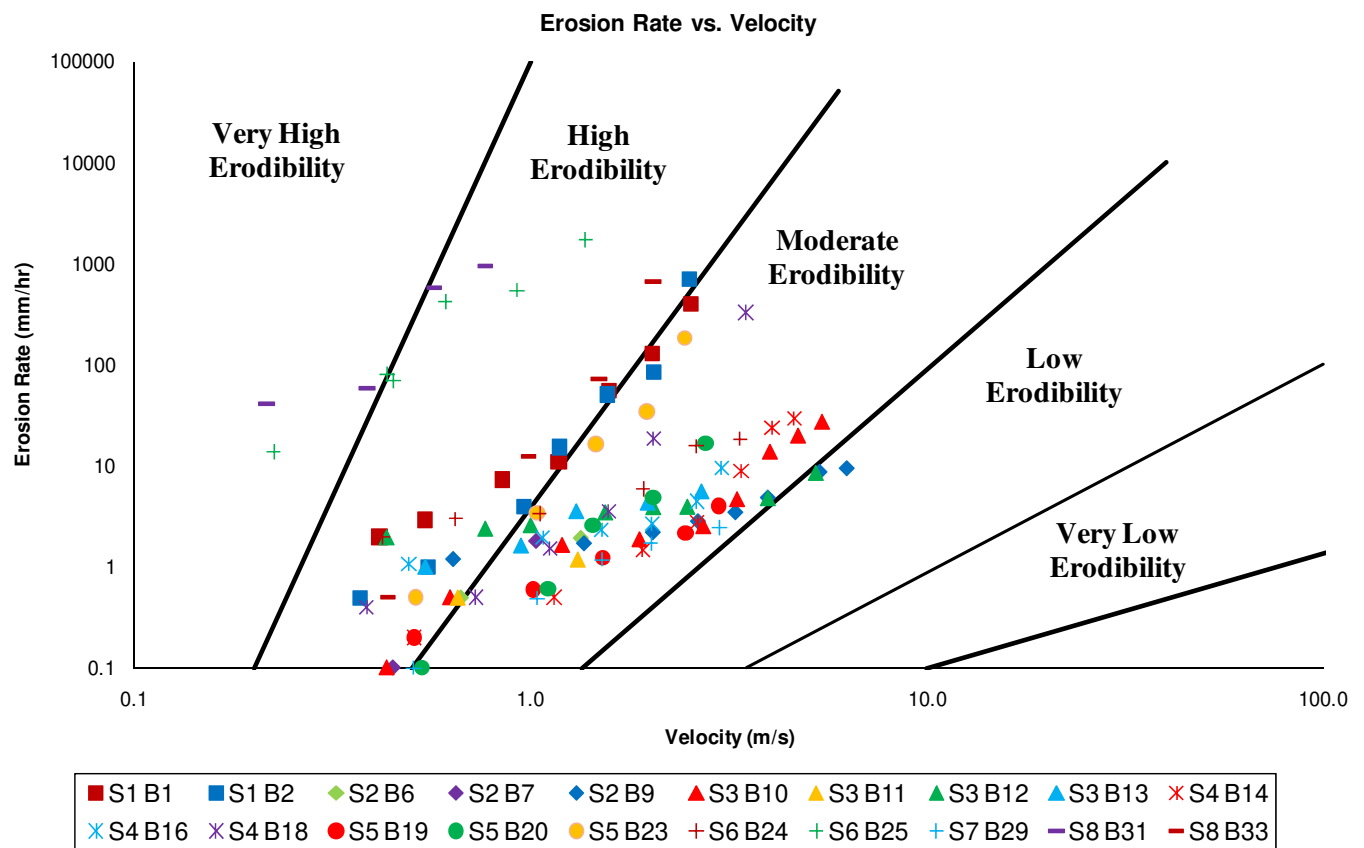
Figure 23. Erosion rate versus velocity for the Midwest Levee samples.

The EFA was used to obtain the erosion functions for 20 Midwest Levee samples. The samples tested were chosen in an effort to encompass a variety of material types, locations within the levee, and erosion performance. In order to compare the erosion functions of the samples, the data points were all plotted on the same graph (Figure 23). This graph also shows the erosion categories developed from previous studies (Briaud 2008). Most of the soils tested show moderate erosion at higher velocity. Please refer to Table 2 for the site identification nomenclature.

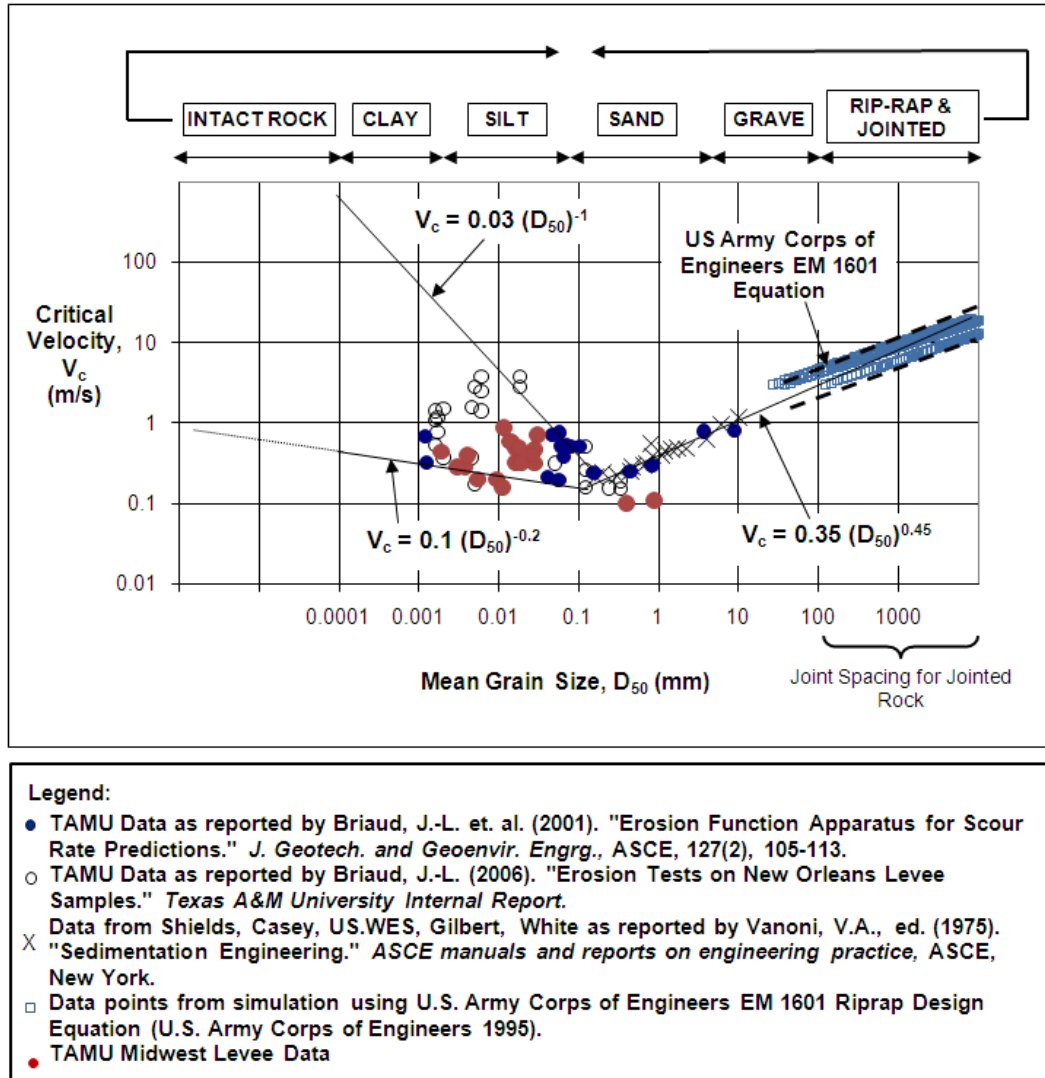
Figure 24. Critical velocity vs. D_{50} combined results.

The critical velocity is defined as the maximum velocity that the soil can resist without erosion. This erosion threshold is considered to correspond to an erosion rate of 0.1 mm/hr. Previous comparisons (Briaud 2008) have been made between critical velocity and D_{50} (average particle diameter). Figure 24 shows the Midwest Levee values plotted with values obtained from previous testing. The values follow the trend set by the previous data.

This plot shows that most of the Midwest levee soils tested have D_{50} values in the silt size range and critical velocities between 0.1 and 1 m/s. Since the levees have heights of 3 to 5 m, the velocity at the bottom of the levee can reach 10 m/s. This can be estimated by equating energies:

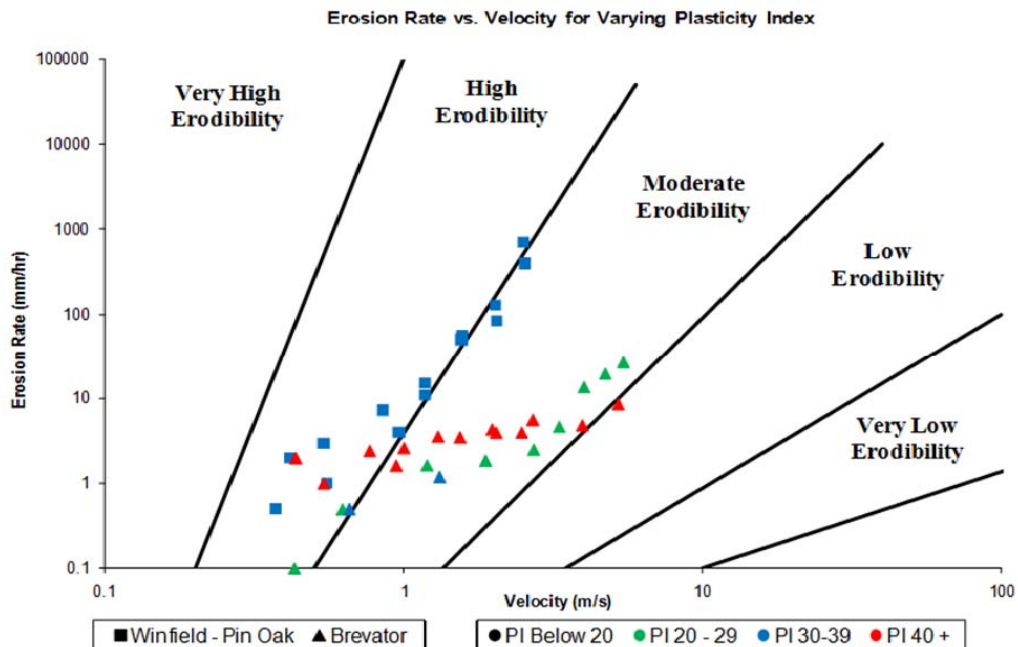
Figure 26. EFA comparison of PI for the Winfield-Pin Oak and Brevator sites.

Laboratory tests were performed to obtain the plasticity index (PI), D_{50} , and percent relative compaction. These soil properties were divided into categories and combined with the EFA results to study the influence of these factors on the erosion resistance of a soil. Figure 26 shows the EFA results for the two sites plotted in different colors based on their PIs. Figure 27 shows the same plot for all of the sites studied.

A weak trend seems to exist with the more erosion resistant soils having higher PIs. The trend is not obvious which indicates that plasticity is not the only factor that influences erosion. It should also be noted that other factors varied for the samples plotted and therefore, the influence of plasticity is not singled out by the graphs shown.

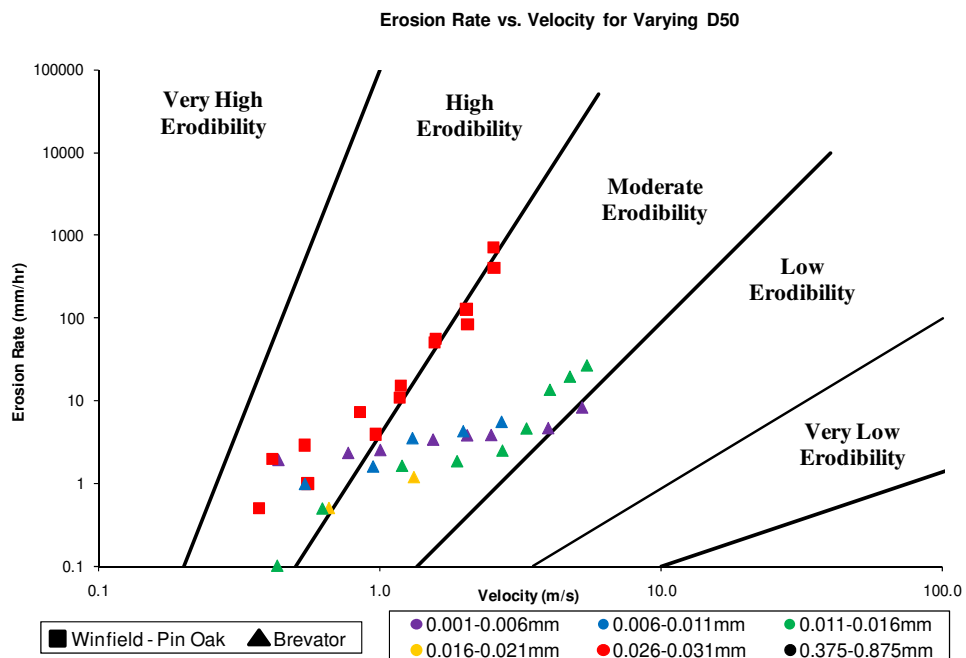
Figure 28. EFA comparison of D_{50} for the Winfield-Pin Oak and Brevator sites.

Again some level of correlation is observed indicating that, within the range of D₅₀ tested, the soils with the smaller D₅₀ are some of the more erosion resistant. It can be seen in Figure 28 that the Brevator site samples are associated with the smallest particle sizes tested while the samples from the Winfield-Pin Oak site were some of the largest. Figure 30 and Figure 31 show the influence of percent relative compaction (% RC) on the erosion resistance of a soil. Because of the small amount of sample available for compaction, a small volume version of the Modified Proctor compaction test was used. Equivalent energies were calculated and applied to the soil contained in a small volume mold per ASTM D-1557. To verify compatibility, compaction curves for a bulk soil sample obtained from the small volume test were compared with those obtained using the full size mold described in the ASTM specifications. The percent relative compaction was calculated by dividing the dry unit weight, γ_d , measured on the intact samples by the $\gamma_{d,max}$ obtained from the small volume Modified Proctor compaction test. Hassan et al. (2004) showed that the erosion resistance of a given soil increased when compacted at higher water contents and higher degrees of compaction. Figure 30 does not show this trend clearly; however, it should be noted that these graphs do not separate out the effects of other factors on erosion. It should also be noted that the trend described by Hassan et al. (2004) only holds for a given soil independently and is not necessarily true for comparing two different soils.

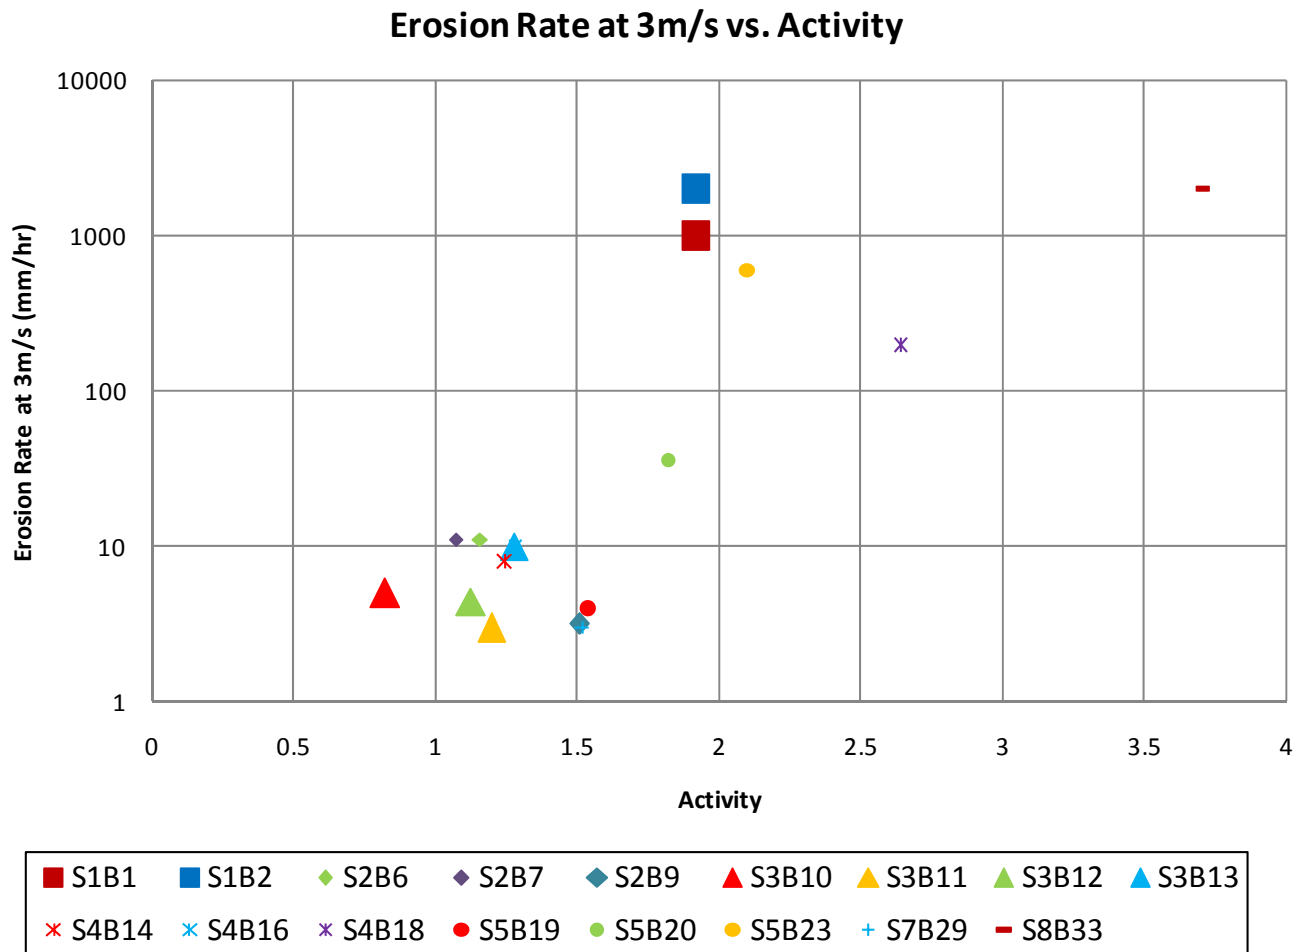
Figure 32. Erosion rate at 3m/s vs. activity.

While most of the correlations did not exhibit a clear trend, it was noticed that as the clay content increased, the erodibility of the soil decreased. A more noticeable trend appeared in the plot of erosion rate versus activity (Figure 32). As activity increases, so does the erosion rate. Activity is the ratio of the Plasticity Index over the percent finer than $2\mu\text{m}$ (clay fraction).

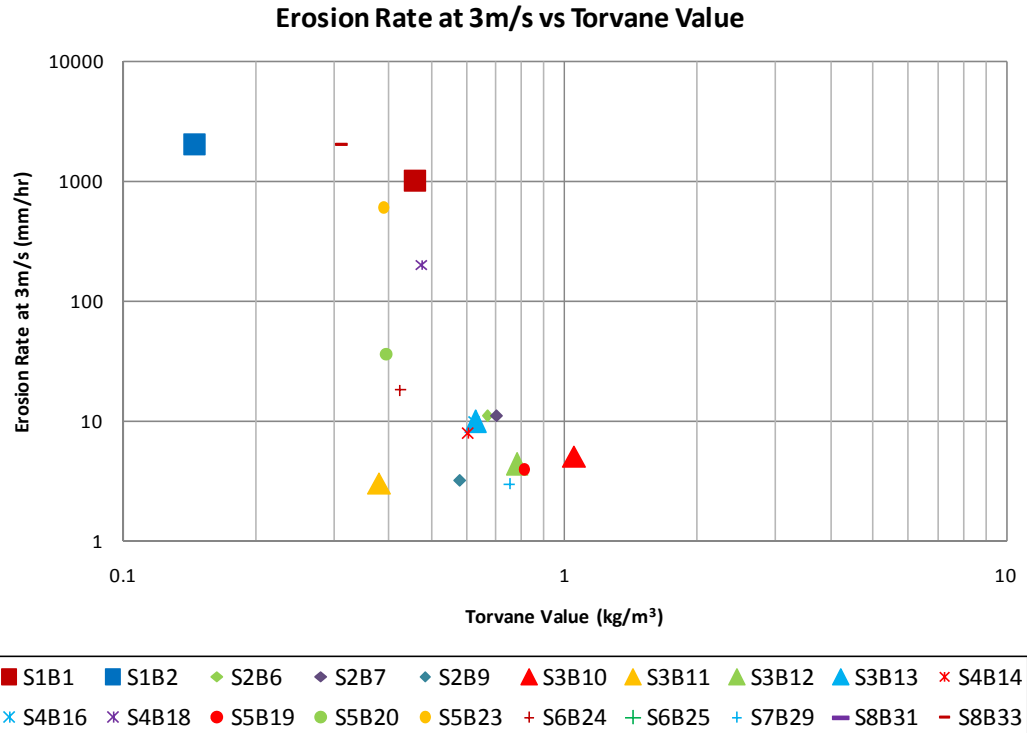
Figure 33. Erosion rate at 3m/s vs. Torvane values.

Figure 33 shows the erosion rate at 3 m/s against the Torvane strength. This graph indicates that as the shear strength increases the erosion rate decreases as may be expected.

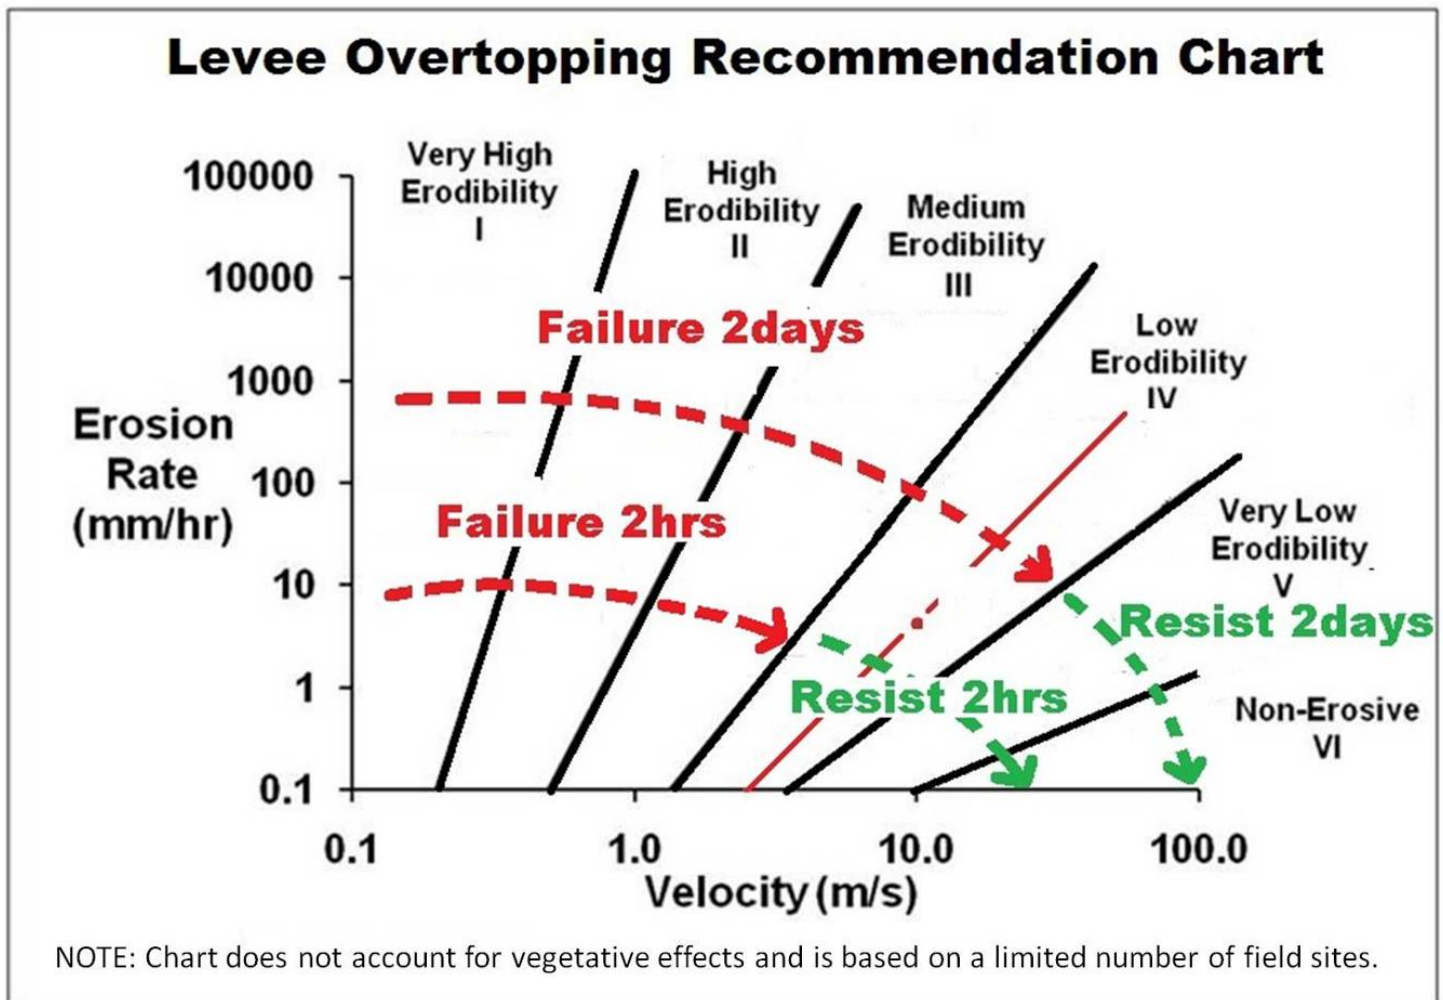
The overtopping recommendation chart given in Briaud et al. (2008) was developed for overtopping periods of less than two hours associated with hurricane events. Based on the findings from this study, the chart was expanded to include the longer overtopping periods of 2 days experienced in flood events (Figure 36). The boundary was determined by considering the data of Figure 34 and setting an erosion limit of 0.3 m over two days for a velocity of 10 m/s. This velocity represents an average value for levees at the bottom of the dry side of the levee. To satisfy this criterion, the erosion rate has to be less than 6 mm/hr (red dot and thin red line shown on Figure 36). It is important to note that the EFA tests used to develop this chart were conducted on barren soil and therefore the chart does not account for vegetation present at a site. Also, this chart is based on a limited number of field sites and may not be representative of every field case.

Figure 36. Recommendation chart for overtopping events.
