Mississippi River Levee Failures: June 2008 Flood

ABSTRACT: *During the spring and summer of 2008, record rainfall in the Midwest United States led to severe flooding as water overtopped the levees bordering the Mississippi River and its tributaries. The erosion associated with the overtopping resulted in levee breaches in many places. After the flooding, a field reconnaissance team was sent to collect time-sensitive data and provide a comprehensive overview of the performance of the levees during the flooding.*

Reference: Bernhardt, M., Briaud, J.L., Kim, D., Leclair, M., Storesund, R., Lim, S.G., Bea, R.G., Rogers, J.D., (2011). *Mississippi River Levee Failures: June 2008 Flood*. International Journal of Geoengineering Case Histories, <http://casehistories.geoengineer.org>, Vol.2, Issue 3, p. 127-162. doi: 10.4417/IJGCH-02-02-03.

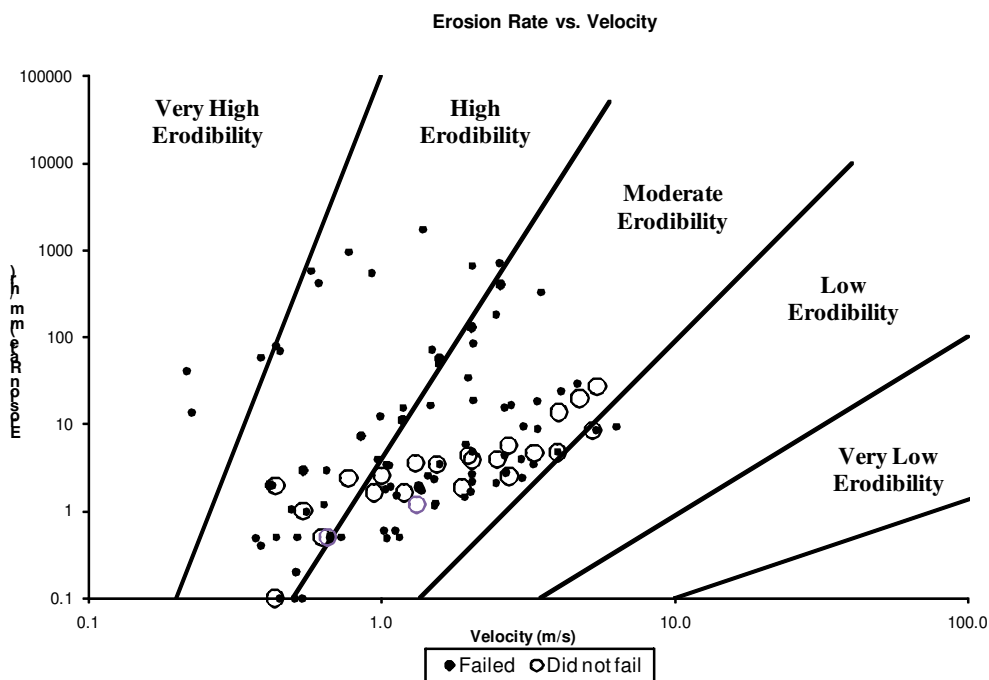
Figure 34. Overtopping comparison of pass vs. fail.

In an attempt to determine a dividing line between the soils that failed due to overtopping and those that passed, the EFA results were plotted with open circles for samples from levees that did not fail and solid circles for samples from levees that failed (Figure 34). Note that the Brevator site was the only site considered to have not failed.

Overall there is no clear division between the two sets of points like what was seen in the Katrina data (Figure 35) given in Briaud et al. (2008). The soils from the Brevator site are among some of the more resistant soils tested; however, there are several sites where the samples are just as resistant yet the sites failed. Comparing the sites that failed to the sites that did not fail based on the plotted points is somewhat deceptive because the EFA tests were limited to the bare soil and did not

account for any of the site conditions, such as vegetation or other variables that may have influenced the sites performance. The strong vegetative cover at the Brevator site would increase the resistance and effectively shift the erosion function towards the low to very low erodibility categories.
