Mississippi River Levee Failures: June 2008 Flood

ABSTRACT: *During the spring and summer of 2008, record rainfall in the Midwest United States led to severe flooding as water overtopped the levees bordering the Mississippi River and its tributaries. The erosion associated with the overtopping resulted in levee breaches in many places. After the flooding, a field reconnaissance team was sent to collect time-sensitive data and provide a comprehensive overview of the performance of the levees during the flooding.*

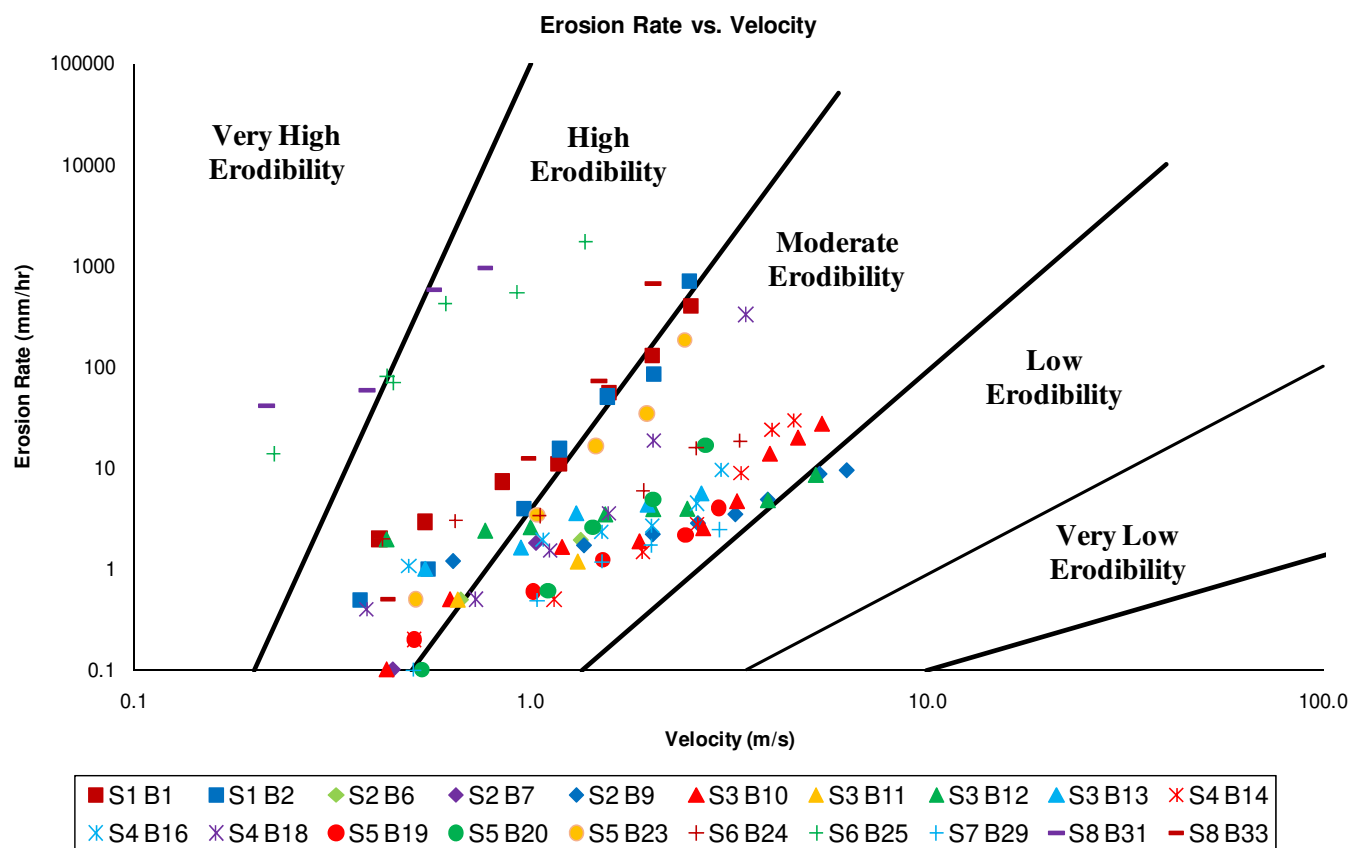
Figure 23. Erosion rate versus velocity for the Midwest Levee samples.

The EFA was used to obtain the erosion functions for 20 Midwest Levee samples. The samples tested were chosen in an effort to encompass a variety of material types, locations within the levee, and erosion performance. In order to compare the erosion functions of the samples, the data points were all plotted on the same graph (Figure 23). This graph also shows the erosion categories developed from previous studies (Briaud 2008). Most of the soils tested show moderate erosion at higher velocity. Please refer to Table 2 for the site identification nomenclature.

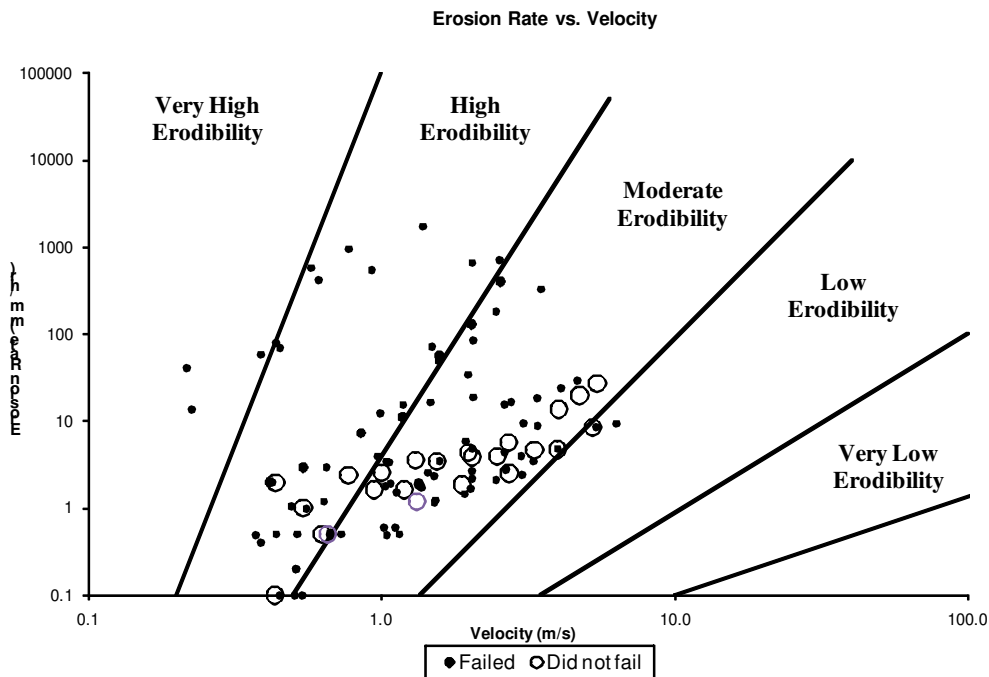
Figure 34. Overtopping comparison of pass vs. fail.

In an attempt to determine a dividing line between the soils that failed due to overtopping and those that passed, the EFA results were plotted with open circles for samples from levees that did not fail and solid circles for samples from levees that failed (Figure 34). Note that the Brevator site was the only site considered to have not failed.

Overall there is no clear division between the two sets of points like what was seen in the Katrina data (Figure 35) given in Briaud et al. (2008). The soils from the Brevator site are among some of the more resistant soils tested; however, there are several sites where the samples are just as resistant yet the sites failed. Comparing the sites that failed to the sites that did not fail based on the plotted points is somewhat deceptive because the EFA tests were limited to the bare soil and did not

account for any of the site conditions, such as vegetation or other variables that may have influenced the sites performance. The strong vegetative cover at the Brevator site would increase the resistance and effectively shift the erosion function towards the low to very low erodibility categories.
