Quarry-Induced Slope Instability at a Broadcasting Transmission Plant near Valcava, Lombardia, Italy

Monica Barbero, Assistant professor, Politecnico di Torino (Torino, Italy); email: monica.barbero@polito.it
Fabrizio Barpi, Assistant professor, Politecnico di Torino (Torino, Italy); email: fabrizio.barpi@polito.it

ABSTRACT: *Since 2006, a broadcasting tower and ancillary buildings on the top of a hill adjacent to a large, active limestone quarry, in northern Italy near the village of Valcava, has been heavily damaged by ground deformation due to slope instability. In 2005, the quarry began to work the slope toward the broadcasting plant, releasing bedding planes that affected the tower site: a number of fractures occurred in the warehouse and in the ground around it, that grew particularly during significant rainfalls. In October 2006 a landslide occurred in the quarry area, close to the broadcasting site. In order to understand what induced the fracture process in the buildings and define a support system to stabilize the broadcasting site, a detailed geotechnical survey and a number of numerical slope stability analyses were carried out. One of the main goals of the paper is t

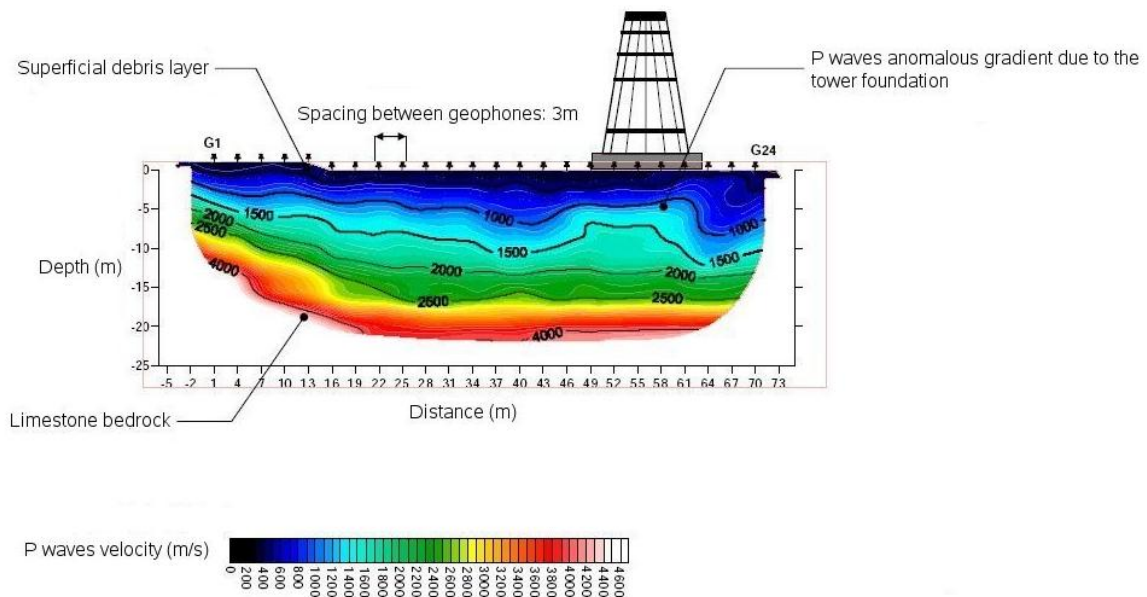
Figure 8. Seismic refraction survey results: P waves velocity trend inside the rock mass near the broadcasting tower.

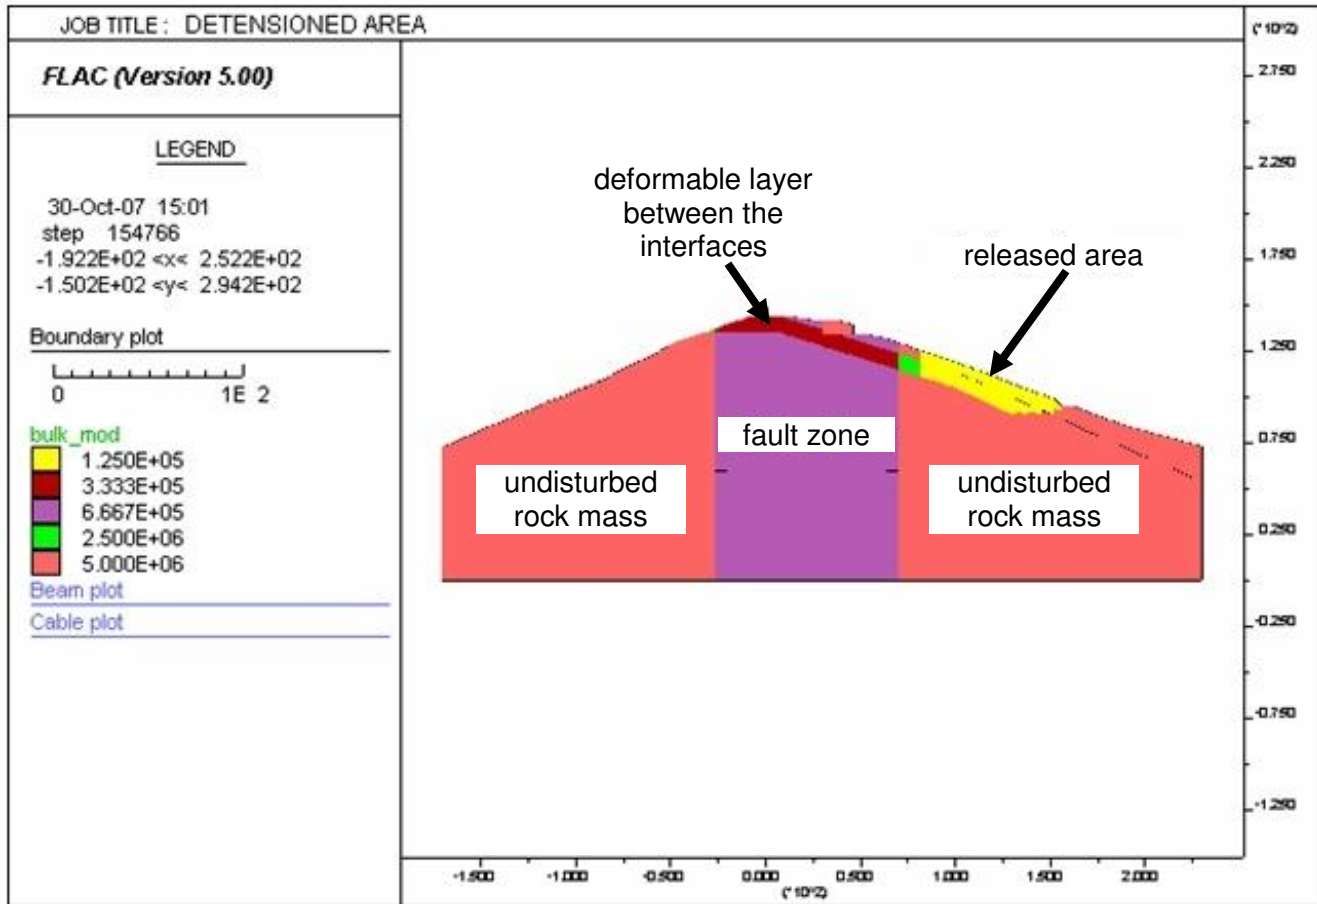
Figure 12. Model with released area to simulate the landslide in the pit (FLAC).

Following the inclinometric and stratigraphic evidences, two interfaces were introduced in the upper part of the slope (Figure 12), at about 8 and 16 m from the ground level, to simulate the presence of a more deformable layer. In order to simulate the bedding planes characterized by high persistence and down slope dipping, the rock mass was considered homogeneous and anisotropic, with ubiquitous joints, dipping of 20° and the mechanical properties obtained with the back-analysis (see the previous subsection).

The slope behavior after the landslide in the pit area was simulated. It was assumed that the landslide induced a stress release in the slope beside it, between 1345 m and 1375 m above sea level with down slope displacements. For this purpose, a 20 m thick layer of the rock mass (equal to the estimated depth of the landslide) has been relieved between 1345 m and 1375 m above sea level. In order to simulate the progressive failure along the critical layer, the deformability and strength properties of the corresponding elements were progressively reduced (Table 6 and Figure 12).

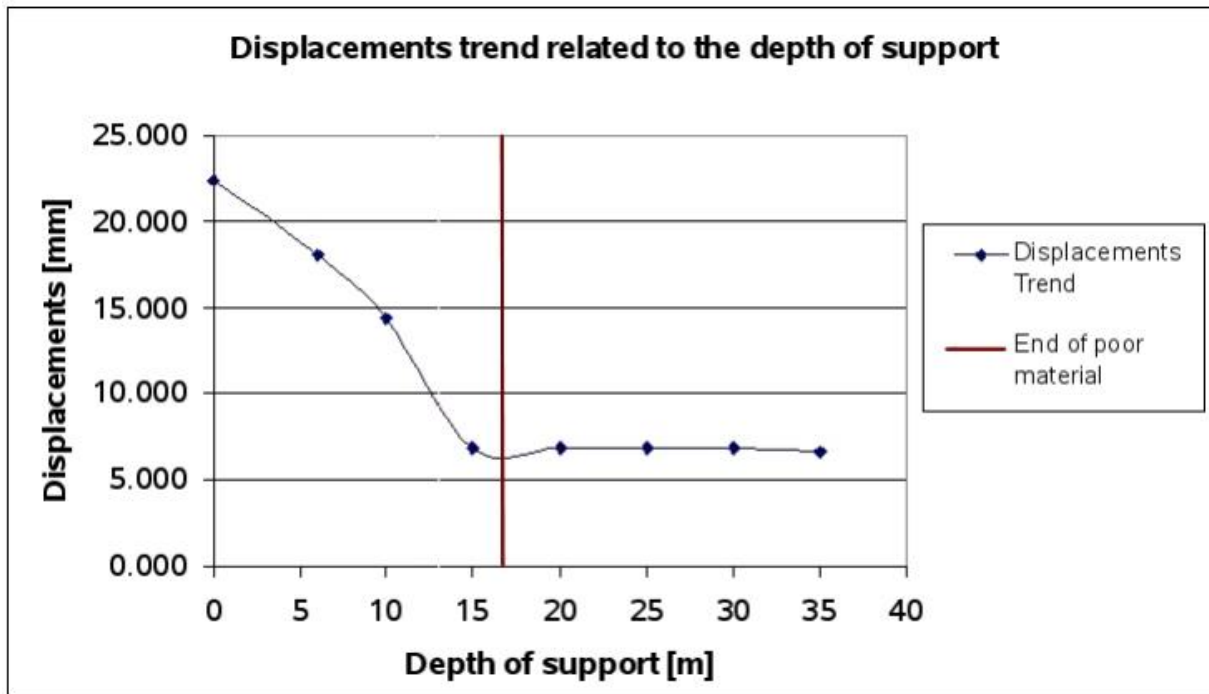
Figure 16. Model displacements in the area upstream the bulkhead, related to the length of the micropiles (assuming that in-situ bedrock is at 16 m depth).

The results (Figure 16) confirm that the minimum length for the micropiles is about 16 m (the depth at which the boundary between the weaker layer and the undisturbed rock mass is located). On the other hand micropile lengths greater than 20 m don't provide further benefit to the plant stability. It is possible to conclude that 27 m is a good estimate of the length for the micropiles.
