Quarry-Induced Slope Instability at a Broadcasting Transmission Plant near Valcava, Lombardia, Italy

Monica Barbero, Assistant professor, Politecnico di Torino (Torino, Italy); email: monica.barbero@polito.it
Fabrizio Barpi, Assistant professor, Politecnico di Torino (Torino, Italy); email: fabrizio.barpi@polito.it

Reference: Barbero, M., Barpi, F. (2011). *Quarry-Induced Slope Instability at a Broadcasting Transmission Plant Near Valcava, Lombardia, Italy*. International Journal of Geoengineering Case histories, <http://casehistories.geoengineer.org>, Vol.2, Issue 2, p.163-181. doi: 10.4417/IJGCH-02-02-04

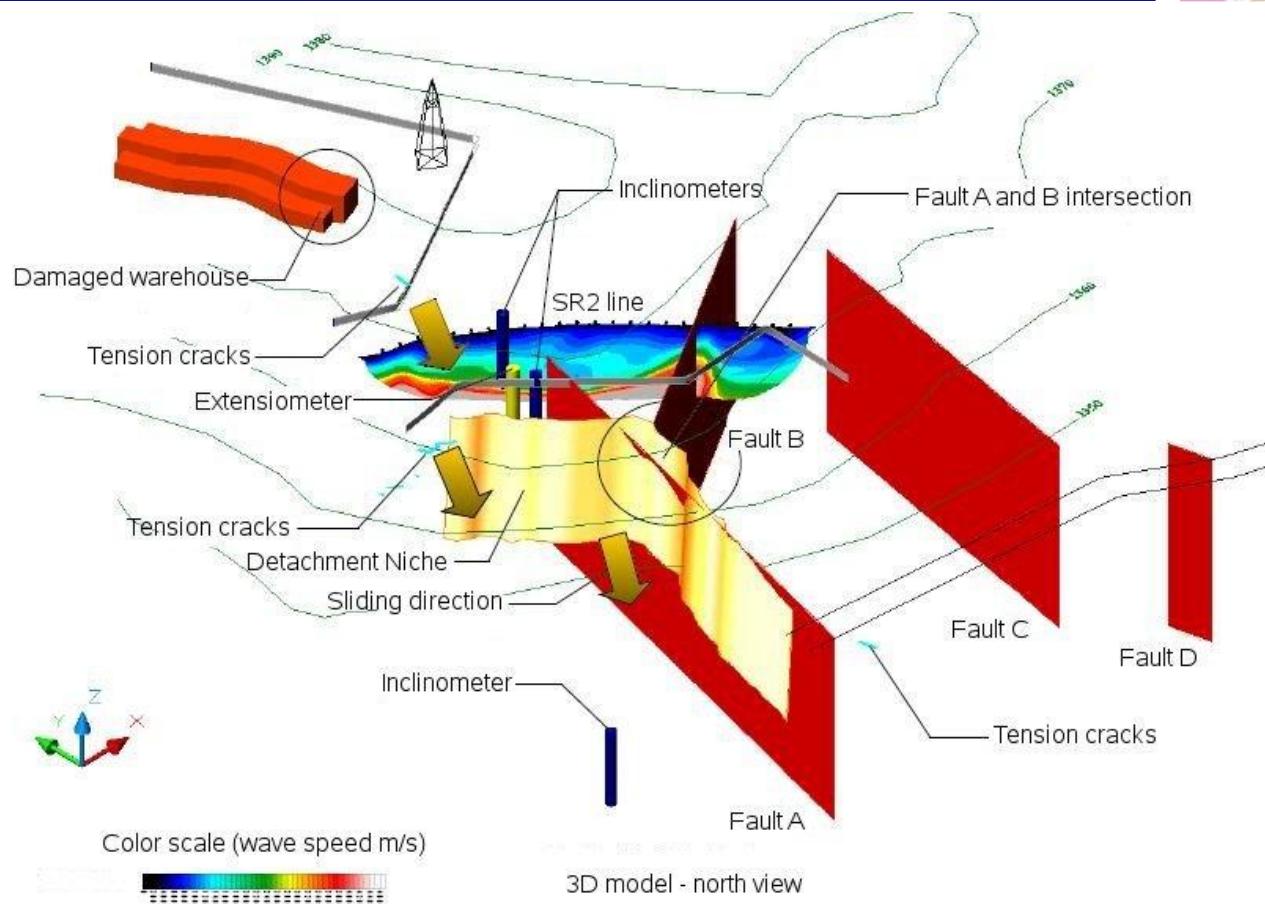
Figure 7. Three dimensional model for the seismic and geo-electrical survey.

One seismic refraction and two geo-electrical soundings were located near the warehouse on the unstable slope, toward the pit. Another pair of seismic and geo-electrical outlines was located close to the broadcasting tower base (Figures 6 and 7). The data were processed with tomographic technique (Hampson & Russel, 1984; Olsen, 1989) and then interpreted considering the conventional exploration with core-drilling data. Similar results were generated in the slope and in the tower area. Upslope of the warehouse, in the tower area, there is a superficial layer of fill about 3 m deep, underlain by a layer of fractured limestone overlying apparently intact bedrock at a depth of about 16 m, as shown in Figure 8. Near the warehouse, upslope from the landslide, a pit showed the same stratigraphic sequence is observed in the tower area, as well as evidence of the two main faults A and B (Figure 9). Because of fault B, the apparently intact limestone is found at a depth of more than 20 m. The seismic survey thus confirmed the likelihood that the sliding surface was located above a depth of 20 m.

The results of the field surveys have shown that many natural weakness elements affect the site. Fault A marks the east boundary of the landslide. Its intersection with fault B (Figures 6 and 7) induces heavy fracturing in the limestone to significant depths contributing to the instability of the area. The downslope dipping bedding planes predispose the slope to sliding and the two sub-vertical sets of discontinuities can become preferential paths for water percolation.

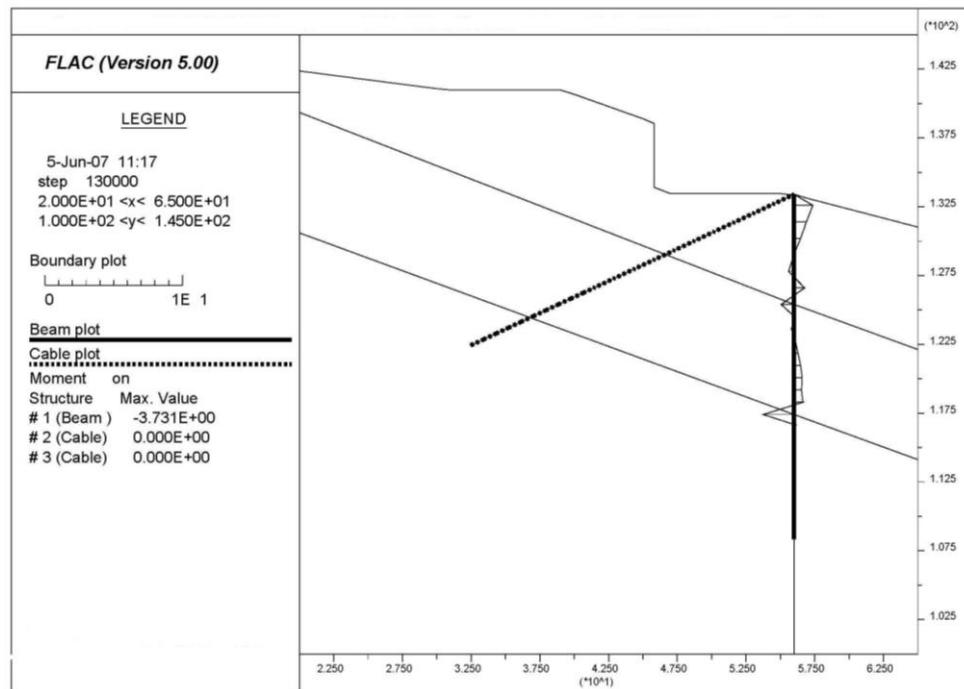
Figure 18. Bending moment acting on micropiles.

numerical analyses provided the normal force, bending moment and shear force acting on the micropiles and the axial forces acting on the anchors (Figures 17, 18 and 19). These results were used to design the steel elements.

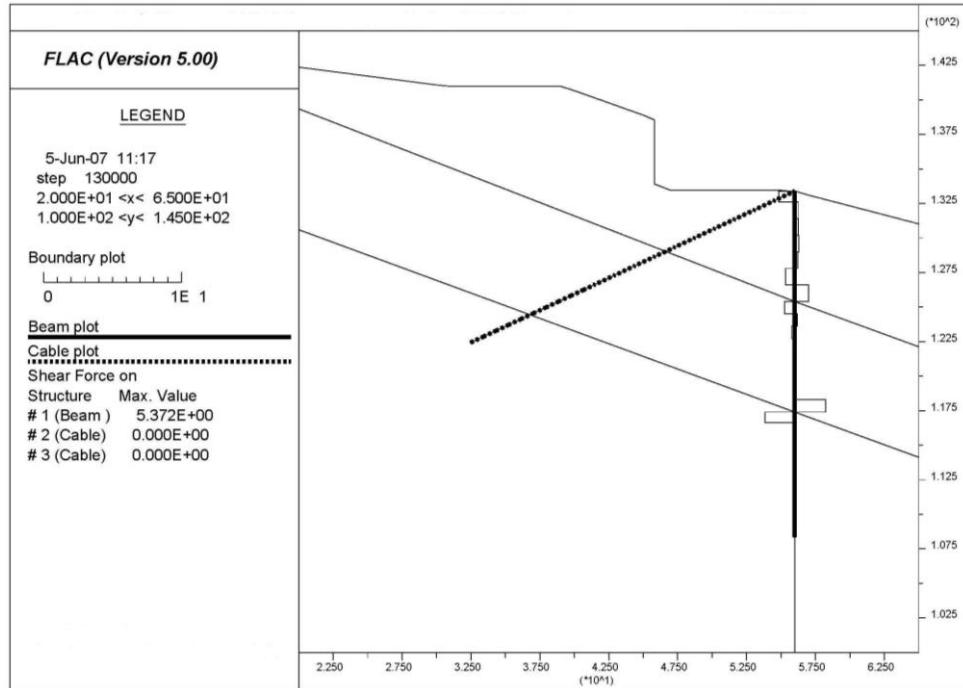
Figure 19. Shear force acting on micropiles.
