Quarry-Induced Slope Instability at a Broadcasting Transmission Plant near Valcava, Lombardia, Italy

Monica Barbero, Assistant professor, Politecnico di Torino (Torino, Italy); email: monica.barbero@polito.it
Fabrizio Barpi, Assistant professor, Politecnico di Torino (Torino, Italy); email: fabrizio.barpi@polito.it

ABSTRACT: *Since 2006, a broadcasting tower and ancillary buildings on the top of a hill adjacent to a large, active limestone quarry, in northern Italy near the village of Valcava, has been heavily damaged by ground deformation due to slope instability. In 2005, the quarry began to work the slope toward the broadcasting plant, releasing bedding planes that affected the tower site: a number of fractures occurred in the warehouse and in the ground around it, that grew particularly during significant rainfalls. In October 2006 a landslide occurred in the quarry area, close to the broadcasting site. In order to understand what induced the fracture process in the buildings and define a support system to stabilize the broadcasting site, a detailed geotechnical survey and a number of numerical slope stability analyses were carried out. One of the main goals of the paper is t

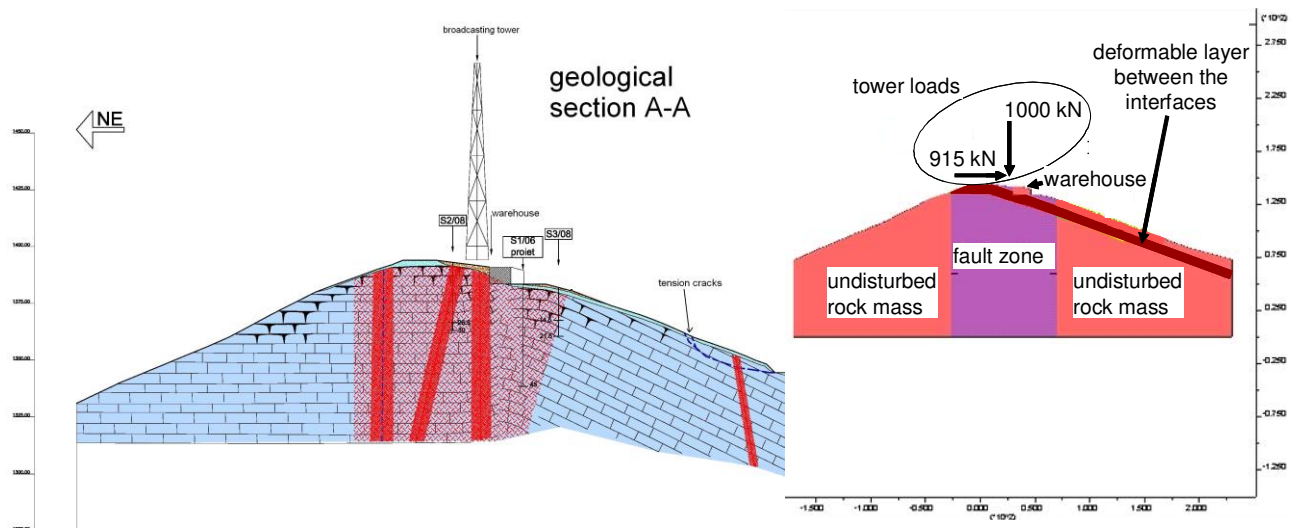
A section of interest was modeled (section A-A in Figure 1 and Figure 11, left), in the NE-SW direction, between the broadcasting site and the pit, across the zone in which tension cracks were observed and close to the landslide. According to the geotechnical characterization, two materials with different mechanical characteristics were used in the model: one to represent the fractured fault zone in the central part of the model, below the broadcasting plant, and the other to simulate the undamaged rock mass.

An ideal elasto-plastic model was considered for the rock mass, the interfaces and the ubiquitous joints. Plane strain conditions were assumed in 2D analyses. The strength and deformability parameters used in the numerical analyses, defined by the geotechnical characterization (minimum values), reduced by a partial safety factor of 2 for the cohesion and 1.25 for the friction coefficient, are collected in Table 5. The model was discretized with quadrangular, four-nodes plane elements; the presence of the warehouse on the top of the slope has been simulated using quadrangular elements with linear elastic behavior (unit weight: 10 kN/m³, elastic parameters equal to those of the undisturbed rock mass). A vertical force of 1000 kN and a horizontal force of 915 kN were applied on the top of the slope, to simulate the broadcasting tower loading, according to the tower design data (Figure 11, right).

Figure 11. Geological section A-A (left) and model for numerical analyses (right).

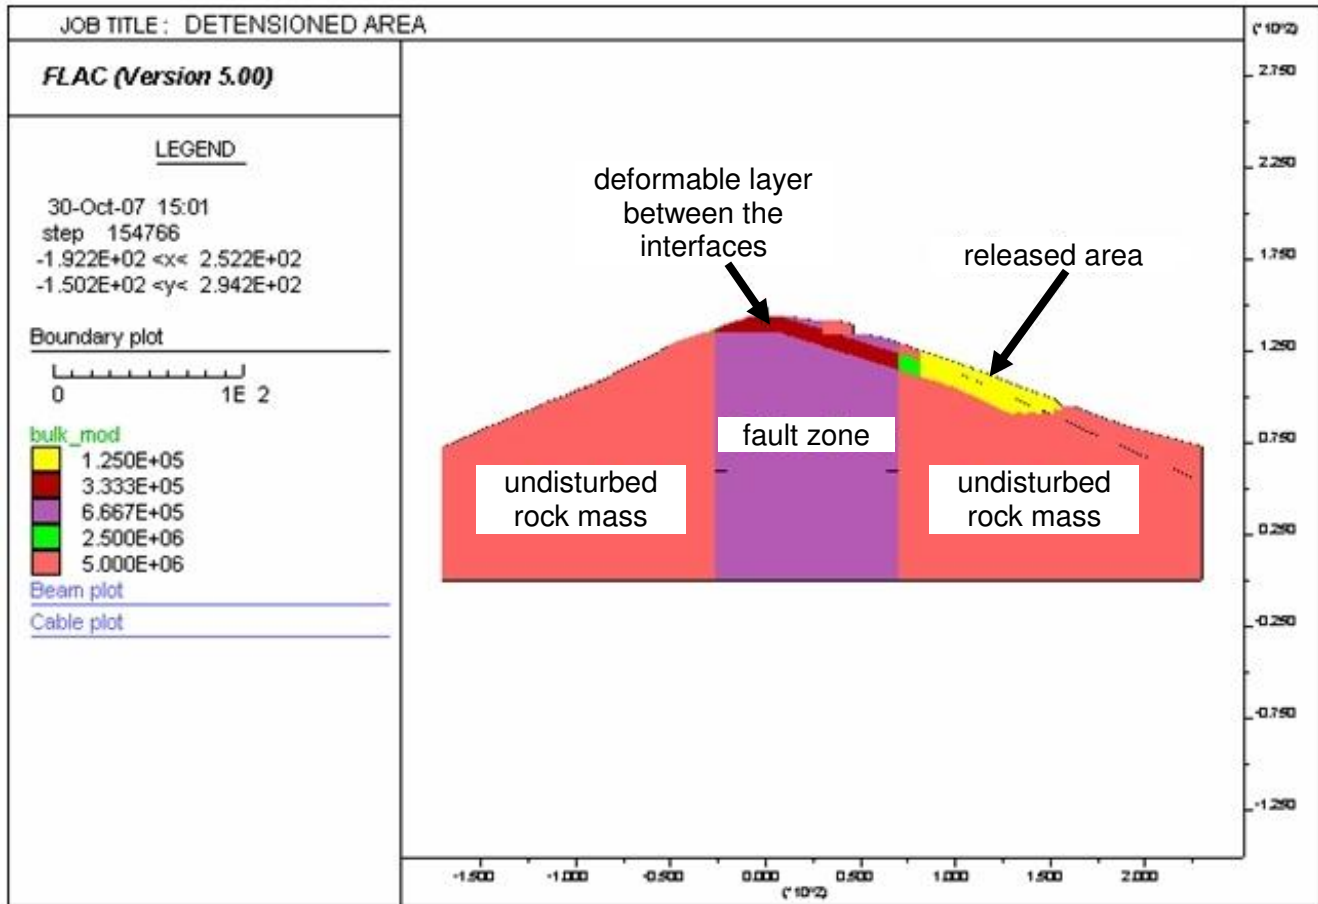
The slope behavior after the landslide in the pit area was simulated. It was assumed that the landslide induced a stress release in the slope beside it, between 1345 m and 1375 m above sea level with down slope displacements. For this purpose, a 20 m thick layer of the rock mass (equal to the estimated depth of the landslide) has been relieved between 1345 m and 1375 m above sea level. In order to simulate the progressive failure along the critical layer, the deformability and strength properties of the corresponding elements were progressively reduced (Table 6 and Figure 12).

Figure 12. Model with released area to simulate the landslide in the pit (FLAC).

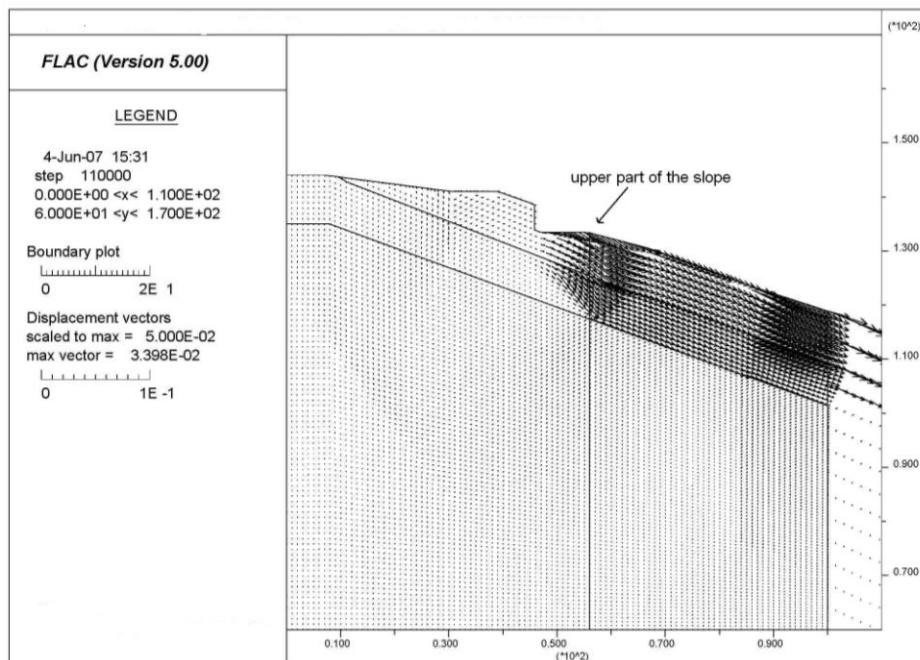
The results show an important displacement increase in the upper part of the slope. The displacements in the warehouse area are appreciable only in the case of water table at 5 m from the level of site (Figure 13). A wide area in the disturbed rock mass reaches the plastic boundary for every hydraulic scenarios. From this, it is possible to reconstruct the slope's stress-strain history. The cuts in the pit area induced a progressive instability in the area immediately below the broadcasting plant, with downwards displacements that started in the pit cut and spread towards the warehouse. The landslide in the pit area quickened the instability phenomenon that worsened with heavy rain falls, leading to considerable displacements in the warehouse area.

Figure 13. Numerical results: displacements in the upper part of the slope.
