# Embankment Failure in Residual Soils at Nivsar, Ratnagiri

**ABSTRACT:** The Nivsar Yard embankment was constructed by the Konkan Railways in 1994. Near the station building, the 22m high embankment runs parallel to the Kajali River for a stretch of about 100m. This stretch has experienced failure and settlement related problems since the record-breaking July 2005 rainfall. Corrective ground improvement measures were implemented immediately after the monsoon. However, these measures were inadequate because the failure surface reappeared during the following monsoon. The failure surface mirrored the shape and size of the failure observed in 2005. Since then after nearly every monsoon, the embankment has moved despite precautionary measures taken by the railway to arrest the movement. The hydrogeological and geotechnical properties which affect slope stability are first discussed. The stability of the embankment is then evaluated at 5 sections drawn along the slope. Two cases are considered. In the first case, the stability of the unreinforced slope is calculated. In the second case, calculations are done using the slope reinforced with soil nails and micropiles installed in 2005 a

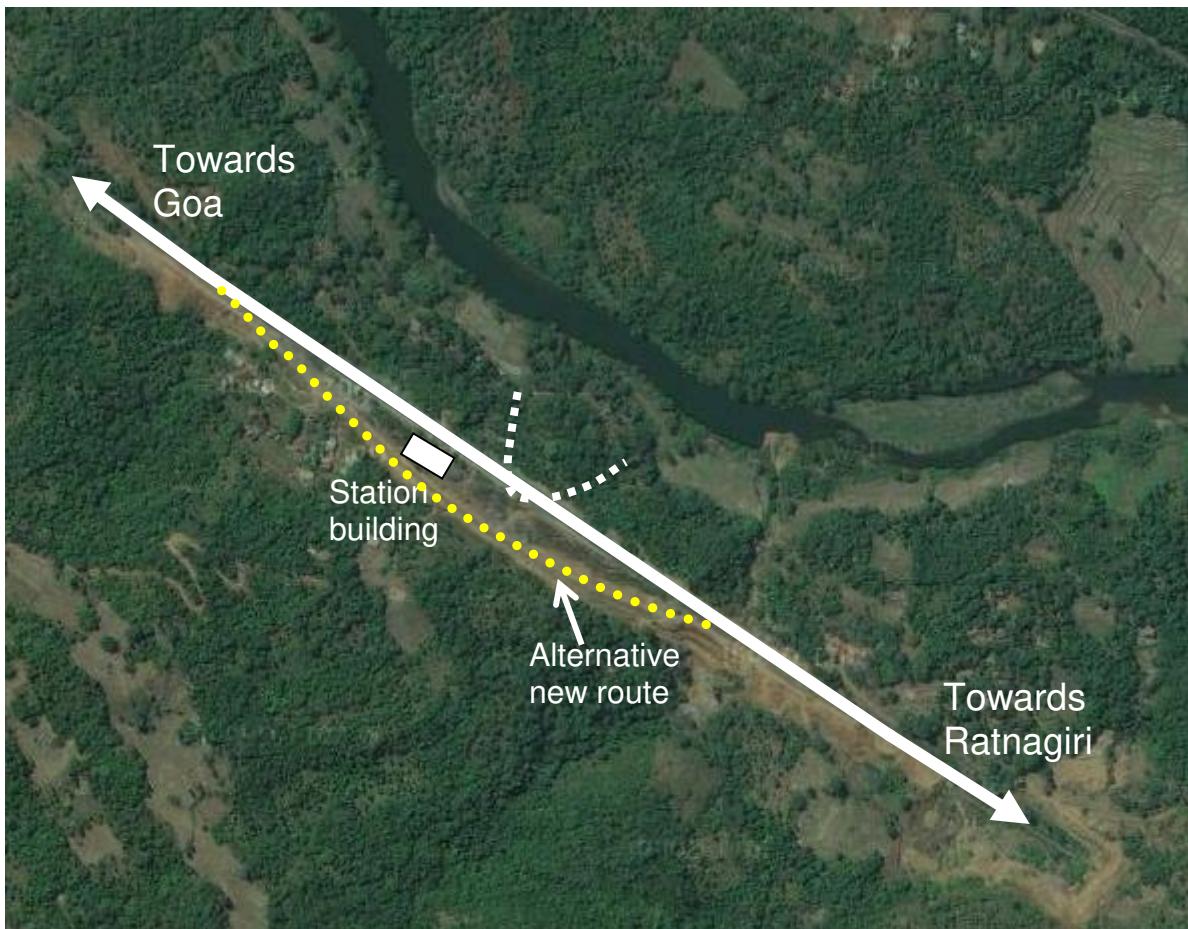
Figure 1. Nivsar Station in Ratnagiri District of Maharashtra (Source: Google earth). Note: The dashed line shows the approximate location of the embankment failure .

In 2010, the rail track was realigned to bypass the failure surface. This arrangement provided immediate relief to the rail-traffic. Figure 1 also shows the new alternate route used by the Konkan Railways. Since then, three other lines have been realigned to follow this alternate route. Irrespective of the above change in the rail alignment, Figure 3 also shows that the rate of settlement of the embankment has reduced since the 2009 monsoon. It is plausible to assume that the slump accumulated at the toe has reduced the gradient and hence affected the soil movement over this period (Figure 5). The site was re-investigated in 2010. The results of the re-investigation are part of this present study. The objective of this paper is to investigate the slope failure at Nivsar as recorded since the year 2005. Stability of the embankment before and after the ground improvement works is discussed. Railway loads from the old as well as the new rail alignment were used in the analysis. The critical failure circle for each case is shown to be affected by the geometry of the slope and the hydrogeological conditions at the site.

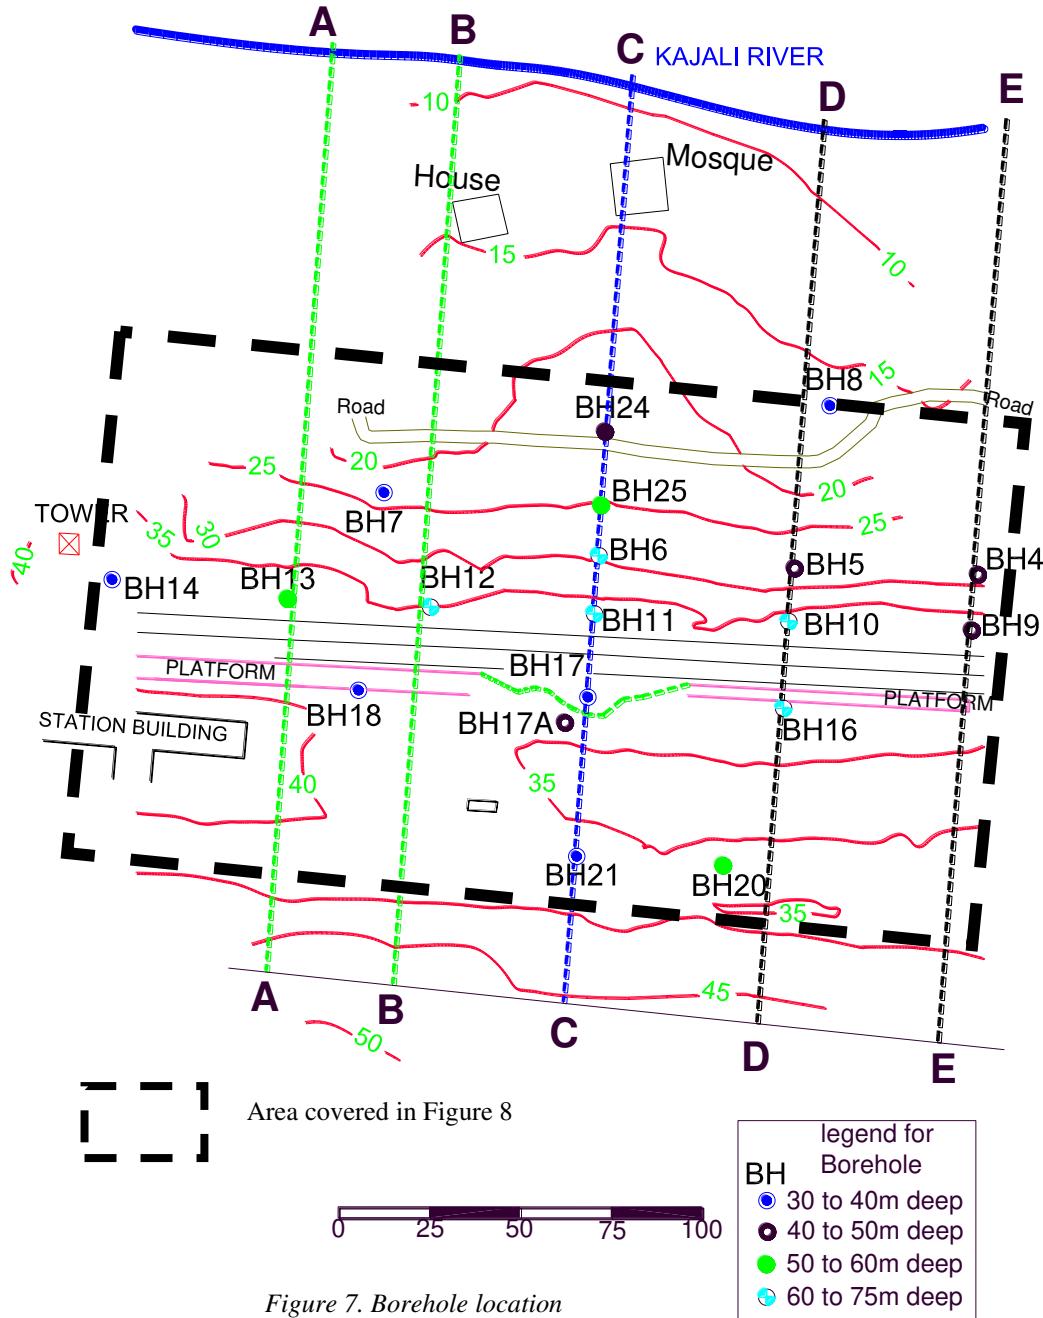
Figure 7. Borehole location

Geotechnical data was collected from 19 boreholes drilled at the top and bottom of the embankment. These boreholes were drilled in the year 2010. Figure 7 shows the location of the boreholes. All boreholes, except for BH-20 and BH-21, were

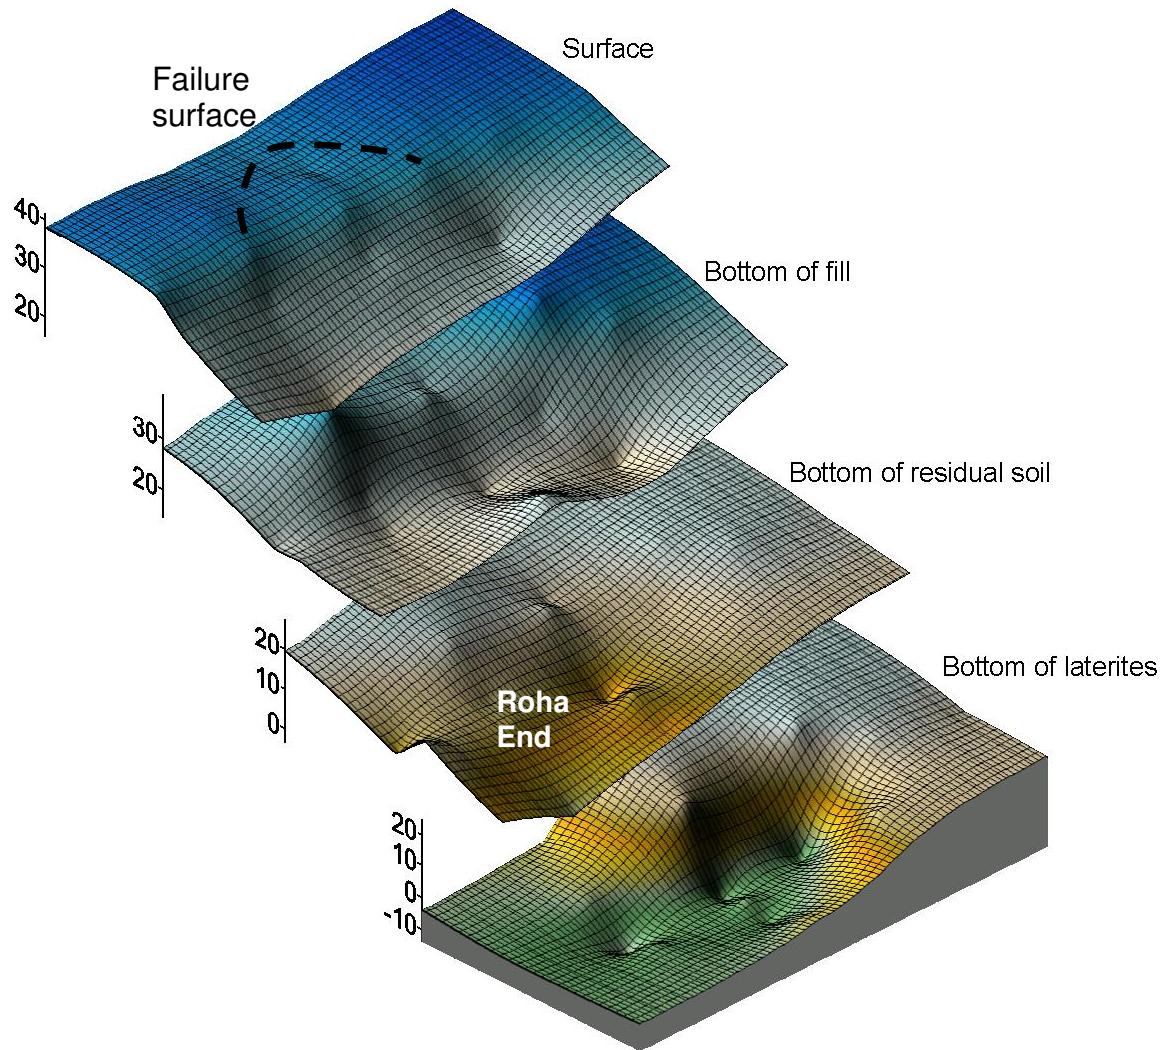
Figure 8. Three dimensional cross-sections of the soil and rock layers

**Fill:** Fill consisted of reddish brown silty clay and clayey sand. The clay matrix was frequently filled with coarse gravel and cobbles, which made this topmost-soil-layer firm to stiff. The fill was classified as medium to dense at locations where the sand and gravel proportions were in majority. The thickness of the fill was in between 13.5 to 15m in boreholes drilled close to the rail line at top of the hill. The thickness of the fill was surprisingly only 9m in borehole BH-17 drilled near the vertex of the failure surface. Apparently, the slip along the failure surface had caused the fill thickness to reduce at this location. The fill gradually narrowed towards the top flat end of the hilltop. Likewise, boreholes BH-7, BH-8, BH-24 and BH-24 indicate that the fill tapered off downhill at the road level. Figure 8 shows that the fill is bowl-shaped with its edges fused to the edges of the section. From Figure 8, it is interesting to note that the shape of the failure surface mimics the shape of the fill.

**Basalt bedrock:** Basalt bedrock was logged from 13m to 49.5m below ground surface. As shown in Figure 8, the top surface of the basalt was undulating which provided a strong grip to the above laterites. The bedrock was weathered at the top with fractures at many locations. The depth from which the quality of the basalt improved to slightly/moderately weathered is shown in Table 3. The UCS of the bedrock was in between 200 kN/m<sup>2</sup> and 124 MN/m<sup>2</sup>. Table 3 also shows the termination depth in each borehole.

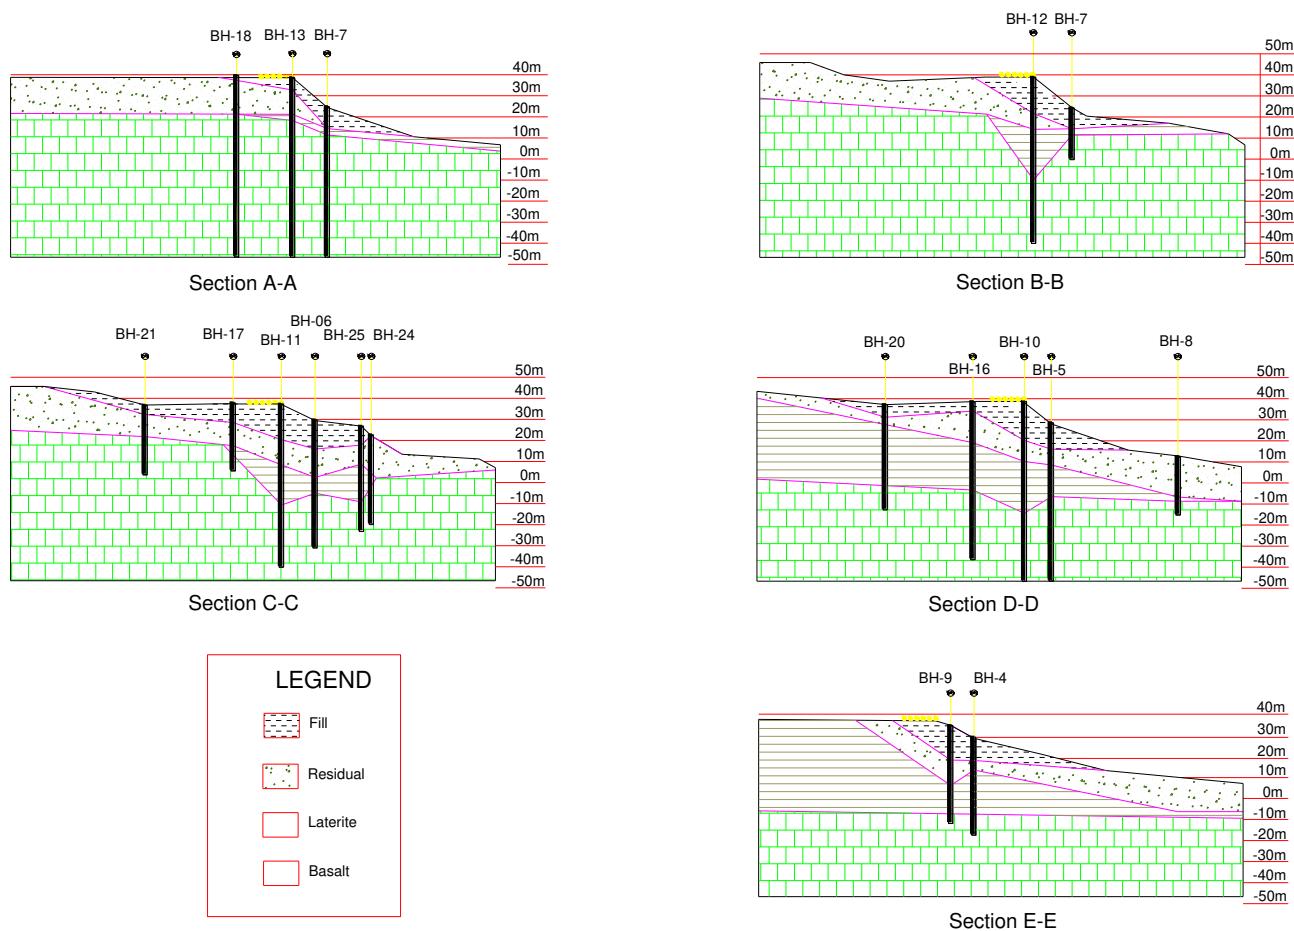
Using the borehole data, five cross-sections were drawn to interpret the subsurface profile of the site. The five sections are marked as A-A to E-E in Figure 7 and are shown in Figure 9. Sections B-B to D-D were chosen to represent the edges and centre of the failure zone. Laterites were nearly absent in section A-A and had the maximum presence in section D-D. The average geotechnical properties at each section are shown in Table 4. The material properties in Table 4 were obtained from the field and laboratory testing programme monitored jointly by Konkan Railways and IIT Bombay. Direct shear tests were conducted to obtain  $c'$  and  $\phi'$ . Unconsolidated undrained (UU) triaxial tests were conducted to obtain  $c_u$ . The secant Young's modulus,  $E$ , of selected samples was obtained from stress-strain curves on UU samples confined with 50 to 200 kN/m<sup>2</sup> mean stress. Unconfined compression tests were conducted to obtain the  $c_u$  of laterites and basalt.

Figure 9. Subsurface profile at the site. Location of sections A-A to E-E are as per Figure 7.

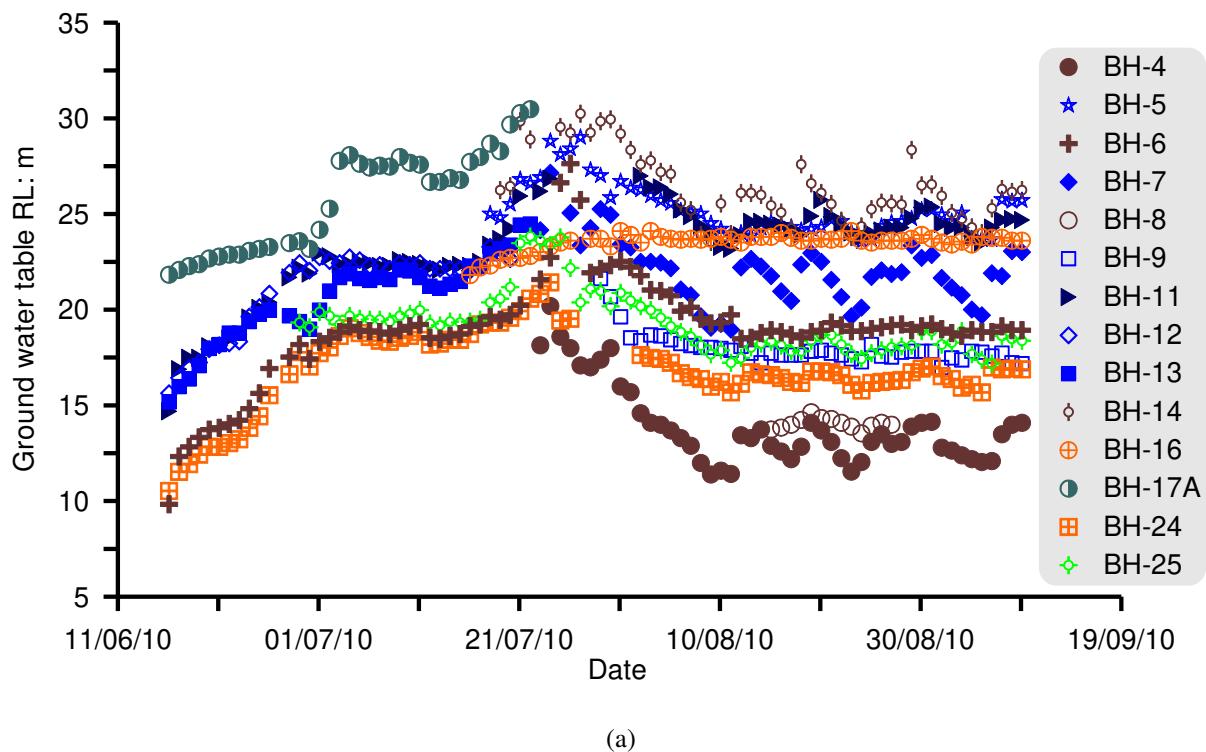
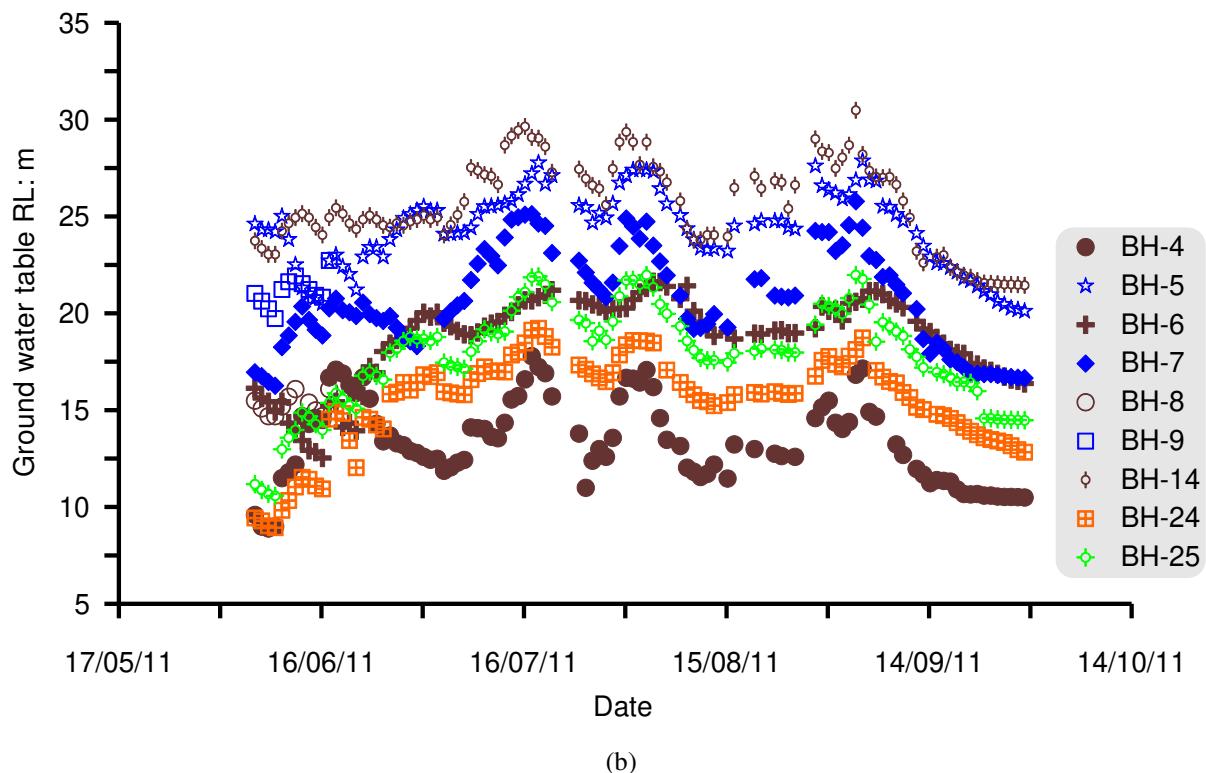
Standpipes were installed in the boreholes after the completion of the drilling. Ground water depths were occasionally recorded in these standpipes for about two years. Figures 10a and 10b show the water table recorded in 2010 and 2011, respectively. The slope movement during the 2010 and 2011 monsoons, sheared-off some of the standpipes. As a result a complete record of ground water data is not available over the monitoring period at these locations. The maximum and minimum water table depths are summarised in Table 5. A few observations may be made from Figures 10a-b and Table 5. First, the water table changed from 12.5m to 20m over the monitoring period in boreholes which were drilled along the centre-line of the failure surface. This variation in the water level possibly created a large pressure gradient. Second, the seasonal variation in the water level was more than 9m in boreholes drilled within the failure zone. There was significant variation in the water level even outside the failure surface. For example, the pressure head difference between boreholes BH-7 and BH-12 was more than 17m although the boreholes were only about 35m apart. Inevitably, these large pressure head difference caused large groundwater flow and significant seepage forces.

Figures 10a-b. Water table in standpipes: (a) In 2010; and (b) In 2011.

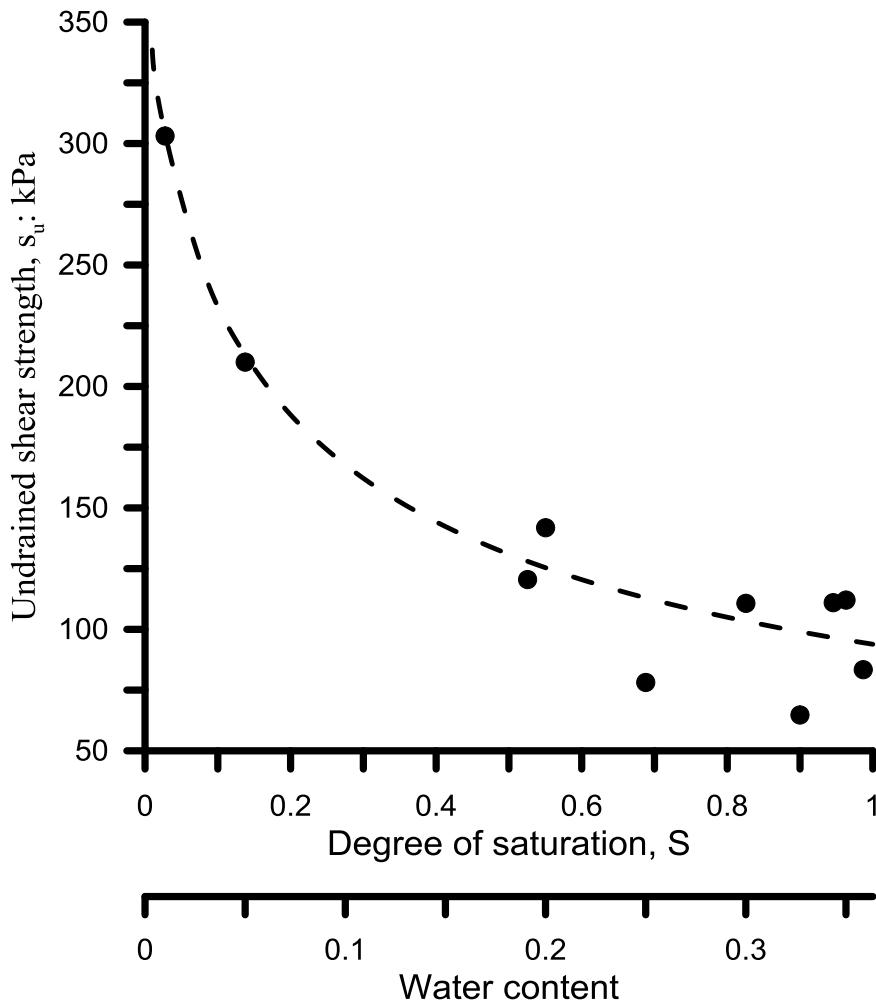
The above slope stability analysis only permits the estimation of the safety factor using the effective (or drained) shear strength parameters. It does not account for the change in strength of the soil due to the change in the degree of saturation as the rainwater percolates. An experimental programme was therefore designed to also study the effect of the change in the degree of saturation on the strength of the residual soils. A series of routine UU-triaxial shear tests were conducted on remoulded and reconstituted samples at 100 to 200 kN/m<sup>2</sup> cell pressure. The samples were compacted at constant void ratios but different degree of saturation. The dry unit weight of all the samples was within the range of 13.5 to 14 kN/m<sup>3</sup>. The tests were carefully conducted to avoid any change in water content during the testing procedure. However, it must be noted that since most of the samples were partially saturated, the tests were not truly undrained. There was no arrangement to measure the pore pressure suction because its effect was considered to be insignificant in view of the short duration of the test (Vanapalli et al. 1999). Figure 13 shows the variation of the undrained shear strength,  $s_u$  with the degree of saturation,  $S$ . Despite the scatter of the data points, the results appear to suggest that the water content has significant influence on the strength of residual soils. For instance, the figure shows that an increase in  $S$  from 0.1 to 1 caused  $s_u$  to decrease by over 100%. Notwithstanding the above, the results also permit a semi-empirical relationship to be fitted to the data:

Figure 13. Variation of undrained shear strength, with degree of saturation at constant void ratio/dry density.

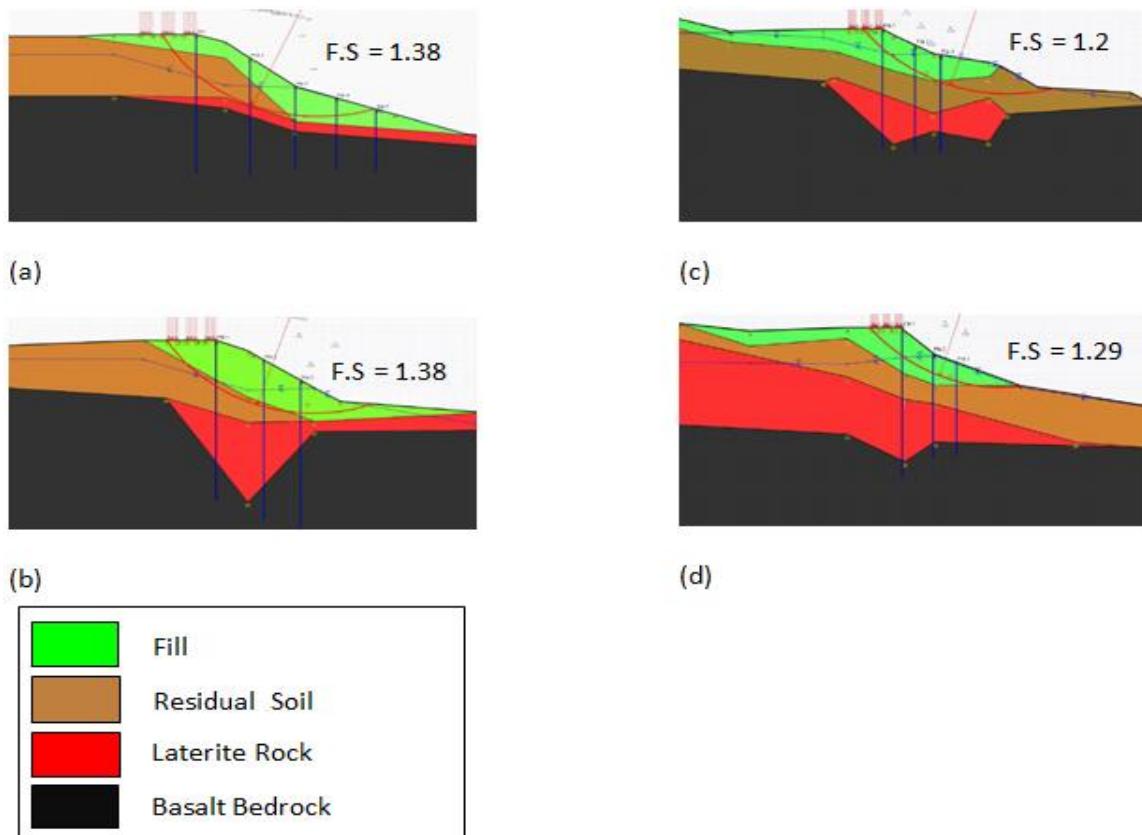
Figures 17a-d. Safety factor during wet season with proposed contiguous bored pile for section: (a) A-A; (b) B-B; (c) C-C; and (d) D-D.

One possible solution to enhance the stability of the slope was with the use of large diameter piles to retain the (failed) soil mass. In this case, safety factors of sections A-A to E-E were also deduced by assuming that the slope was reinforced with single or multiple rows of contiguous bored pile wall constructed parallel to the platform. Figure 16 shows the schematic layout of the proposed bored pile wall. The 1.2m diameter piles terminated below the slightly-to-moderately weathered basalt rock because of which sections B-B and C-C had long piles to provide adequate anchorage (Table 3). Table 9 shows the location and length of the piles used in the analysis. Figures 17a-d show the minimum safety factor and the location of critical circles in sections A-A to D-D for the wet season when the slope is reinforced with contiguous bored pile wall. As can be seen, the minimum safety factor increased up to 1.2 and 1.38 with the use of contiguous bored pile wall.

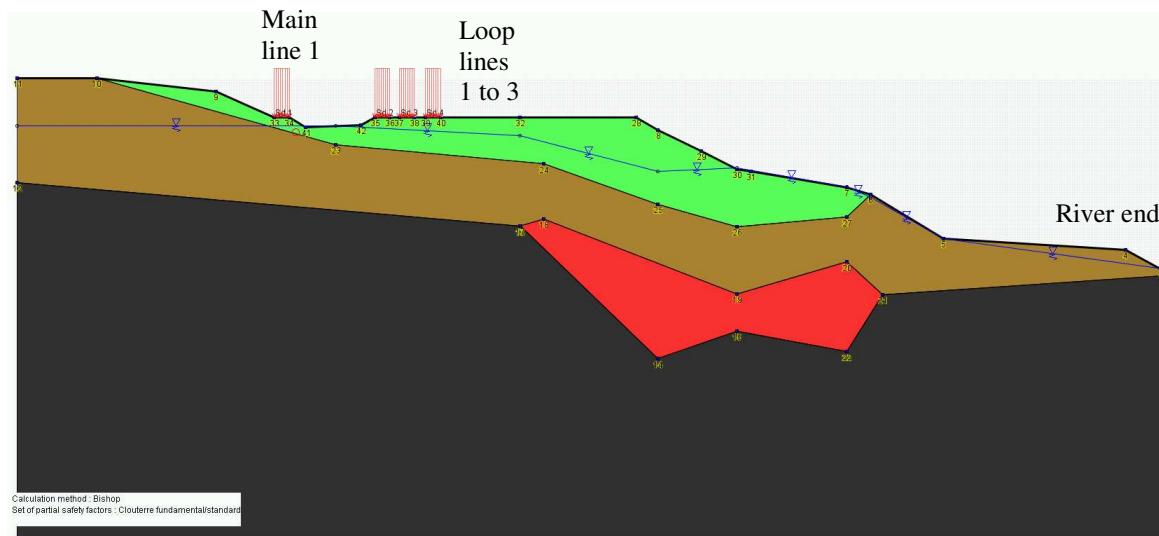
Figure 18. Section C-C with new rail alignment. The main alignment consists of 3 loop lines and 1 main line.

The cost to use the bored pile wall was over 200 million Indian Rupees (US\$ 3.6 million) and appeared to be prohibitive. As an alternative to this design, the old rail alignment was removed and replaced by a new alignment. The new alignment consisted of 3 loop-lines and 1 main-line. Figure 18 shows section C-C along with the location of the new alignment. In this section, the top left side of the hill was slightly levelled to accommodate the main line and the loop lines. Section C-C was chosen because the new alignment was closest to the failure surface at this section. The horizontal distance from the vertex of the failure surface and the 4 lines was 16m, 21.3m, 26.2m and 46.4m, respectively. The stability of the slope was then reinvestigated using the computer program Talren-4 (Terrsol 2005). As in the previous case, all the lines were loaded by 125 kN/m<sup>2</sup>. This assumption was unduly conservative in absence of strict guidelines (RDSO 2003b). Nonetheless, it permitted trains with more overtaking opportunities on the passing-loops. The ground water level was modeled using the highest RL recorded in Table 5. The failure circles are shown in Figure 19. As can be seen, the minimum safety factor is
