## Embankment Failure in Residual Soils at Nivsar, Ratnagiri

**ABSTRACT:** *The Nivsar Yard embankment was constructed by the Konkan Railways in 1994. Near the station building, the 22m high embankment runs parallel to the Kajali River for a stretch of about 100m. This stretch has experienced failure and settlement related problems since the record-breaking July 2005 rainfall. Corrective ground improvement measures were implemented immediately after the monsoon. However, these measures were inadequate because the failure surface reappeared during the following monsoon. The failure surface mirrored the shape and size of the failure observed in 2005. Since then after nearly every monsoon, the embankment has moved despite precautionary measures taken by the railway to arrest the movement. The hydrogeological and geotechnical properties which affect slope stability are first discussed. The stability of the embankment is then evaluated at 5 sections drawn along the slope. Two cases are considered. In the first case, the stability of the unreinforced slope is calculated. In the second case, calculations are done using the slope reinforced with soil nails and micropiles installed in 2005

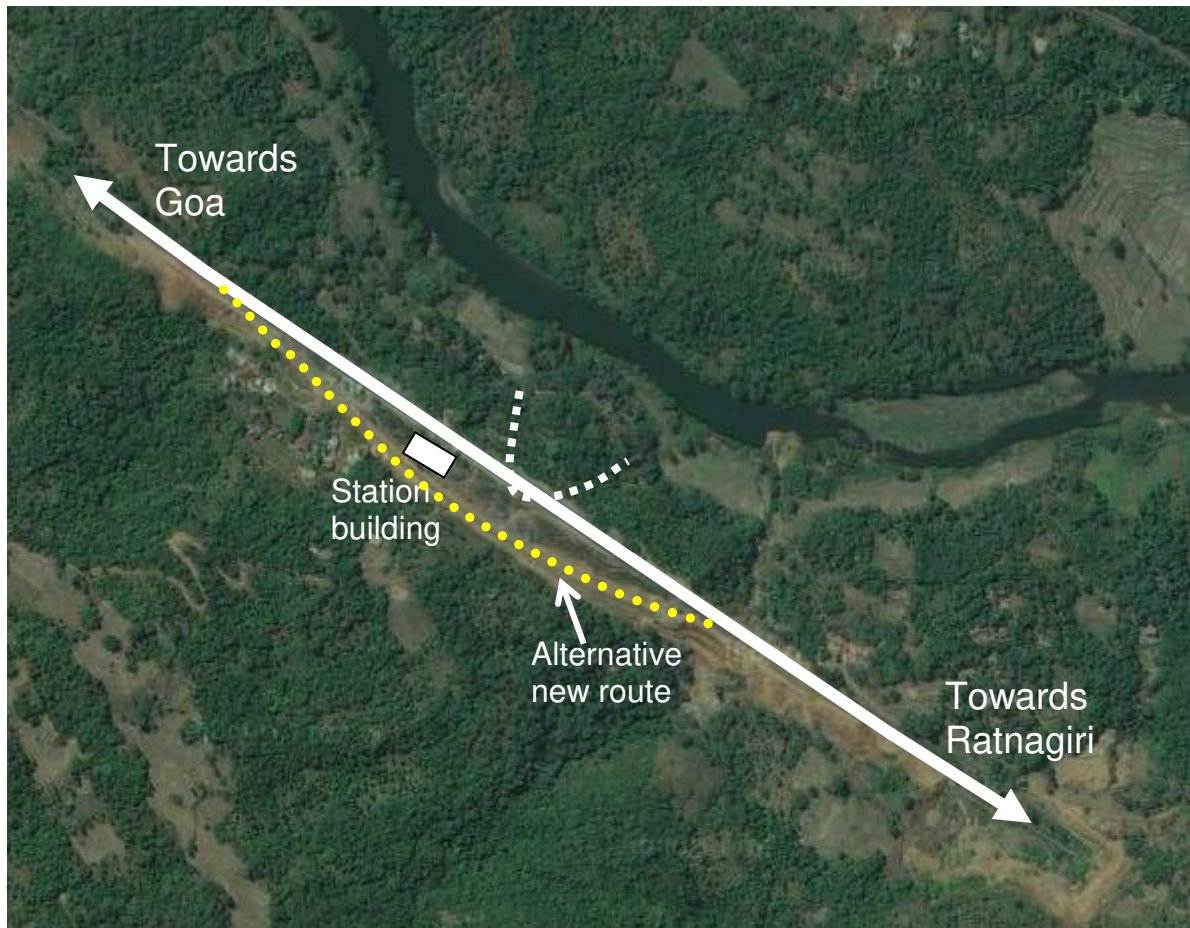
Figure 1. Nivsar Station in Ratnagiri District of Maharashtra (Source: Google earth). Note: The dashed line shows the approximate location of the embankment failure .

In 2010, the rail track was realigned to bypass the failure surface. This arrangement provided immediate relief to the rail-traffic. Figure 1 also shows the new alternate route used by the Konkan Railways. Since then, three other lines have been realigned to follow this alternate route. Irrespective of the above change in the rail alignment, Figure 3 also shows that the rate of settlement of the embankment has reduced since the 2009 monsoon. It is plausible to assume that the slump accumulated at the toe has reduced the gradient and hence affected the soil movement over this period (Figure 5). The site was re-investigated in 2010. The results of the re-investigation are part of this present study. The objective of this paper is to investigate the slope failure at Nivsar as recorded since the year 2005. Stability of the embankment before and after the ground improvement works is discussed. Railway loads from the old as well as the new rail alignment were used in the analysis. The critical failure circle for each case is shown to be affected by the geometry of the slope and the hydrogeological conditions at the site.
