The July 10 2000 Payatas Landfill Slope Failure

ABSTRACT: *This paper presents an investigation of the slope failure in the Payatas landfill in Quezon City, Philippines. This failure, which killed at least 330 persons, occurred July 10th 2000 after two weeks of heavy rain from two typhoons. Slope stability analyses indicate that the raised leachate level, existence of landfill gas created by natural aerobic and anaerobic degradation, and a significantly over-steepened slope contributed to the slope failure. The Hydrologic Evaluation of Landfill Performance (HELP) model was used to predict the location of the leachate level in the waste at the time of the slope failure for analysis purposes. This paper presents a description of the geological and environmental conditions, identification of the critical failure surface, and slope stability analyses to better understand the failure and present recommendations for other landfills in tropical areas. In addition, this case history is used to evaluate uncertainty in parameters used in back-analysis of a landfill slope failure.*

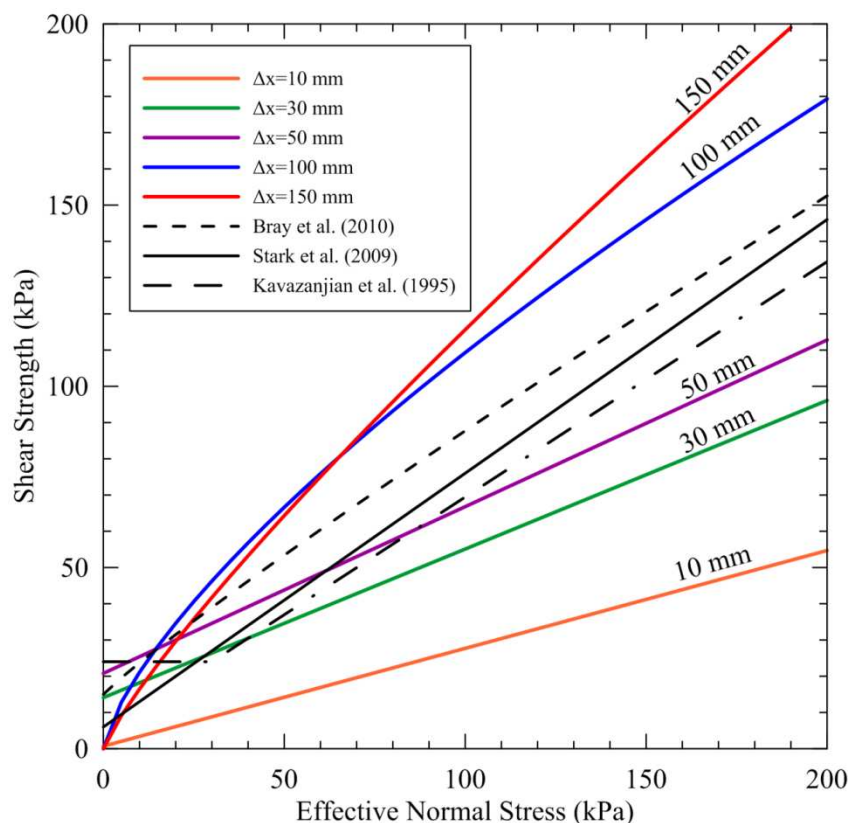
Figure 10. MSW shear strength envelopes.

In addition to being dependent on the effective normal stress on the failure plane, the shear strength of MSW is also shear displacement or axial strain dependent and tends to increase with increasing deformation (Eid et al., 2000). Review of existing laboratory data show that most of the laboratory shear tests investigated are not continued to sufficient displacement or strain to mobilize the peak shear strength of the MSW. As a result, Stark et al. (2009) provide MSW shear strength envelopes mobilized at horizontal displacements of 10, 30, 50, 100, and 150 mm. Table 3 shows equations for each strength envelope estimated from direct shear tests, where R^2 values are all above 0.90. Figure 10 compares the shear strength envelopes in Table 2 to envelopes recommended by others (e.g., Stark et al., 2009; Bray et al., 2009; Kavazanjian et al., 1995). As highlighted in Figure 10, all of the recommended envelopes fall between the 50 and 100 mm of shear displacement strength envelopes.

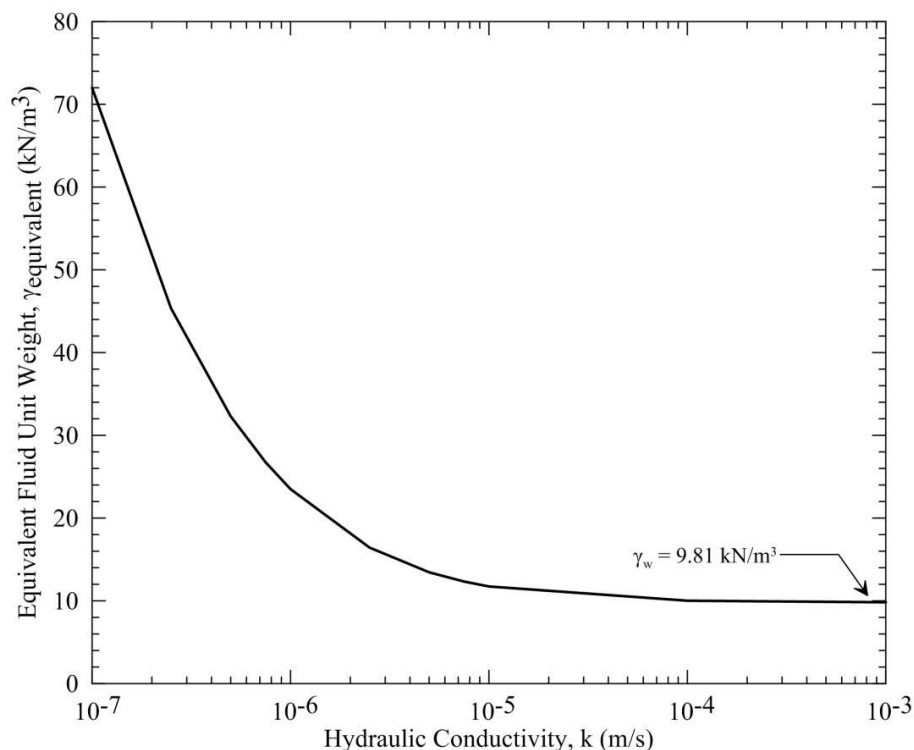
Figure 12. Dependence of equivalent fluid unit weight, $\gamma_{\text{equivalent}}$, on MSW saturated hydraulic conductivity, $K_{\text{waste,sat}}$

It is hypothesized that landfill gas and leachate pressure reduced the effective stress along the failure surface. Landfill gas, which is dominated by methane and carbon dioxide, is formed as a natural part of anaerobic degradation. In landfills that are sufficiently dry, landfill gas migrates readily through the pore space and is released into the atmosphere with little build-up of pressure in the waste. However, as saturation levels in the waste rise, the permeability of the waste to landfill gas migration decreases. Merry et al. (2006) use a one-dimensional (1-D) column of saturated media where degradable waste exists only in the lowest portion of the column to model this situation. This model shows that below the level of saturation, the steady-state excess gas pressure increases linearly similar to a hydrostatic condition. The combination of hydrostatic leachate pressure and gas-induced pore pressure may be accounted for using an equivalent fluid unit weight for the pore fluid that is artificially higher than water. A subsequent parametric study of the input parameters shows that the equivalent fluid unit weight of the pore fluid is dependent on waste hydraulic conductivity (Merry et al., 2006). The corresponding MSW hydraulic conductivity for this case is assumed to be greater than 1×10^{-5} m/s. Figure 12 shows the relationship between waste hydraulic conductivity and equivalent fluid unit weight of the pore fluid and is used to estimate an equivalent fluid unit weight. The input parameters for Figure 12 are provided in Table 5. The gas generation rate (Q_i) is estimated by Eq. (1):

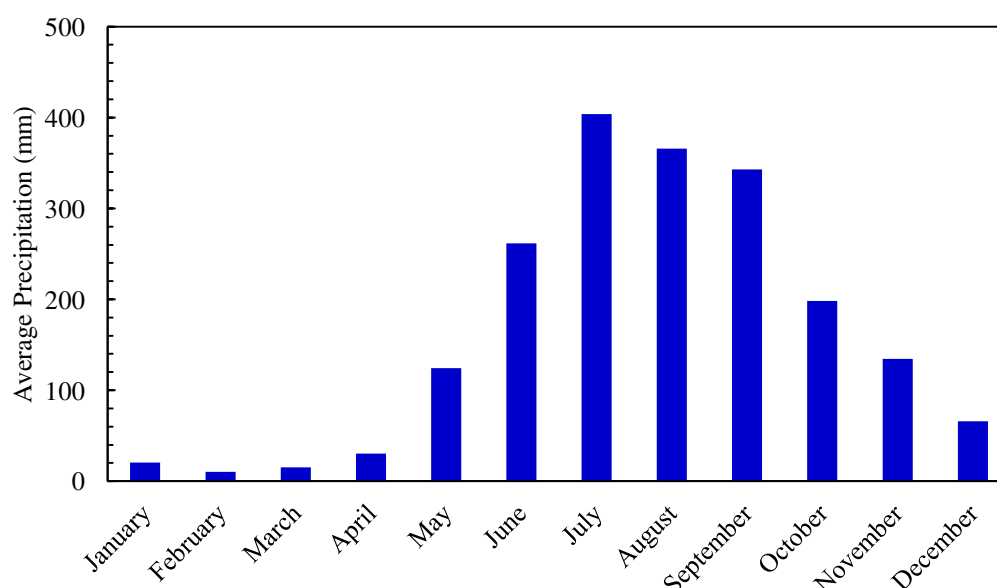
Figure 13. Average monthly precipitation for Manila, Philippines from Quezon City weather station (data from www.weather.com).

The precipitation database in the HELP model does not provide historical precipitation data for Quezon City, so recorded rainfall data from 1 May through 31 July 2000, was obtained from the Quezon City weather station and imported into HELP. This provides a reasonable simulation of the two months of precipitation immediately preceding the slope failure. Replicating approximate initial moisture conditions before May 1st 2000 involved executing the HELP model for several years prior to the failure. As a result, weather and climate conditions similar to Quezon City were required because this data is not available from the Quezon City weather station. Quezon City, located at 14° latitude, is closer to the equator than the United States and hence, has different climate conditions. Quezon City weather is dominated by high humidity, precipitation, and warm conditions year round. Table 7 presents a summary of the key weather conditions for Quezon City. The HELP program can also generate daily precipitation data using a synthetic weather generator. By entering the normal mean monthly precipitation values of Manila, Philippines shown in Figure 13, HELP generated synthetic precipitation records for 10 years preceding the failure. This synthetic record was used until May 1st of the 10th year, so that the water content and saturation levels reached a reasonable steady state value before applying the recorded data from the Quezon City weather station. From May 1st to July 31st, recorded precipitation values from the Quezon City station (Canty and Associates LLC, 2004) were input to HELP.

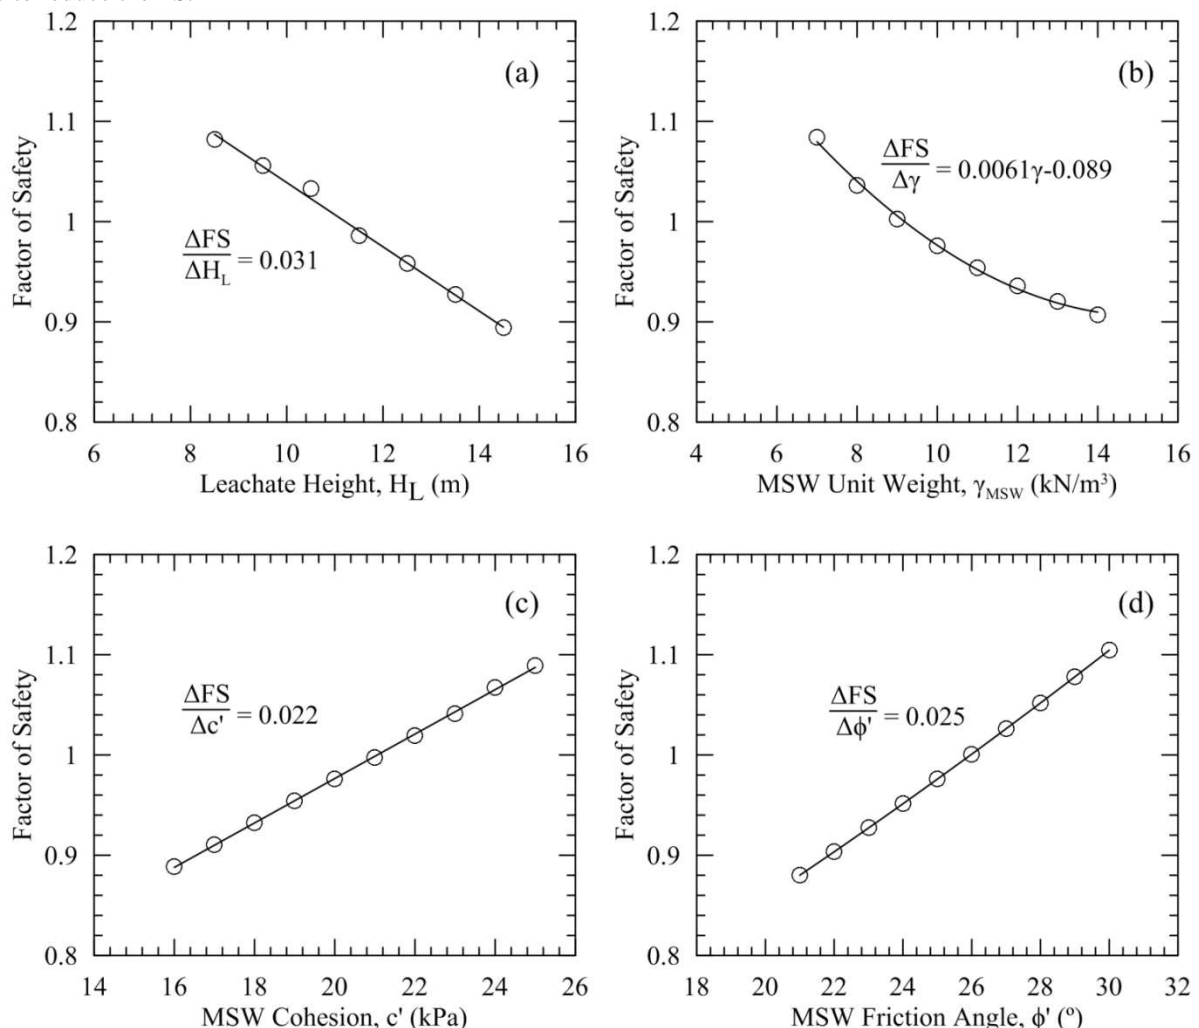
Figure 14. Sensitivity of Inverse analysis to MSW input parameters for FS of unity.

Using site reconnaissance information, pictures, and reports of the wasteslide, an inverse analysis was conducted to estimate the piezometric level at the time of failure. Figures 14(a), 14(b), 14(c), and 14(d) show the sensitivity of the factor of safety for a range of MSW shear strength parameters, MSW unit weight, and leachate level. For each sensitivity parameter, the factor of safety was computed using the circular failure surface in Figure 11(a). In Figure 14, the trend line slope is used to capture the sensitivity of FS to each parameter. For example, Figure 14(a) shows that FS decreases by 0.031 for a 1 m increase in leachate level. Using the trend line slopes for each parameter, the contributing factors leading to failure can be compared. MSW unit weight can increase when rain infiltrates into the waste mass and increases moisture content. The sensitivity of MSW unit weight is a nonlinear relationship shown in Figure 14(b). Figures 14(c) and 14(d) indicate that reducing MSW cohesion and friction, i.e., slopes equal to 0.022 and 0.025, respectively, contributes less to failure than increasing the leachate height (slope=0.031). Thus, Figure 14 suggests that leachate height has the greatest influence to reduce the FS.
