## The July 10 2000 Payatas Landfill Slope Failure

**ABSTRACT:** *This paper presents an investigation of the slope failure in the Payatas landfill in Quezon City, Philippines. This failure, which killed at least 330 persons, occurred July 10<sup>th</sup> 2000 after two weeks of heavy rain from two typhoons. Slope stability analyses indicate that the raised leachate level, existence of landfill gas created by natural aerobic and anaerobic degradation, and a significantly over-steepened slope contributed to the slope failure. The Hydrologic Evaluation of Landfill Performance (HELP) model was used to predict the location of the leachate level in the waste at the time of the slope failure for analysis purposes. This paper presents a description of the geological and environmental conditions, identification of the critical failure surface, and slope stability analyses to better understand the failure and present recommendations for other landfills in tropical areas. In addition, this case history is used to evaluate uncertainty in parameters used in back-analysis of a landfill slope failure.*

Reference: Jafari, N. H., Stark, T. D., and Merry, S. (2013). *The July 10 2000 Payatas Land

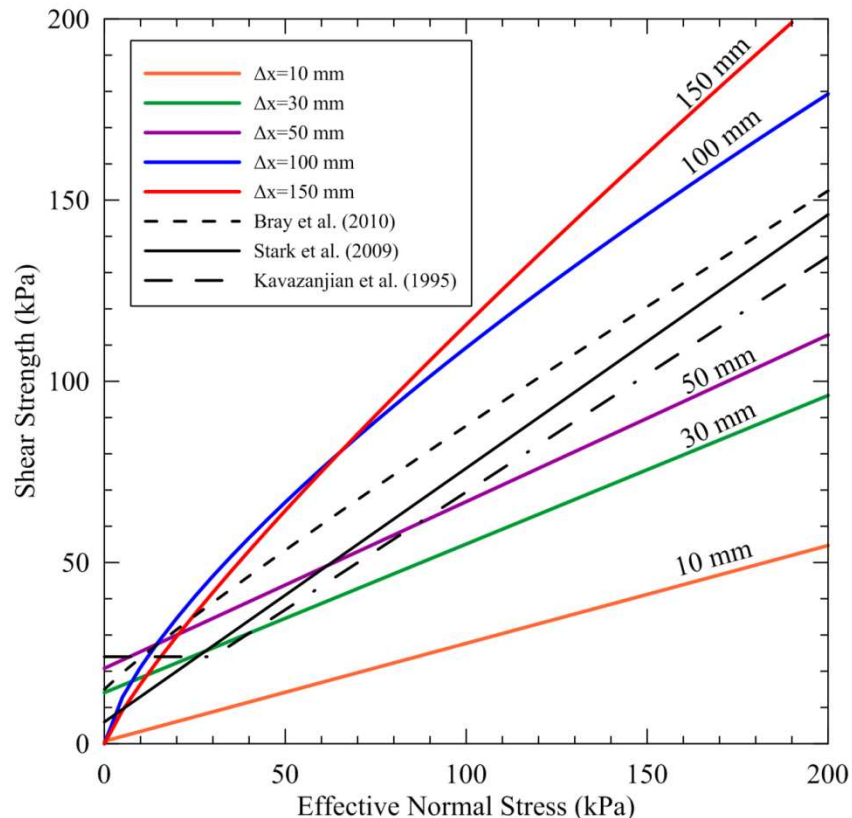
In addition to being dependent on the effective normal stress on the failure plane, the shear strength of MSW is also shear displacement or axial strain dependent and tends to increase with increasing deformation (Eid et al., 2000). Review of existing laboratory data show that most of the laboratory shear tests investigated are not continued to sufficient displacement or strain to mobilize the peak shear strength of the MSW. As a result, Stark et al. (2009) provide MSW shear strength envelopes mobilized at horizontal displacements of 10, 30, 50, 100, and 150 mm. Table 3 shows equations for each strength envelope estimated from direct shear tests, where  $R^2$  values are all above 0.90. Figure 10 compares the shear strength envelopes in Table 2 to envelopes recommended by others (e.g., Stark et al., 2009; Bray et al., 2009; Kavazanjian et al., 1995). As highlighted in Figure 10, all of the recommended envelopes fall between the 50 and 100 mm of shear displacement strength envelopes.

Figure 10. MSW shear strength envelopes.

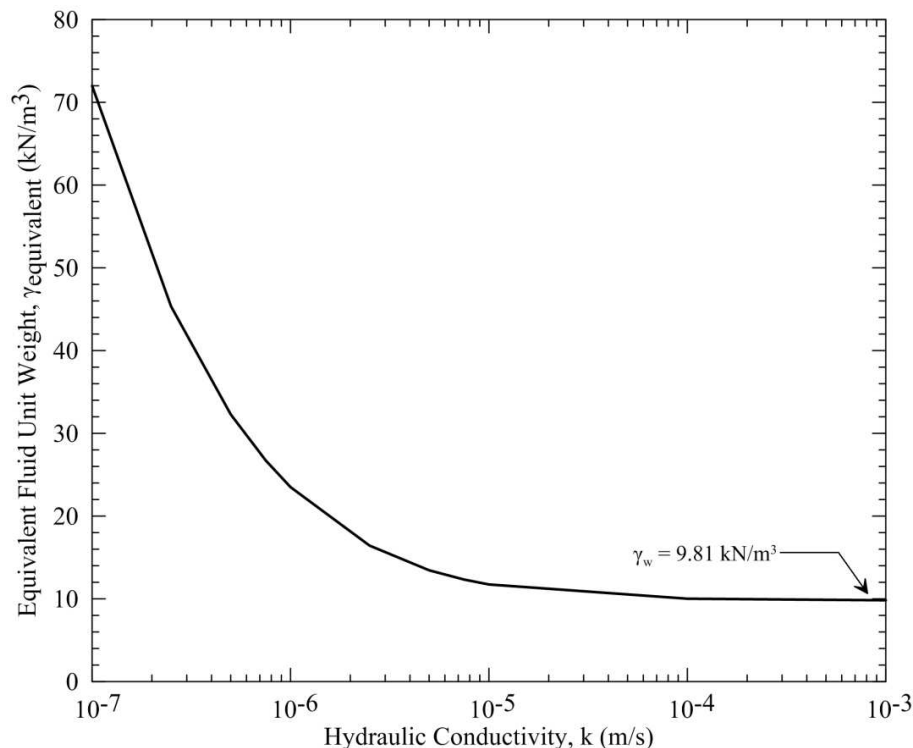
It is hypothesized that landfill gas and leachate pressure reduced the effective stress along the failure surface. Landfill gas, which is dominated by methane and carbon dioxide, is formed as a natural part of anaerobic degradation. In landfills that are sufficiently dry, landfill gas migrates readily through the pore space and is released into the atmosphere with little build-up of pressure in the waste. However, as saturation levels in the waste rise, the permeability of the waste to landfill gas migration decreases. Merry et al. (2006) use a one-dimensional (1-D) column of saturated media where degradable waste exists only in the lowest portion of the column to model this situation. This model shows that below the level of saturation, the steady-state excess gas pressure increases linearly similar to a hydrostatic condition. The combination of hydrostatic leachate pressure and gas-induced pore pressure may be accounted for using an equivalent fluid unit weight for the pore fluid that is artificially higher than water. A subsequent parametric study of the input parameters shows that the equivalent fluid unit weight of the pore fluid is dependent on waste hydraulic conductivity (Merry et al., 2006). The corresponding MSW hydraulic conductivity for this case is assumed to be greater than  $1 \times 10^{-5}$  m/s. Figure 12 shows the relationship between waste hydraulic conductivity and equivalent fluid unit weight of the pore fluid and is used to estimate an equivalent fluid unit weight. The input parameters for Figure 12 are provided in Table 5. The gas generation rate ( $Q_t$ ) is estimated by Eq. (1):

Figure 12. Dependence of equivalent fluid unit weight,  $\gamma_{equivalent}$ , on MSW saturated hydraulic conductivity,  $K_{waste,sat}$

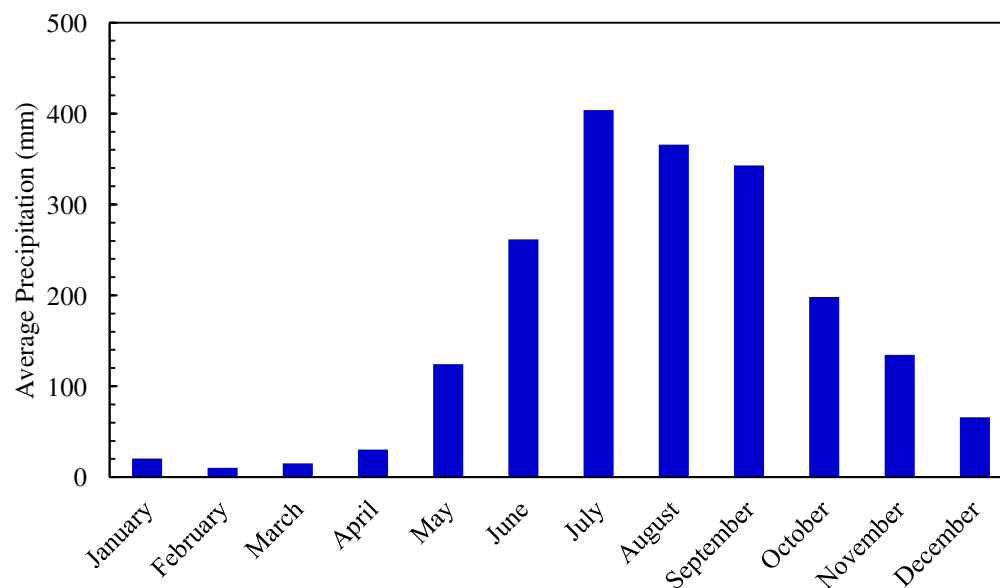
The precipitation database in the HELP model does not provide historical precipitation data for Quezon City, so recorded rainfall data from 1 May through 31 July 2000, was obtained from the Quezon City weather station and imported into HELP. This provides a reasonable simulation of the two months of precipitation immediately preceding the slope failure. Replicating approximate initial moisture conditions before May 1<sup>st</sup> 2000 involved executing the HELP model for several years prior to the failure. As a result, weather and climate conditions similar to Quezon City were required because this data is not available from the Quezon City weather station. Quezon City, located at 14° latitude, is closer to the equator than the United States and hence, has different climate conditions. Quezon City weather is dominated by high humidity, precipitation, and warm conditions year round. Table 7 presents a summary of the key weather conditions for Quezon City. The HELP program can also generate daily precipitation data using a synthetic weather generator. By entering the normal mean monthly precipitation values of Manila, Philippines shown in Figure 13, HELP generated synthetic precipitation records for 10 years preceding the failure. This synthetic record was used until May 1<sup>st</sup> of the 10<sup>th</sup> year, so that the water content and saturation levels reached a reasonable steady state value before applying the recorded data from the Quezon City weather station. From May 1<sup>st</sup> to July 31<sup>st</sup>, recorded precipitation values from the Quezon City station (Canty and Associates LLC, 2004) were input to HELP.

Figure 13. Average monthly precipitation for Manila, Philippines from Quezon City weather station (data from [www.weather.com](http://www.weather.com)).
