The July 10 2000 Payatas Landfill Slope Failure

ABSTRACT: This paper presents an investigation of the slope failure in the Payatas landfill in Quezon City, Philippines. This failure, which killed at least 330 persons, occurred July 10th 2000 after two weeks of heavy rain from two typhoons. Slope stability analyses indicate that the raised leachate level, existence of landfill gas created by natural aerobic and anaerobic degradation, and a significantly over-steepened slope contributed to the slope failure. The Hydrologic Evaluation of Landfill Performance (HELP) model was used to predict the location of the leachate level in the waste at the time of the slope failure for analysis purposes. This paper presents a description of the geological and environmental conditions, identification of the critical failure surface, and slope stability analyses to better understand the failure and present recommendations for other landfills in tropical areas. In addition, this case history is used to evaluate uncertainty in parameters used in back-analysis of a landfill slope failure.

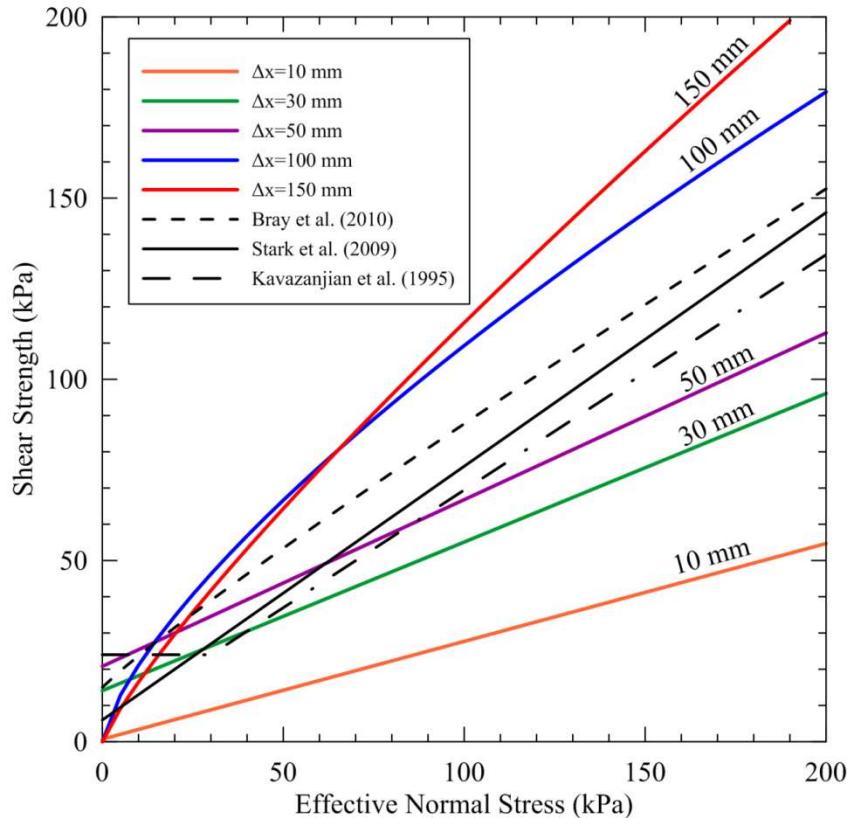
Figure 10. MSW shear strength envelopes.

In addition to being dependent on the effective normal stress on the failure plane, the shear strength of MSW is also shear displacement or axial strain dependent and tends to increase with increasing deformation (Eid et al., 2000). Review of existing laboratory data show that most of the laboratory shear tests investigated are not continued to sufficient displacement or strain to mobilize the peak shear strength of the MSW. As a result, Stark et al. (2009) provide MSW shear strength envelopes mobilized at horizontal displacements of 10, 30, 50, 100, and 150 mm. Table 3 shows equations for each strength envelope estimated from direct shear tests, where R^2 values are all above 0.90. Figure 10 compares the shear strength envelopes in Table 2 to envelopes recommended by others (e.g., Stark et al., 2009; Bray et al., 2009; Kavazanjian et al., 1995). As highlighted in Figure 10, all of the recommended envelopes fall between the 50 and 100 mm of shear displacement strength envelopes.

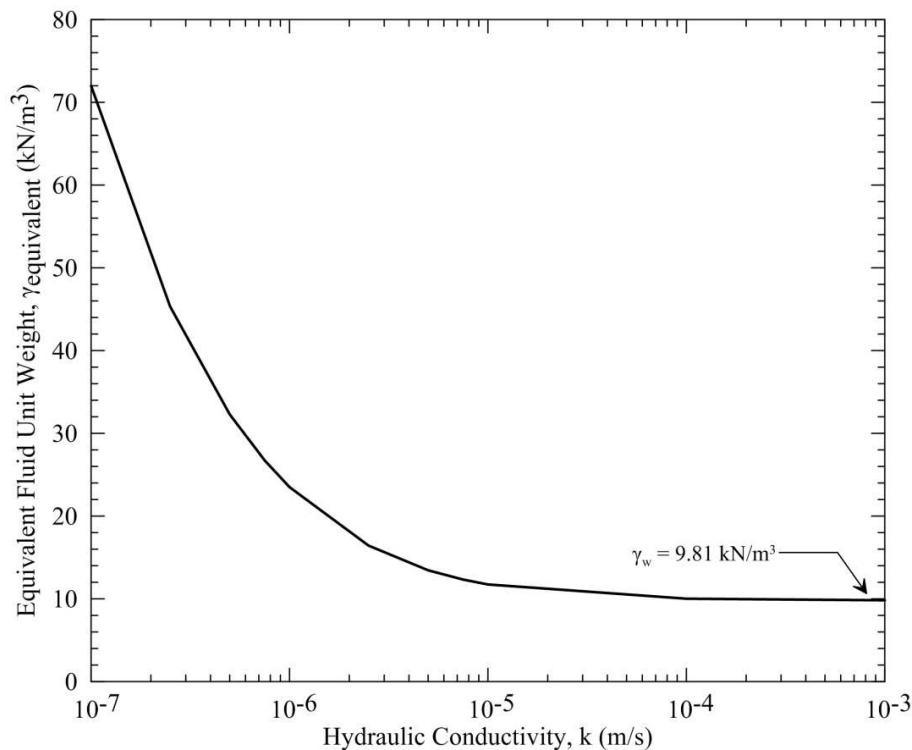
It is hypothesized that landfill gas and leachate pressure reduced the effective stress along the failure surface. Landfill gas, which is dominated by methane and carbon dioxide, is formed as a natural part of anaerobic degradation. In landfills that are sufficiently dry, landfill gas migrates readily through the pore space and is released into the atmosphere with little build-up of pressure in the waste. However, as saturation levels in the waste rise, the permeability of the waste to landfill gas migration decreases. Merry et al. (2006) use a one-dimensional (1-D) column of saturated media where degradable waste exists only in the lowest portion of the column to model this situation. This model shows that below the level of saturation, the steady-state excess gas pressure increases linearly similar to a hydrostatic condition. The combination of hydrostatic leachate pressure and gas-induced pore pressure may be accounted for using an equivalent fluid unit weight for the pore fluid that is artificially higher than water. A subsequent parametric study of the input parameters shows that the equivalent fluid unit weight of the pore fluid is dependent on waste hydraulic conductivity (Merry et al., 2006). The corresponding MSW hydraulic conductivity for this case is assumed to be greater than 1×10^{-5} m/s. Figure 12 shows the relationship between waste hydraulic conductivity and equivalent fluid unit weight of the pore fluid and is used to estimate an equivalent fluid unit weight. The input parameters for Figure 12 are provided in Table 5. The gas generation rate (Q_t) is estimated by Eq. (1):

Figure 12. Dependence of equivalent fluid unit weight, $\gamma_{\text{equivalent}}$, on MSW saturated hydraulic conductivity, $K_{\text{waste,sat}}$

Using Table 5, the equivalent fluid unit weight of the pore fluid, $\gamma_{\text{equivalent}}$, that accounts for both hydrostatic water pressure and gas pore pressure is 11.7 kN/m³. Due to the inclusion of gas pressure in the inverse analysis, the piezometric surface that gives a FS of unity is lowered by 1 m for both the circular and planar failure surfaces in Figure 11.

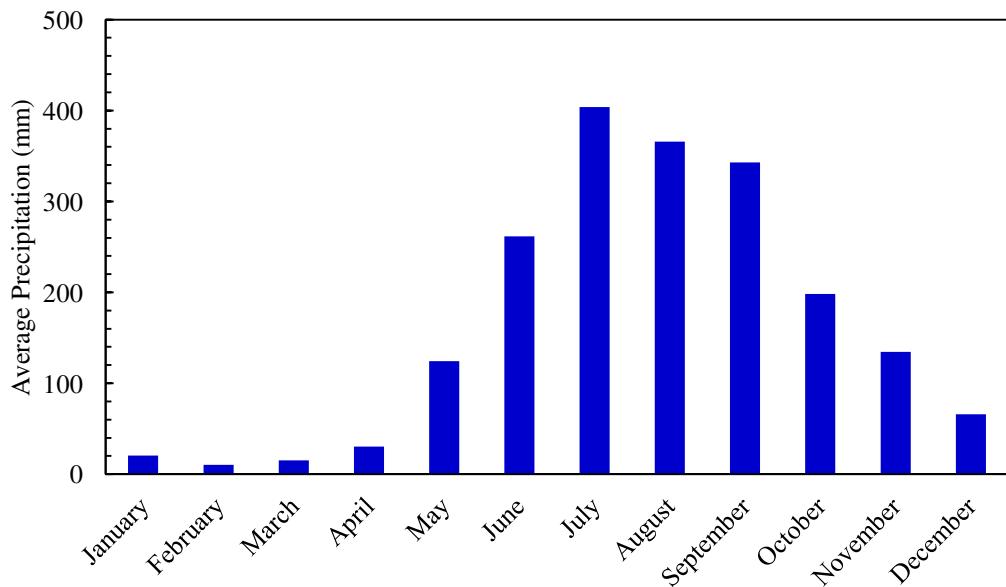
The precipitation database in the HELP model does not provide historical precipitation data for Quezon City, so recorded rainfall data from 1 May through 31 July 2000, was obtained from the Quezon City weather station and imported into HELP. This provides a reasonable simulation of the two months of precipitation immediately preceding the slope failure. Replicating approximate initial moisture conditions before May 1st 2000 involved executing the HELP model for several years prior to the failure. As a result, weather and climate conditions similar to Quezon City were required because this data is not available from the Quezon City weather station. Quezon City, located at 14° latitude, is closer to the equator than the United States and hence, has different climate conditions. Quezon City weather is dominated by high humidity, precipitation, and warm conditions year round. Table 7 presents a summary of the key weather conditions for Quezon City. The HELP program can also generate daily precipitation data using a synthetic weather generator. By entering the normal mean monthly precipitation values of Manila, Philippines shown in Figure 13, HELP generated synthetic precipitation records for 10 years preceding the failure. This synthetic record was used until May 1st of the 10th year, so that the water content and saturation levels reached a reasonable steady state value before applying the recorded data from the Quezon City weather station. From May 1st to July 31st, recorded precipitation values from the Quezon City station (Canty and Associates LLC, 2004) were input to HELP.

Figure 13. Average monthly precipitation for Manila, Philippines from Quezon City weather station (data from www.weather.com).

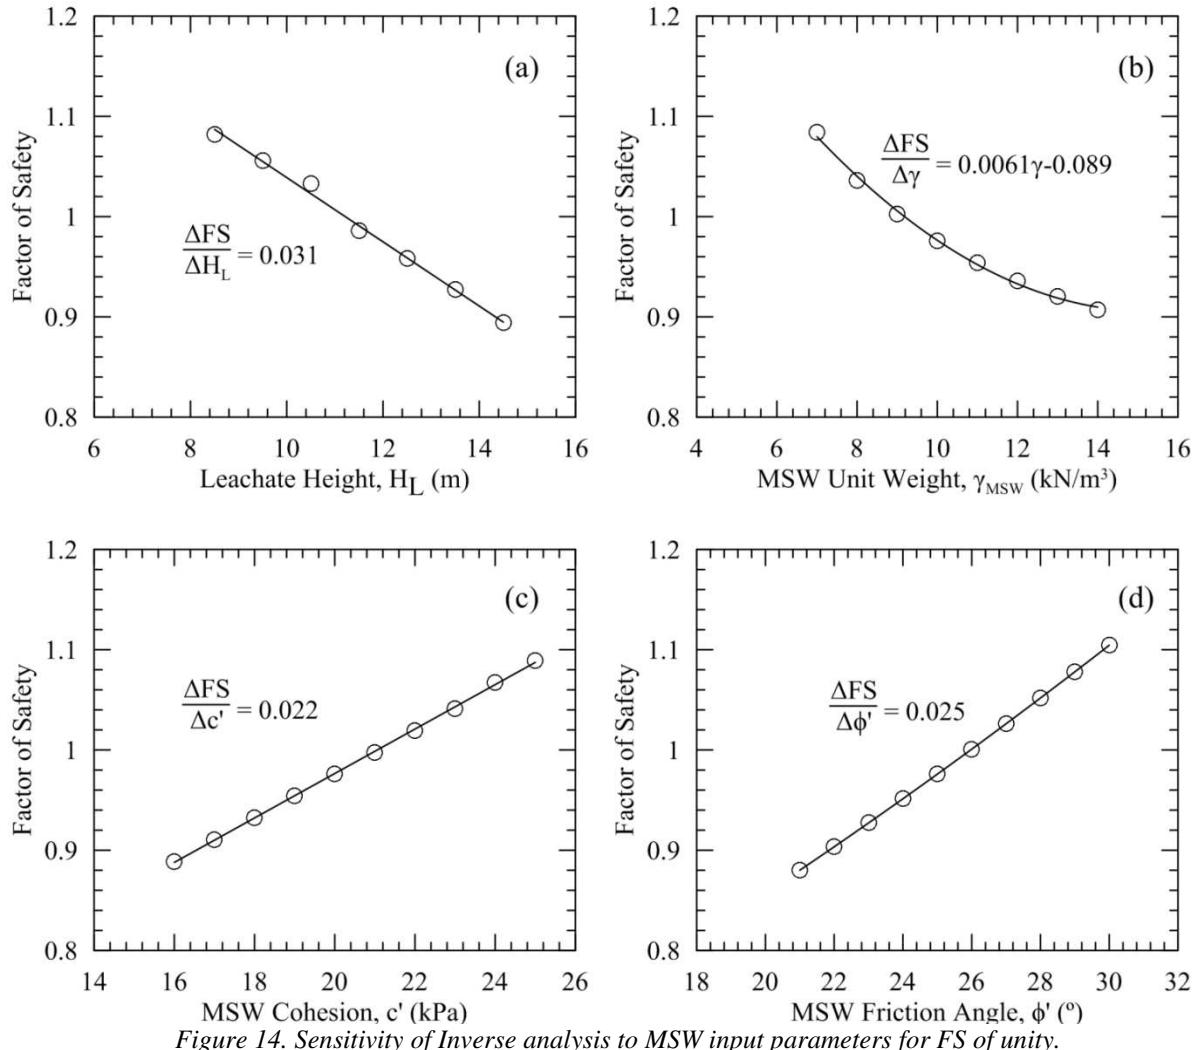
Using site reconnaissance information, pictures, and reports of the wasteslide, an inverse analysis was conducted to estimate the piezometric level at the time of failure. Figures 14(a), 14(b), 14(c), and 14(d) show the sensitivity of the factor of safety for a range of MSW shear strength parameters, MSW unit weight, and leachate level. For each sensitivity parameter, the factor of safety was computed using the circular failure surface in Figure 11(a). In Figure 14, the trend line slope is used to capture the sensitivity of FS to each parameter. For example, Figure 14(a) shows that FS decreases by 0.031 for a 1 m increase in leachate level. Using the trend line slopes for each parameter, the contributing factors leading to failure can be compared. MSW unit weight can increase when rain infiltrates into the waste mass and increases moisture content. The sensitivity of MSW unit weight is a nonlinear relationship shown in Figure 14(b). Figures 14(c) and 14(d) indicate that reducing MSW cohesion and friction, i.e., slopes equal to 0.022 and 0.025, respectively, contributes less to failure than increasing the leachate height (slope=0.031). Thus, Figure 14 suggests that leachate height has the greatest influence to reduce the FS.

Figure 14. Sensitivity of Inverse analysis to MSW input parameters for FS of unity.
