Preliminary Field Assessment of Sinkhole Damage in Pokhara, Nepal

ABSTRACT: Since November 2013, numerous sinkholes have been forming in the Armala area of Pokhara Valley, Central Nepal, posing serious threat to local residents. In order to provide measures aimed at reducing sinkhole risk, investigations into the cause and features of the sinkholes are crucial. This paper presents early research results based on two damage surveys conducted in June 2014 and November 2014 in the Armala area. Comparison of photos, taken in the two surveys, clearly indicates not only the formation of new sinkholes, but also the re-activation of filled sinkholes. By means of dynamic cone penetration tests and surface wave method investigations, qualitative characterization of the soil profile was attained, and shallow weak soil layers which are believed to be the location for future sinkholes could be identified. On the basis of the field investigation results, possible sinkhole formation mechanisms are identified for the Armala area. Furthermore, results of a reconnaissance survey conducted in the Armala area in early May 2015 (following the 2015 Gorkha Nepal Earthquake, which occurred on April 25th)

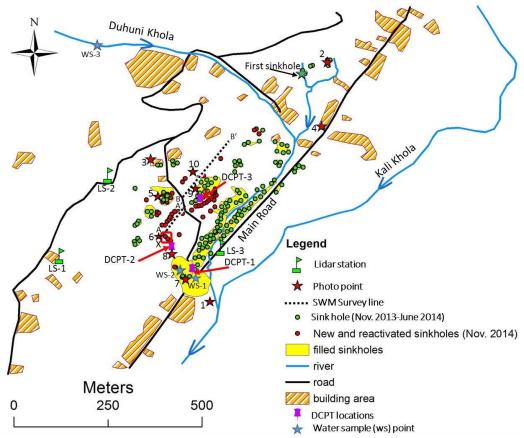
Figure 2. Detailed map of the sinkhole damaged area in Armala.

A detailed map of the study area reporting the location of sinkholes observed in June and November 2014, photo points and field investigations are shown in Figure 2. Topographically, the study area is a low-elevated zone as shown by the bird's eye view presented in Figure 3. This 3D image was obtained by overlapping LiDAR scanning carried out at three different locations (i.e. LS-1, LS-2 and LS-3 reported in Figure 2). There is a very gentle slope in the south-east direction, while a steep slope can be noticed in the north-west part. The black zones enclosed within circles are interconnected sinkholes as observed in November 2014.

During the June 2014 survey, the trace of a number of sinkholes previously formed since November 2013 could be typically observed in both sides of the Duhuni Khola (green dots in Figure 2). All the sinkholes were completely back filled, except for the sinkholes at photo points 7 and 8 (see also Figures 10 and 11). Originally, they had a diameter of about 10m and a depth of about 7 m. However, at the time of the survey, the upper part was already partially filled by sediments, and the measured depth was less than 4 m.

During the November 2014 survey, a number of sinkholes of recent formation (known to have formed in August 2014) were mostly observed in the west side of the surveyed area. In the map shown in Figure 2, it can be seen that the new sinkholes (shown as red dots) are concentrated on the western side of the old sinkholes. Some of the new sinkholes may be old sinkholes re-activated during the rainy season in 2014.

Immediately after the occurrence of the sinkholes, a wide area affected by the cave-in was backfilled by using gravelly soil retrieved from nearby quarries, which is identified by a yellow color filled area in Figure 2. Though, at the time of the first damage survey in June 2014, most of the sinkholes had been fully backfilled (Figure 7a corresponding to photo point 5), the photos taken in November 2014 at the same location clearly show that the backfilling was not an adequate solution as most of the former sinkholes were re-activated (Figure 7b) likely in August 2014 during the peak rainy season in Pokhara Valley.

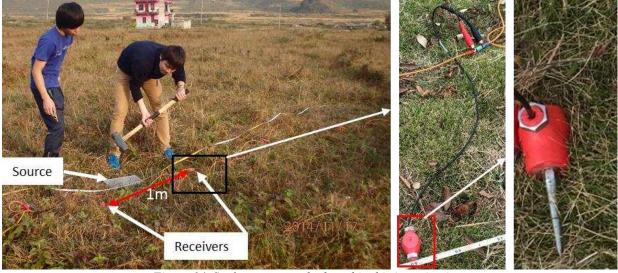
Figure 14. Surface wave method used in this investigation.

SWM surveys were performed along the two sections A-A' and B-B' shown in Figure 2 and Figure 3. The total length of the survey was 263 m (i.e. 95 m along the section A-A' and 168 m along the section B-B'). The testing conditions consisted of 24 vertical-component geo-phones (Figure 14) placed at 1m interval while ensuring good contact with soil. A 5 kg hammer was used to generate surface waves by impacting vertically on a rubber plate. The source was also positioned at 1m interval, to be precise at 0.5 m between two subsequent geophones.

After finishing one 24 m profile, the subsequent measurement was made with at least 3 geophones overlapping. The nearest source to the receiver offset was 0.5 m. An OYO MCSEIS-SW was used for data acquisition. Figure 14 shows the typical surface wave method alignment used in this investigation.
