# Preliminary Field Assessment of Sinkhole Damage in Pokhara, Nepal

**ABSTRACT:** Since November 2013, numerous sinkholes have been forming in the Armala area of Pokhara Valley, Central Nepal, posing serious threat to local residents. In order to provide measures aimed at reducing sinkhole risk, investigations into the cause and features of the sinkholes are crucial. This paper presents early research results based on two damage surveys conducted in June 2014 and November 2014 in the Armala area. Comparison of photos, taken in the two surveys, clearly indicates not only the formation of new sinkholes, but also the re-activation of filled sinkholes. By means of dynamic cone penetration tests and surface wave method investigations, qualitative characterization of the soil profile was attained, and shallow weak soil layers which are believed to be the location for future sinkholes could be identified. On the basis of the field investigation results, possible sinkhole formation mechanisms are identified for the Armala area. Furthermore, results of a reconnaissance survey conducted in the Armala area in early May 2015 (following the 2015 Gorkha Nepal Earthquake, which occurred on April

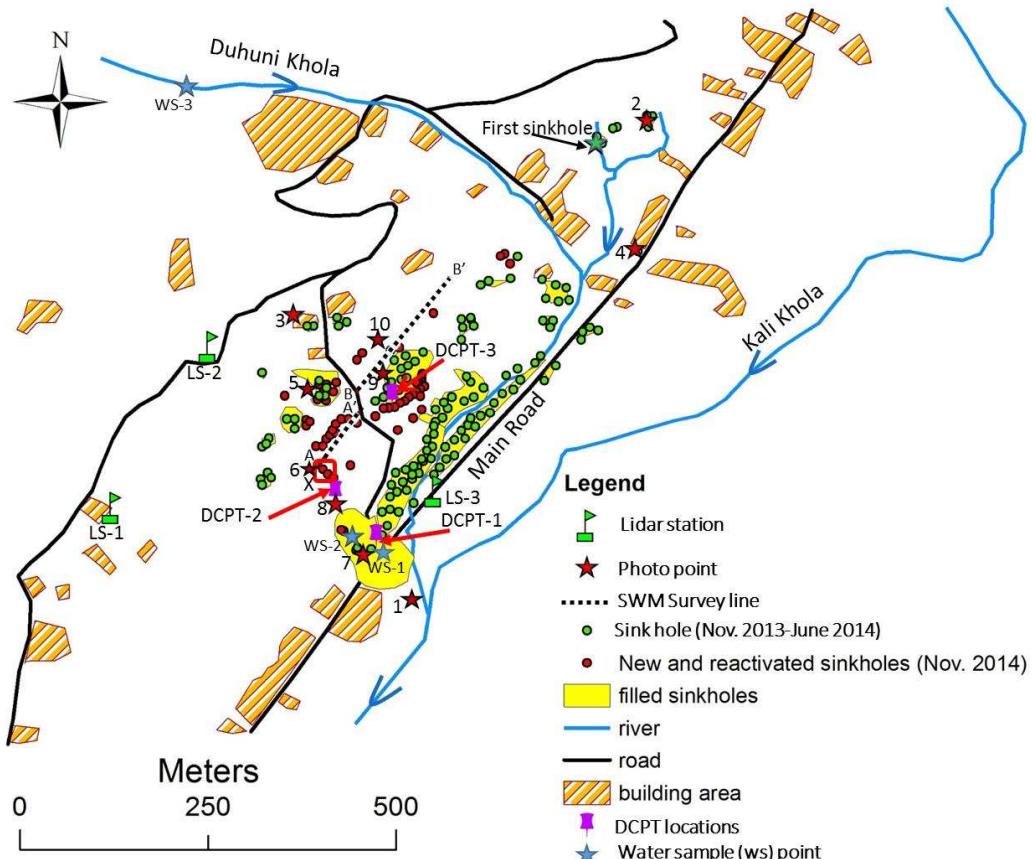
Figure 2. Detailed map of the sinkhole damaged area in Armala.

A detailed map of the study area reporting the location of sinkholes observed in June and November 2014, photo points and field investigations are shown in Figure 2. Topographically, the study area is a low-elevated zone as shown by the bird's eye view presented in Figure 3. This 3D image was obtained by overlapping LiDAR scanning carried out at three different locations (i.e. LS-1, LS-2 and LS-3 reported in Figure 2). There is a very gentle slope in the south-east direction, while a steep slope can be noticed in the north-west part. The black zones enclosed within circles are interconnected sinkholes as observed in November 2014.

During the June 2014 survey, the trace of a number of sinkholes previously formed since November 2013 could be typically observed in both sides of the Duhuni Khola (green dots in Figure 2). All the sinkholes were completely back filled, except for the sinkholes at photo points 7 and 8 (see also Figures 10 and 11). Originally, they had a diameter of about 10m and a depth of about 7 m. However, at the time of the survey, the upper part was already partially filled by sediments, and the measured depth was less than 4 m.

During the November 2014 survey, a number of sinkholes of recent formation (known to have formed in August 2014) were mostly observed in the west side of the surveyed area. In the map shown in Figure 2, it can be seen that the new sinkholes (shown as red dots) are concentrated on the western side of the old sinkholes. Some of the new sinkholes may be old sinkholes re-activated during the rainy season in 2014.

Immediately after the occurrence of the sinkholes, a wide area affected by the cave-in was backfilled by using gravelly soil retrieved from nearby quarries, which is identified by a yellow color filled area in Figure 2. Though, at the time of the first damage survey in June 2014, most of the sinkholes had been fully backfilled (Figure 7a corresponding to photo point 5), the photos taken in November 2014 at the same location clearly show that the backfilling was not an adequate solution as most of the former sinkholes were re-activated (Figure 7b) likely in August 2014 during the peak rainy season in Pokhara Valley.

Among many, sinkholes N1, N2 and N3 in the area X shown in Figure 2 were found to be of particular interest. They were developed in a delimited area of approximately  $10\text{ m} \times 20\text{ m}$ , as shown in the schematic map shown in Figure 8. They have a circular pattern and diameters ranging from 4.6 m (N3) to 6.8 m (N1). Their depth measured at the top of the collapsed soil varied from 2.2 m (N1, N3) to a maximum of 3.5 m (N2). According to witnesses, N1 was the first sinkhole to be formed. A few days later, N2 caved-in and finally N3 developed. This progressive formation of several sinkholes along a straight line (moving along the uphill direction from N1 to N3) may suggest that the collapse of N1 caused the complete disruption of underground water flow. Consequently, water started to erode the soil just adjacent to N1 until a new cave-in (N2) was formed. In a similar way, N3 was later developed. The same pattern of sinkhole formation occurred often since November 2013. Most of the newly developed sinkholes are located on the upstream side of the underground water flow.

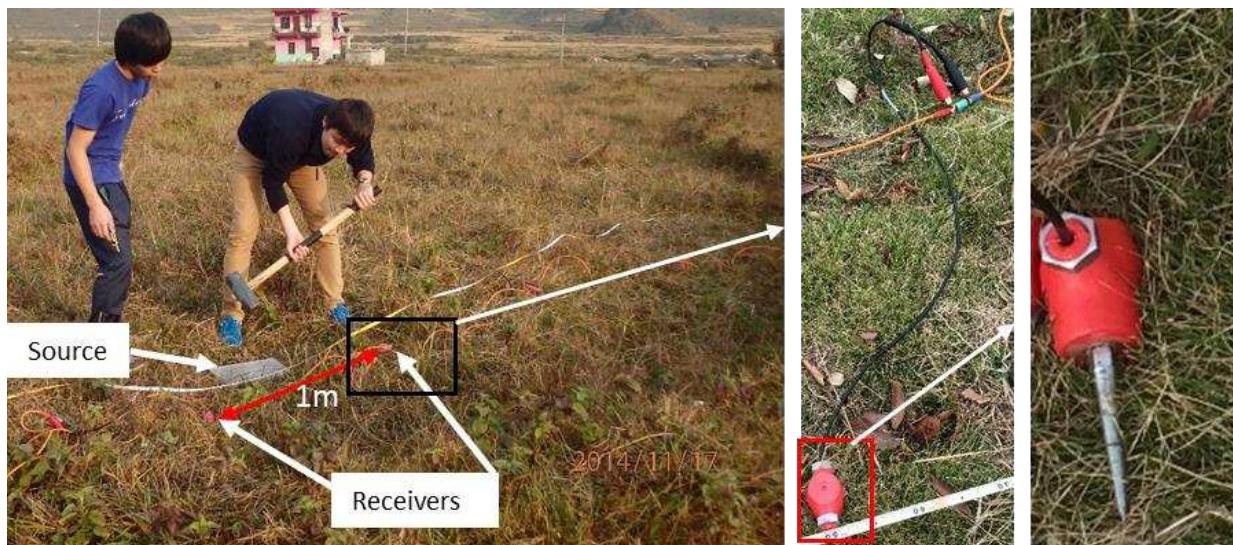
Figure 14. Surface wave method used in this investigation.

SWM surveys were performed along the two sections A-A' and B-B' shown in Figure 2 and Figure 3. The total length of the survey was 263 m (i.e. 95 m along the section A-A' and 168 m along the section B-B'). The testing conditions consisted of 24 vertical-component geo-phones (Figure 14) placed at 1m interval while ensuring good contact with soil. A 5 kg hammer was used to generate surface waves by impacting vertically on a rubber plate. The source was also positioned at 1m interval, to be precise at 0.5 m between two subsequent geophones.

After finishing one 24 m profile, the subsequent measurement was made with at least 3 geophones overlapping. The nearest source to the receiver offset was 0.5 m. An OYO MCSEIS-SW was used for data acquisition. Figure 14 shows the typical surface wave method alignment used in this investigation.
