Preliminary Field Assessment of Sinkhole Damage in Pokhara, Nepal

KEYWORDS: sinkholes, site investigation, dynamic cone penetration test, surface wave method, Pokhara

Reference: Pokhrel R.M., Kiyota T., Kuwano R., Chiaro G., Katagiri T. and Arai I. (2015). *Preliminary Field Assessment of sinkhole damage in Pokhara, Nepal*. International Journal of Geoenvironmental Engineering Case histories, <http://casehistories.geoengineer.org>, Vol.3, Issue 2, p.113-125. doi: 10.4417/IJGCH-03-02-04

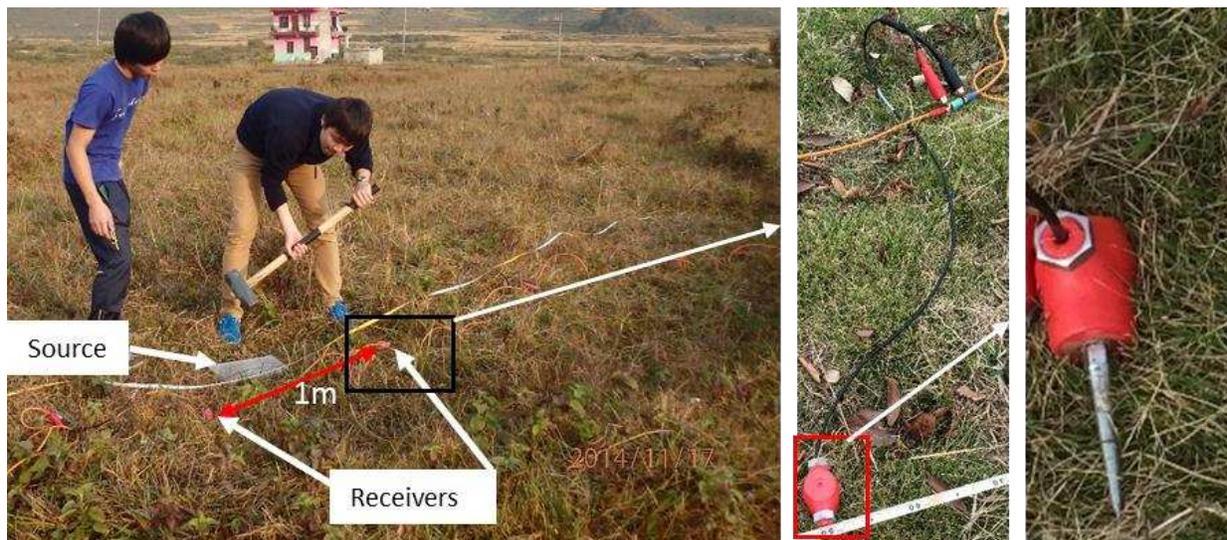
SWM surveys were performed along the two sections A-A' and B-B' shown in Figure 2 and Figure 3. The total length of the survey was 263 m (i.e. 95 m along the section A-A' and 168 m along the section B-B'). The testing conditions consisted of 24 vertical-component geo-phones (Figure 14) placed at 1m interval while ensuring good contact with soil. A 5 kg hammer was used to generate surface waves by impacting vertically on a rubber plate. The source was also positioned at 1m interval, to be precise at 0.5 m between two subsequent geophones.

After finishing one 24 m profile, the subsequent measurement was made with at least 3 geophones overlapping. The nearest source to the receiver offset was 0.5 m. An OYO MCSEIS-SW was used for data acquisition. Figure 14 shows the typical surface wave method alignment used in this investigation.

Figure 14. Surface wave method used in this investigation.
