The May 25th 2011 Railroad Embankment Failure in Ann Arbor, Michigan, As a Means for Teaching Geotechnical Engineering

ABSTRACT: A 30-m long railroad embankment failure that occurred on May 25 2011 in the city of Ann Arbor, Michigan, is presented. Emphasis is given on the field observations of the failure, the characterization of the site conditions and the seepage and slope stability analyses, all of which represent important components of the training and practice of a geotechnical engineer. The failure occurred following a record wet season that resulted in ponding water against the embankment and high enough water pressures and exit gradients that resulted in instability of the railroad embankment. Detailed background material and the methodology for using the case history in geotechnical engineering education are presented.

International Journal of Geoengineering Case histories, Vol.3, Issue 4, p.234-245. doi: 10.4417/IJGCH-03-04-03

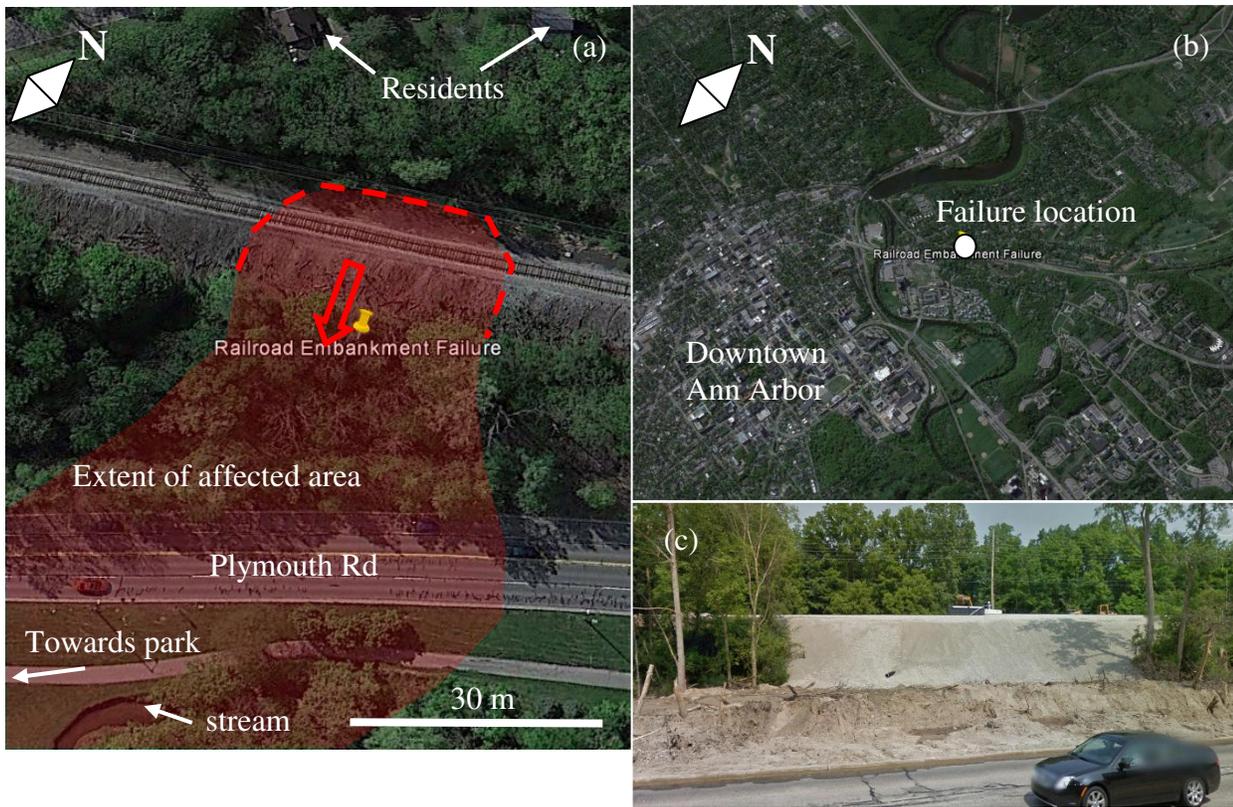
Figure 2. (a) Satellite imagery of the railroad embankment at the failure location; (b) location of the failure; (c) View of the repair works as recorded by coincidence by the Google Earth Camera.

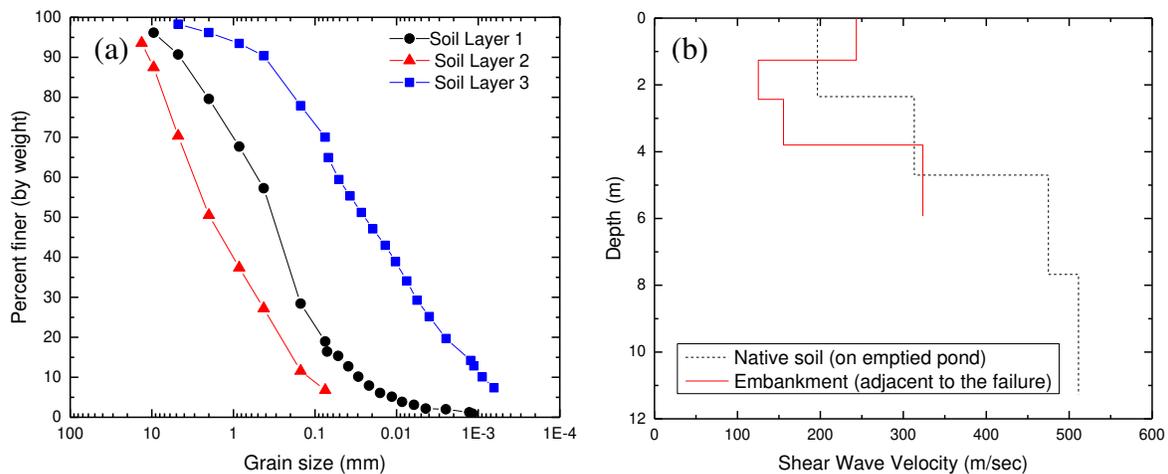
Soil Layer 1: This soil layer represents the main embankment layer, as shown in Fig. 5, and is classified per USCS as silty sand (SM). 18.9% of the material are non-plastic fines as shown in Fig. 8a. Since undisturbed samples were impossible to collect for the sandy fill, tests were conducted on reconstituted specimens at two different density states to evaluate the range of shear strengths expected for these materials. The direct shear tests were conducted in dry conditions. The shear strength of the material at a dense state was evaluated on the basis of direct shear testing, and the peak friction angle was found to be equal to 46° , whereas the post-peak was found to be equal to 38° without any cohesion, as shown in Fig. 9. The large-displacement friction angle at a dense state is approaching the peak friction angle of the soil at the loose state that was found to be equal to 35° . The hydraulic conductivity of the soil at a dry unit weight of 1.71 gr/cm^3 , was equal to $5.1 \cdot 10^{-5} \text{ cm/sec}$ based on a falling head hydraulic conductivity test conducted in the laboratory.

Figure 8. Results of (a) grain size distribution analyses and (b) in-situ shear wave velocity

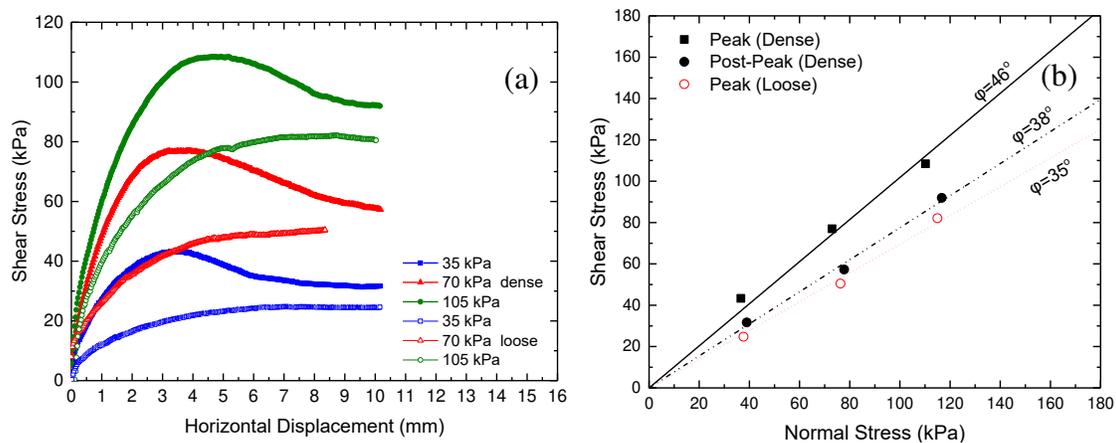
Figure 9. Direct shear results at nominal vertical stresses of 35 kPa, 70 kPa, and 105 kPa on reconstituted specimens of Soil Layer 1.
