The May 25th 2011 Railroad Embankment Failure in Ann Arbor, Michigan, As a Means for Teaching Geotechnical Engineering

Reference: Zekkos, D., Athanasopoulos-Zekkos, A., Grizi, A., and Greenwood, W. (2016). *The May 25th 2011 Railroad Embankment Failure in Ann Arbor, Michigan, As a Means for Teaching Geotechnical Engineering*.

International Journal of Geoengineering Case histories, Vol.3, Issue 4, p.234-245. doi: 10.4417/IJGCH-03-04-03

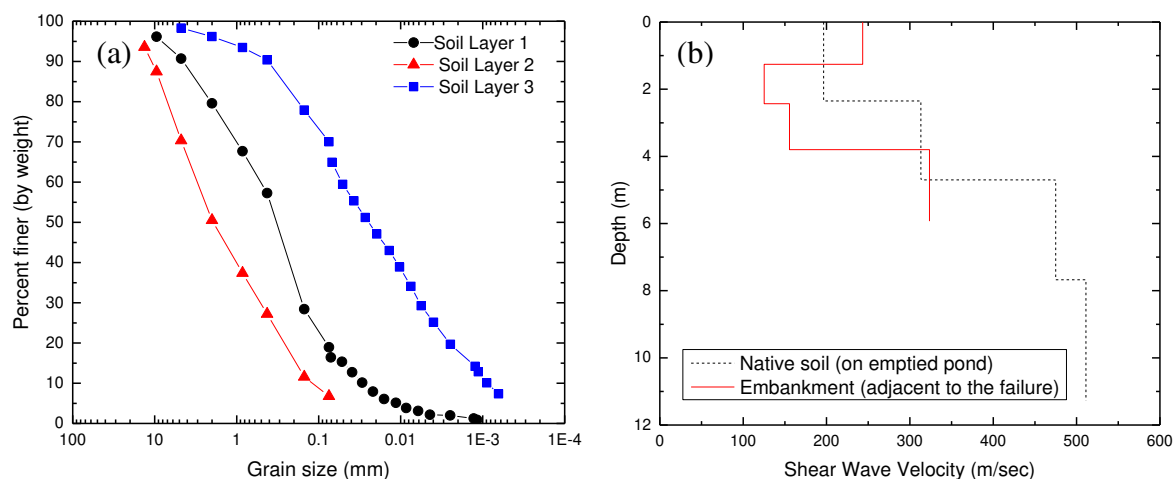
Soil Layer 1: This soil layer represents the main embankment layer, as shown in Fig. 5, and is classified per USCS as silty sand (SM). 18.9% of the material are non-plastic fines as shown in Fig. 8a. Since undisturbed samples were impossible to collect for the sandy fill, tests were conducted on reconstituted specimens at two different density states to evaluate the range of shear strengths expected for these materials. The direct shear tests were conducted in dry conditions. The shear strength of the material at a dense state was evaluated on the basis of direct shear testing, and the peak friction angle was found to be equal to 46° , whereas the post-peak was found to be equal to 38° without any cohesion, as shown in Fig. 9. The large-displacement friction angle at a dense state is approaching the peak friction angle of the soil at the loose state that was found to be equal to 35° . The hydraulic conductivity of the soil at a dry unit weight of 1.71 gr/cm^3 , was equal to $5.1 \cdot 10^{-5} \text{ cm/sec}$ based on a falling head hydraulic conductivity test conducted in the laboratory.

Figure 8. Results of (a) grain size distribution analyses and (b) in-situ shear wave velocity

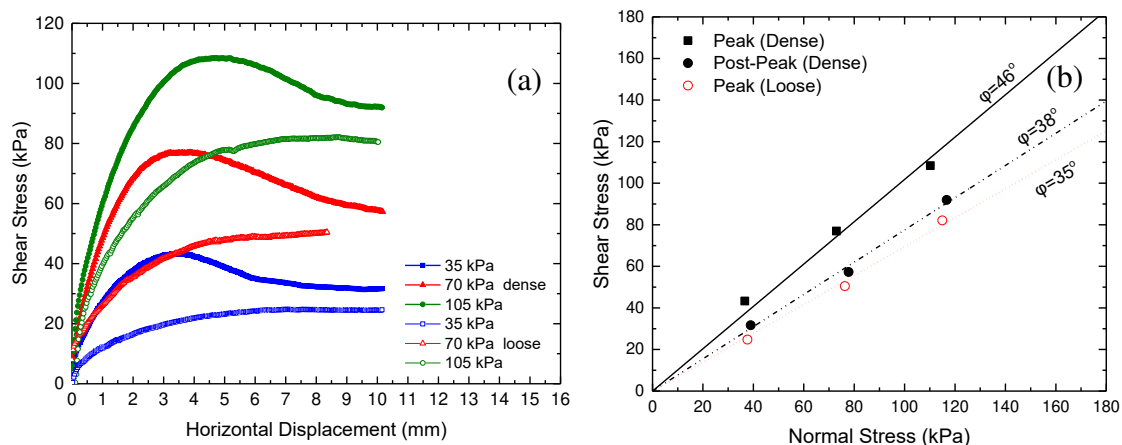
Figure 9. Direct shear results at nominal vertical stresses of 35 kPa, 70 kPa, and 105 kPa on reconstituted specimens of Soil Layer 1.
