# The May 25<sup>th</sup> 2011 Railroad Embankment Failure in Ann Arbor, Michigan, As a Means for Teaching Geotechnical Engineering

**ABSTRACT:** A 30-m long railroad embankment failure that occurred on May 25 2011 in the city of Ann Arbor, Michigan, is presented. Emphasis is given on the field observations of the failure, the characterization of the site conditions and the seepage and slope stability analyses, all of which represent important components of the training and practice of a geotechnical engineer. The failure occurred following a record wet season that resulted in ponding water against the embankment and high enough water pressures and exit gradients that resulted in instability of the railroad embankment. Detailed background material and the methodology for using the case history in geotechnical engineering education are presented.

Reference: Zekkos, D., Athanasopoulos-Zekkos, A., Grizi, A., and Greenwood, W. (2016). *The May 25th 2011 Railroad Embankment Failure in Ann Arbor, Michigan, As a Means for Teaching Geotechnical Engineering*.

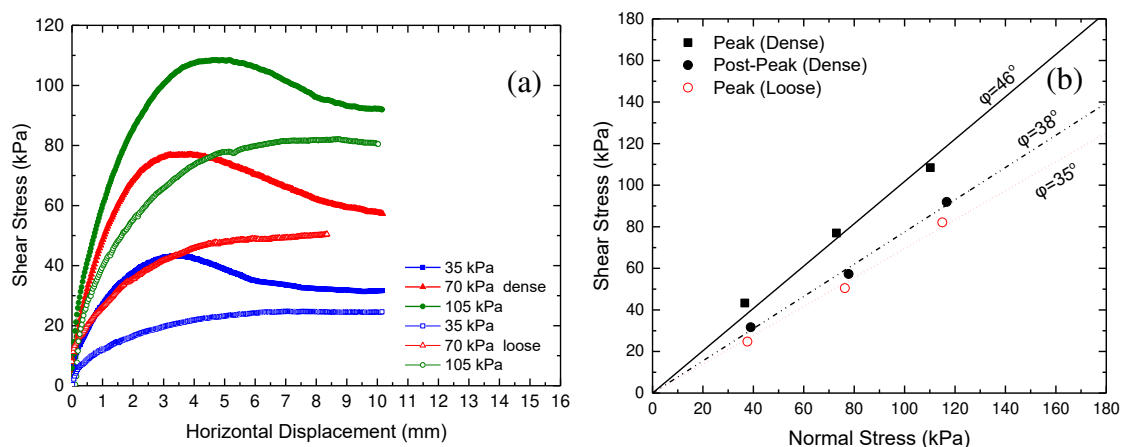
Figure 9. Direct shear results at nominal vertical stresses of 35 kPa, 70 kPa, and 105 kPa on reconstituted specimens of Soil Layer 1.
