The May 25th 2011 Railroad Embankment Failure in Ann Arbor, Michigan, As a Means for Teaching Geotechnical Engineering

ABSTRACT: A 30-m long railroad embankment failure that occurred on May 25 2011 in the city of Ann Arbor, Michigan, is presented. Emphasis is given on the field observations of the failure, the characterization of the site conditions and the seepage and slope stability analyses, all of which represent important components of the training and practice of a geotechnical engineer. The failure occurred following a record wet season that resulted in ponding water against the embankment and high enough water pressures and exit gradients that resulted in instability of the railroad embankment. Detailed background material and the methodology for using the case history in geotechnical engineering education are presented.

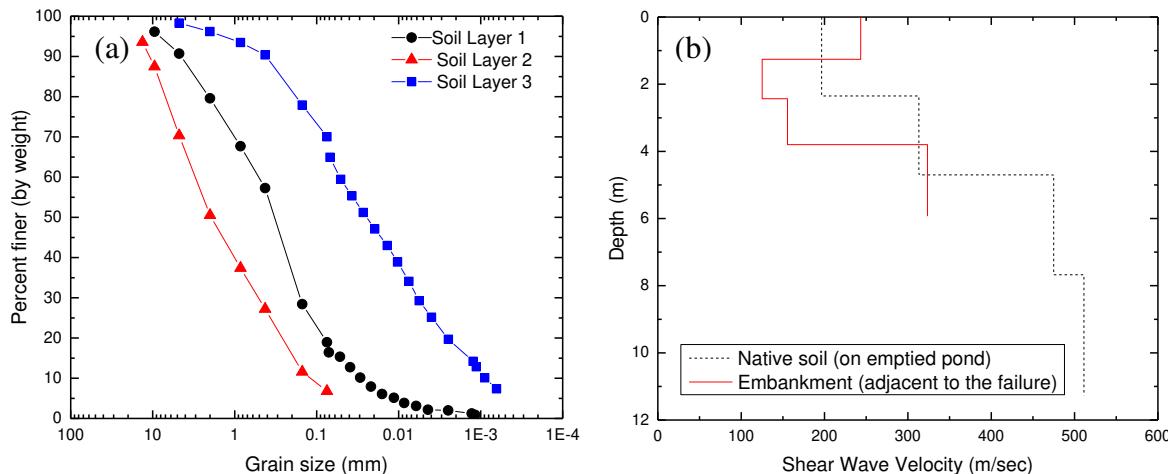
Soil Layer 1: This soil layer represents the main embankment layer, as shown in Fig. 5, and is classified per USCS as silty sand (SM). 18.9% of the material are non-plastic fines as shown in Fig. 8a. Since undisturbed samples were impossible to collect for the sandy fill, tests were conducted on reconstituted specimens at two different density states to evaluate the range of shear strengths expected for these materials. The direct shear tests were conducted in dry conditions. The shear strength of the material at a dense state was evaluated on the basis of direct shear testing, and the peak friction angle was found to be equal to 46° , whereas the post-peak was found to be equal to 38° without any cohesion, as shown in Fig. 9. The large-displacement friction angle at a dense state is approaching the peak friction angle of the soil at the loose state that was found to be equal to 35° . The hydraulic conductivity of the soil at a dry unit weight of 1.71 gr/cm^3 , was equal to $5.1 \times 10^{-5} \text{ cm/sec}$ based on a falling head hydraulic conductivity test conducted in the laboratory.

Figure 8. Results of (a) grain size distribution analyses and (b) in-situ shear wave velocity
