A Large Scale Landslide in a Coal Mine in Marly Formations: Evaluation, Analysis and Rehabilitation

ABSTRACT: This paper describes a large scale landslide in a coal mine in Servia area in Kozani, Greece, which occurred in February 2011. The landslide, of ~250m width and ~350m length, took place in marly lacustrine sediments. The main factors for the manifestation of the landslide were a temporary interruption of works, the existence of a specific weak surface, the clayey nature and the sensitivity of marl to environmental agents, the action of water and the large slope height. Due to the magnitude and the position of the failure, a geotechnical solution was proposed that involved rearrangement of ground masses. The proposed solution led to successful rehabilitation and unimpeded continuation of the exploitation process.

Reference: Prountzopoulos, G., Fortsakis, P., Marinos, V. and Marinos, P. (2016). *A Large Scale Landslide in a Coal Mine in Marly Formations: Evaluation, Analysis and Rehabilitation*. International Journal of Geoengineering Case Histories, Vol.4, Issue 1, p.29-45. doi: 10.4417/IJGCH-04-01-03

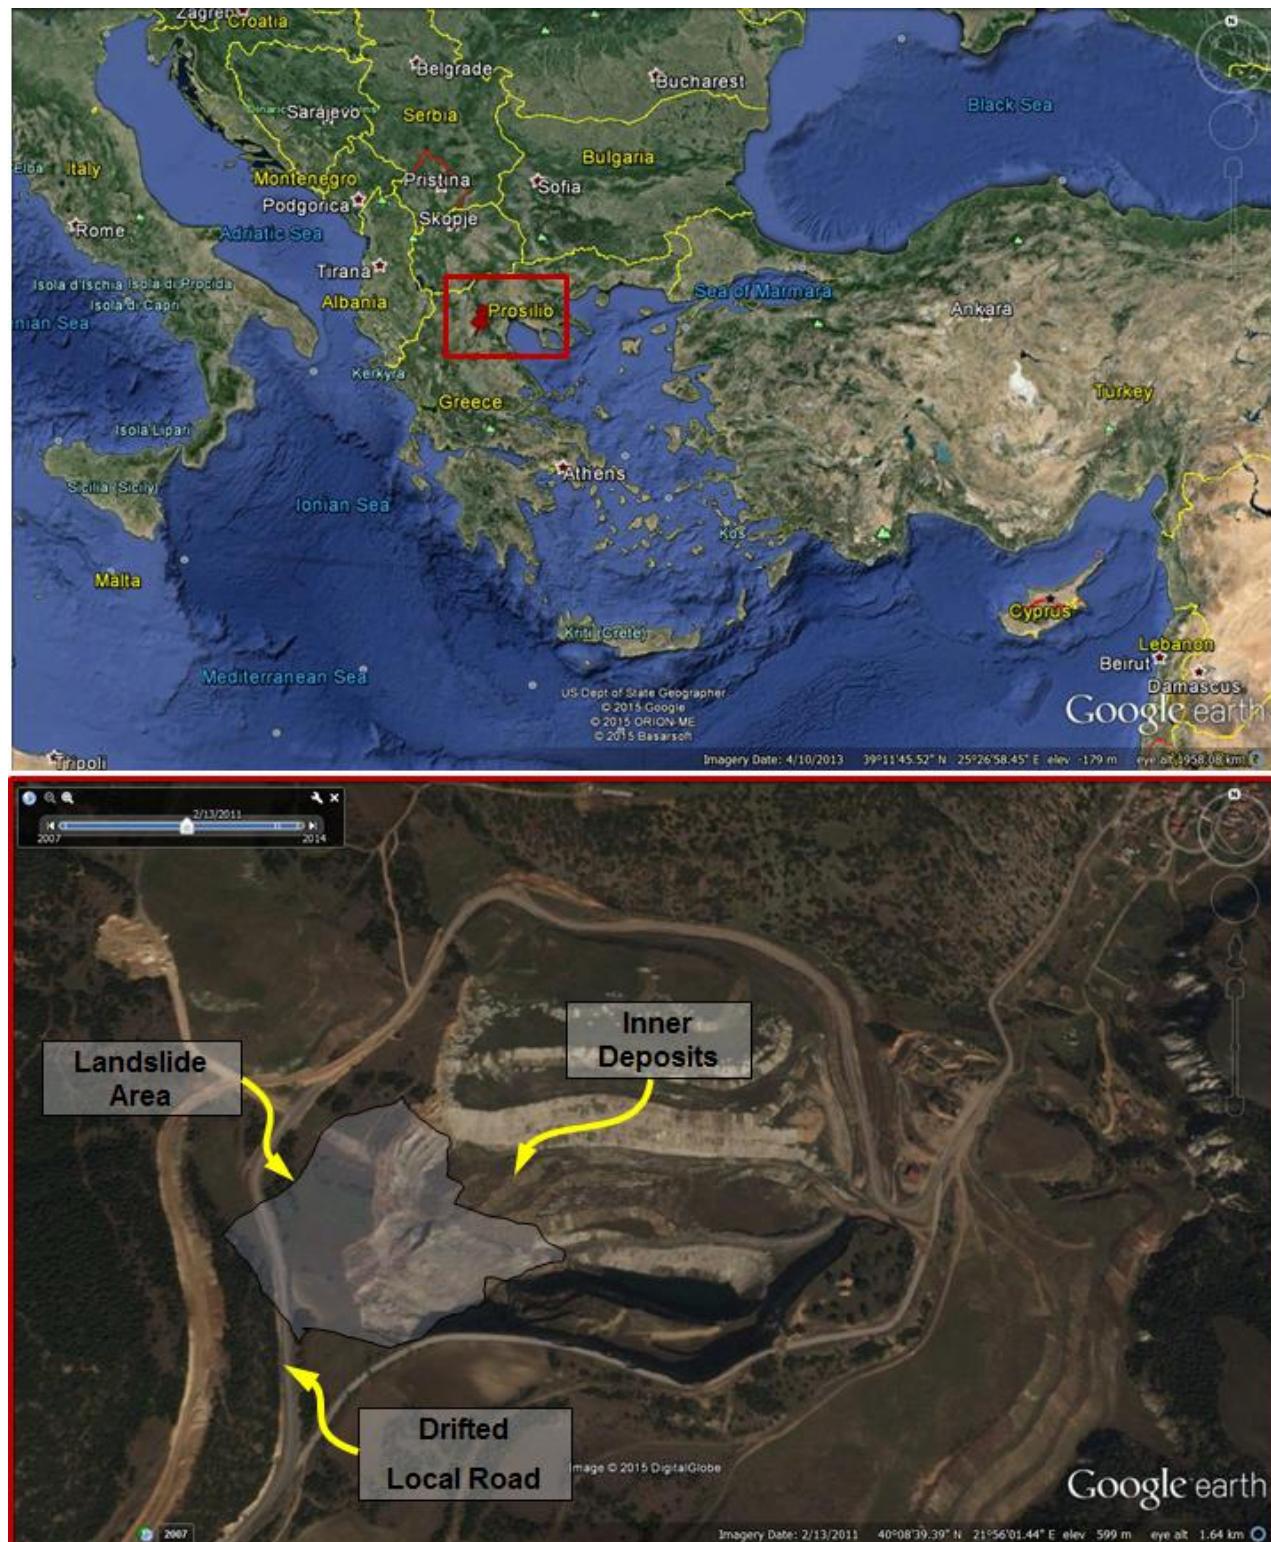
Figure 1 includes a demarcation of the position of the landslide, together with an aerial photo of the coal mine, only few days before the landslide. The landslide area, the local road affected by the landslide and the initially placed deposits for lateral retaining action to the mine slope are indicated on the satellite photo.

Figure 1. Position of landslide (up – red pin inside the red rectangle) and aerial photograph of the coal mine 2 weeks before the landslide (down). The area that was later occupied by the landslide is indicated with the transparent shape.
