# Remediation of The Pissouri Landslide in Cyprus

**ABSTRACT:** During the winter of 2001-2002, a landslide of 80.000 m<sup>3</sup> was activated and moved downslope at the Northeast outskirts of the Pissouri village in Cyprus (Limassol prefecture), displacing a section of a country road that was crossing the upper part of the sliding mass and destroying three newly built residences. This paper presents the geologic and hydrogeologic regime of the landslide and its implication on the landslide's mobilization. Geotechnical site investigation and post failure monitoring, in conjunction with slope stability back analysis formed the basis for the study of the slide and subsequently guided the remediation strategy. Various possible interventions to stabilize the slope and allow the safe reconstruction of the displaced road have been investigated and compared considering both economic and environmental criteria. The performance of the remediation measures has been studied in terms of stability safety, using numerical models previously calibrated via back analyses. Observations made during the execution of the stabilization works provided additional data verifying and supplementing the o

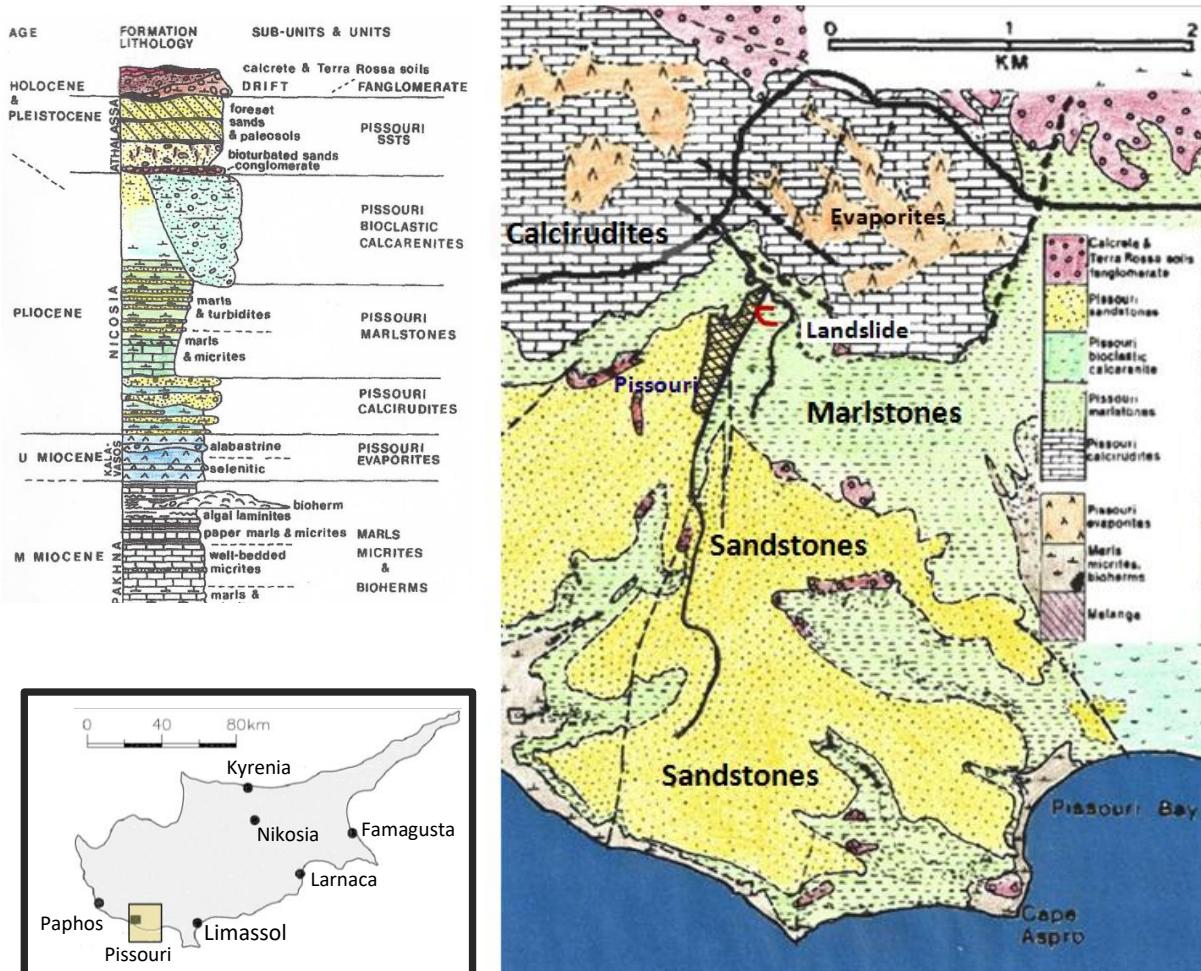
reddish-brown rock which in places disintegrates into a compound of marl blocks within a matrix of stiff fissured silty/clayey soil. The regional distribution of the aforementioned sedimentary units is depicted in Figure 3 (after Stow et al., 1995). The location of the landslide is also noted on the map.

Figure 3. Regional Geology of the Pissouri area. The village is developed on sandstones (yellow) underlain by the Pissouri marls (olive green). Geology after Stow et al., (1995)

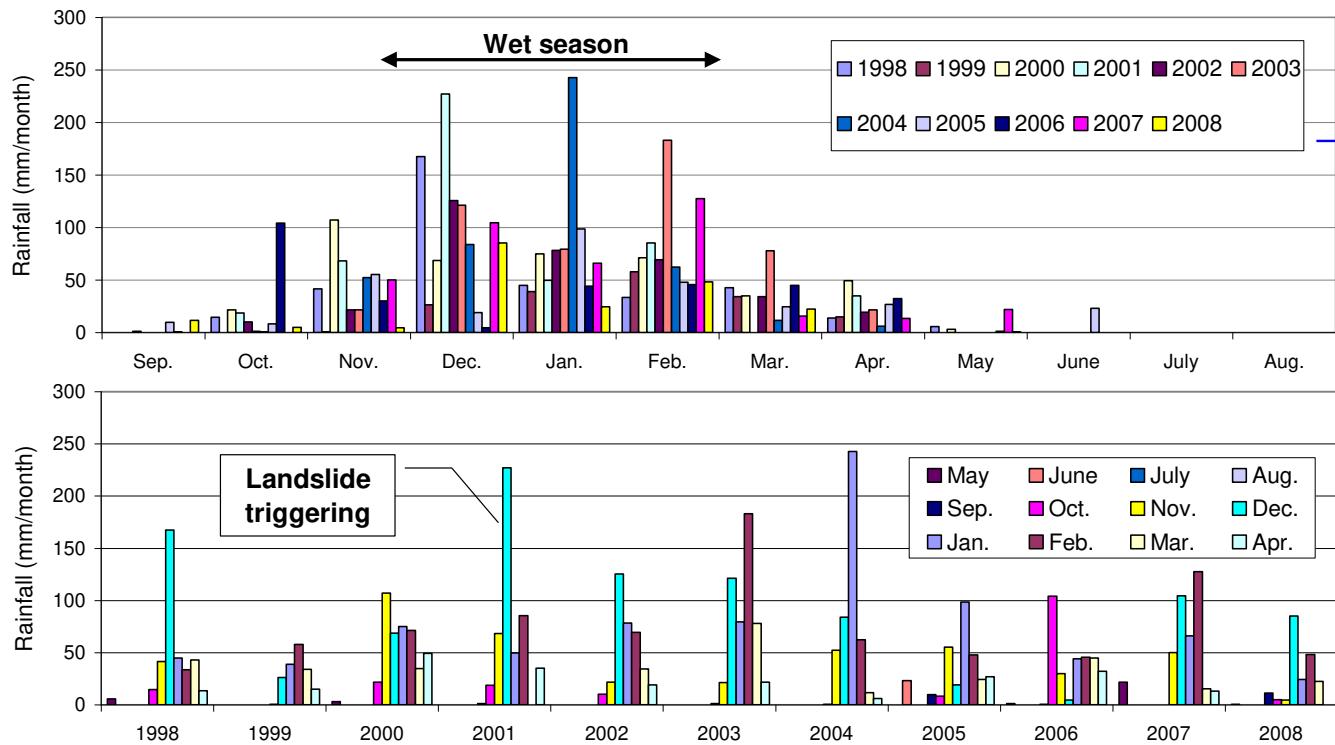
In the Limassol prefecture in particular, the annual precipitation is low, averaging 300-400 mm per year. The monthly rainfall time series retrieved by the Pissouri meteorological station during the 1998-2008 decade is presented in Figure 4. It is observed that during the December of 2001, when the Pissouri landslide was mobilized, precipitation was indeed high, exceeding 230 mm, but not a unique event in the decade. High precipitation undoubtedly triggered the landslide, but the contribution of other factors to slope instability should also be investigated. The high precipitation of December 2001 is associated with subsequent landslide events that took place in other parts of the island, as reported by Hadjigeorgiou et al., (2006) and Kyriakou & Hadjigeorgiou (2008).

Figure 4 Seasonal (upper figure) and annual (lower figure) distribution of monthly precipitation for the decade 1998 ~ 2008. Data from the "Pissouri" meteorological station.

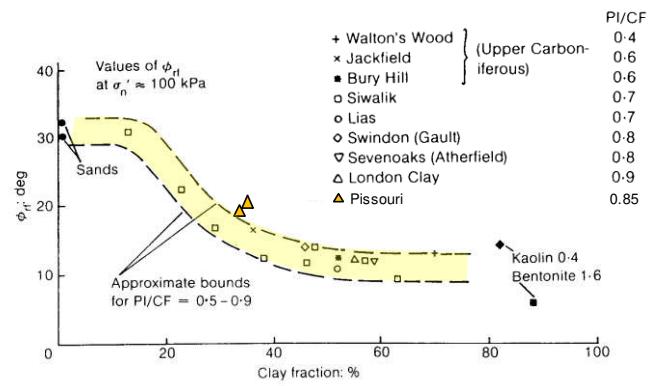
Figure 8. A comparison of the residual angle of shearing resistance of the weathered Pissouri marl with the dataset presented by Skempton (1985).

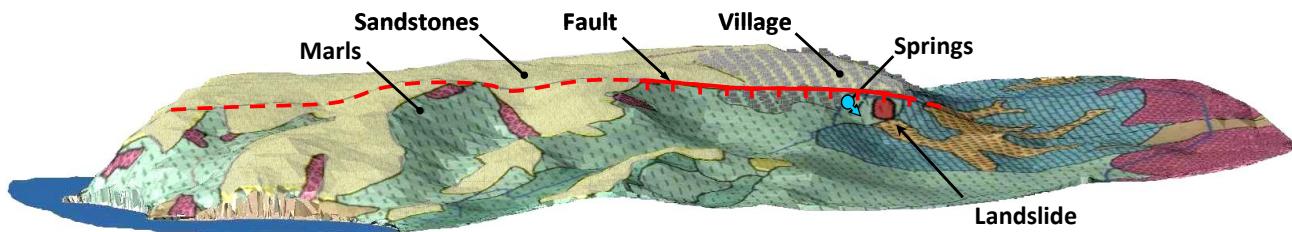
Figure 9. Hydrogeologic setting of the Pisouri area. Geological units (after Stow et al., 1995) are projected on the distorted relief of the Pisouri hill (exaggerated vertical scale H/V 2:1). Location of the landslide and the springs with respect to the major hydrogeologic units are also noted.

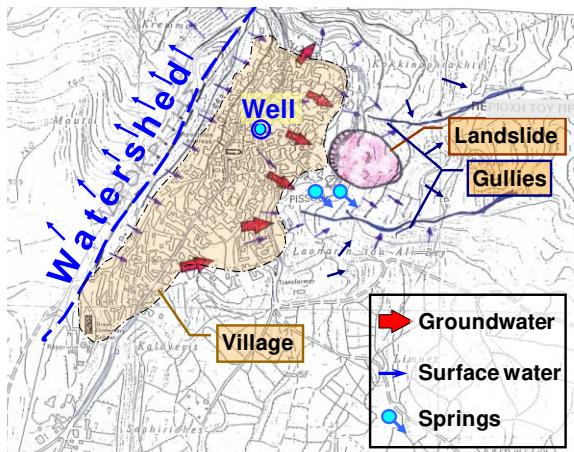
sandstones with the impermeable underlying marls, as shown schematically in Figure 10. A few seasonally discharging springs and water collecting wells have been located at the southeastern edge of the hill, near the landslide site (see Figure 11), which are exploited by local farmers for irrigation. A probable fault trending NNE-SSW, mapped by Stow et al. (1995), is running parallel to the eastern boundary of the village and dissects the sandstone layer. This fault is believed to control the steeper slopes of the Eastern side of the hill and is probably associated with the presence of the water springs down slope.

Figure 10. Surface and subsurface drainage patterns. Arrows indicate surface and subsurface water flow. Springs and wells are also noted.

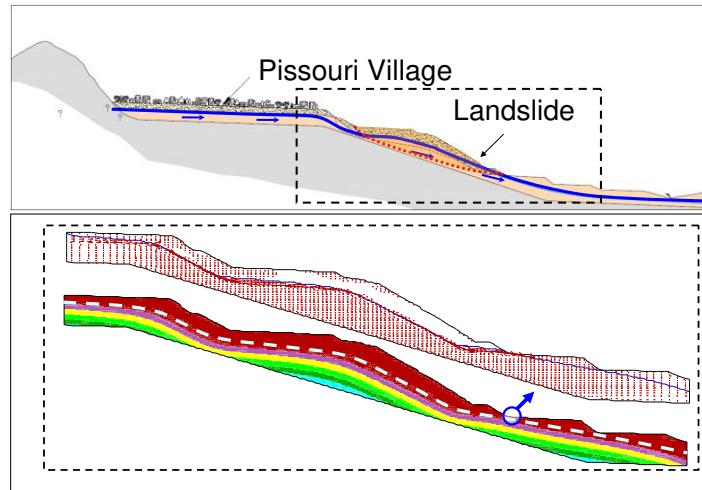
Figure 12. Typical results of the seepage analysis (flow vectors and pore water pressures).

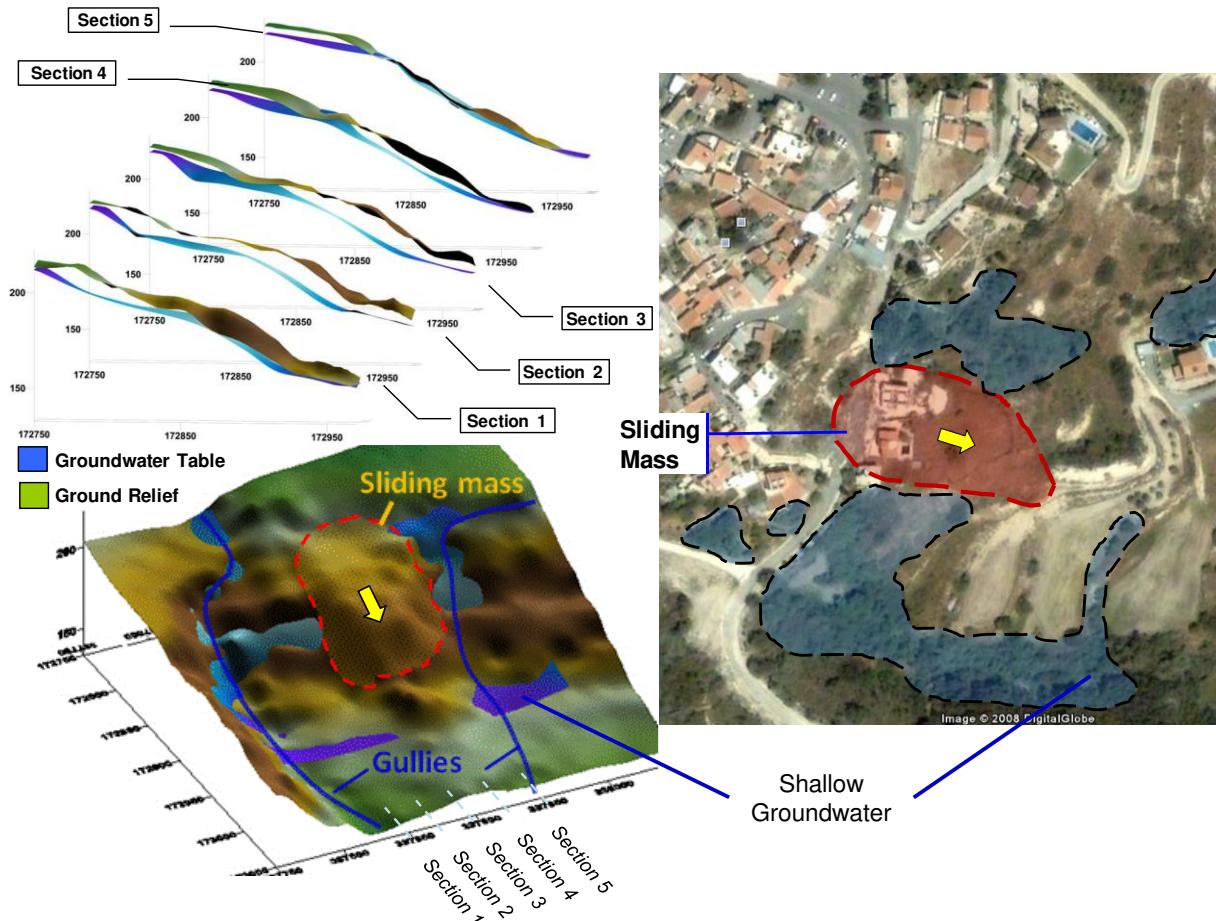
photographs, (Figure 12) and compares well with groundwater level measurements from piezometers installed in the vicinity of the landslide. The piezometric surface of Figure 13 represent the average dry season water table. During a wet season the water table within the landslide mass is expected to rise significantly and the development of a perched water table during thunderstorms should also be considered.

Figure 13. Left: A digital elevation model of the landslide area, overlain to the surface of the computed groundwater table. The groundwater table geometry is also presented as a series of sections in the upper figure.

Right: Blue areas in satellite image indicate areas where the ground water table is at shallow depth and coincide with the most densely vegetated areas.
