A High Rock Cut Stabilization in Muscat City, Oman

Tahir M. Hayat, Vice President, Geotechnical and Geonvironmental Engineering Division, NESPAK, Lahore, Pakistan; email: tmhayat786@yahoo.com

Reference: Hayat, T.M., Bhatti, T.J. and Goldsmith, R. (2017). *A High Rock Cut Stabilization in Muscat City, Oman*.

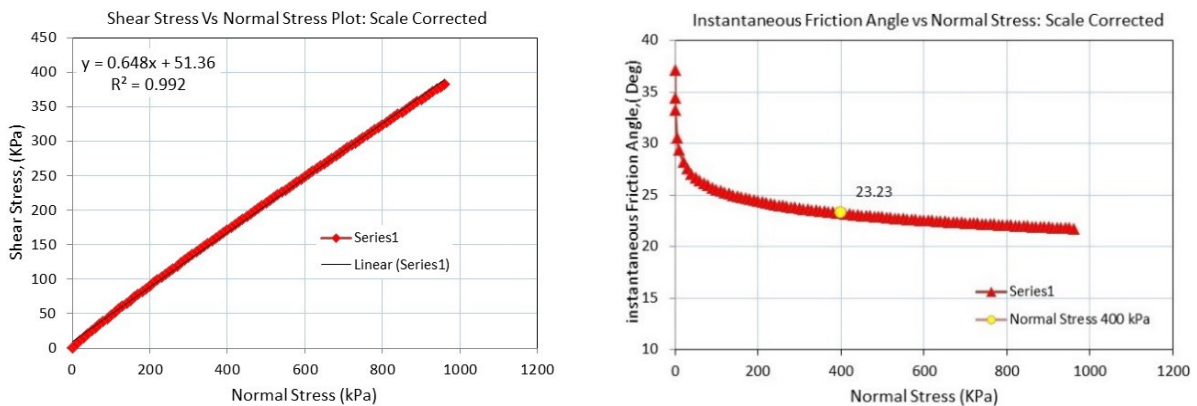
Figure 7. Friction angle at various stress levels for a deep seated sliding plane.

Figure 7 shows the spreadsheet results of ϕ_L at various normal stress levels for deep seated failures.

The average normal stress range was found to be about 400 kPa. Considering this, the corresponding friction angle (ϕ_L) was selected as 23.2° from Figure 7. In addition, based on site observations of intact rock bridges and test results, a cohesion value of 80 kPa was selected for analysis in deep seated failures. Similarly, for small scale failure, the ϕ_L value was calculated as 28° and zero cohesion was assumed in this case.
