A High Rock Cut Stabilization in Muscat City, Oman

Reference: Hayat, T.M., Bhatti, T.J. and Goldsmith, R. (2017). *A High Rock Cut Stabilization in Muscat City, Oman*.

International Journal of Geoengineering Case histories, <http://casehistories.geoengineer.org>, Vol.4, Issue 2, p.96-112.

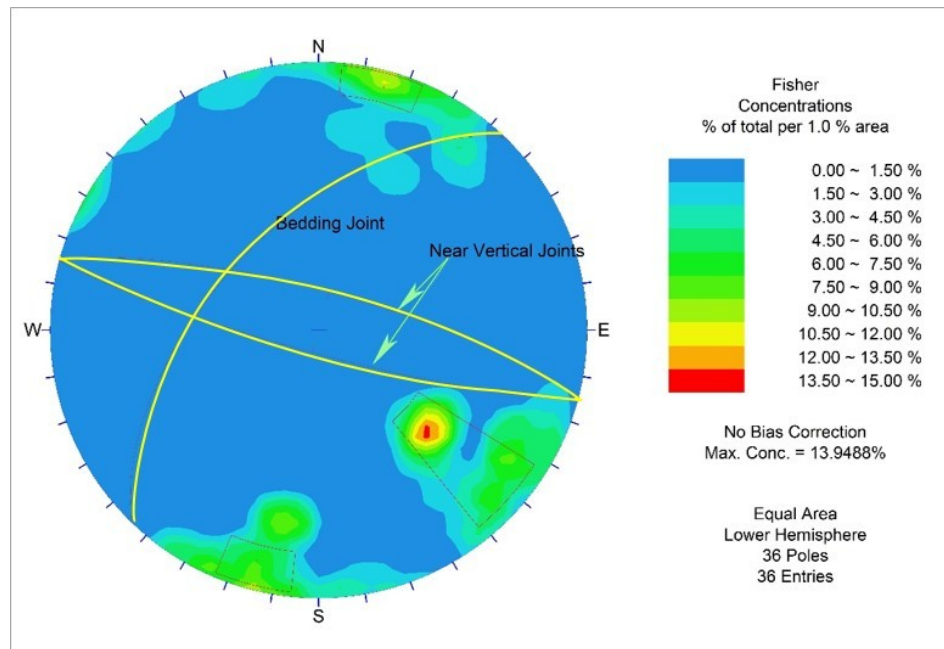
Figure 5. Stereoplot of the discontinuities representing the left slope in Box Cut 1.

In Box Cut #1, from approximately RD 0+220 to 0+500 m, the interlayering of the beds is quite prominent and dips at 30° to 45° daylighting out of the face and within +/- 20° of the face orientation. In addition to the bedding, there are joints and faults that are steeply dipping at 70° to 90° and strike NE-SW or SSW. These joints have high persistence over all cut benches to the full 40 m height. Some of these features are faulted with noticeable displacements. Figure 5 shows the pole plot of the joints and great circles drawn through the centre of poles concentration by visual examination.
