A High Rock Cut Stabilization in Muscat City, Oman

Reference: Hayat, T.M., Bhatti, T.J. and Goldsmith, R. (2017). *A High Rock Cut Stabilization in Muscat City, Oman*.

International Journal of Geoengineering Case histories, <http://casehistories.geoengineer.org>, Vol.4, Issue 2, p.96-112.

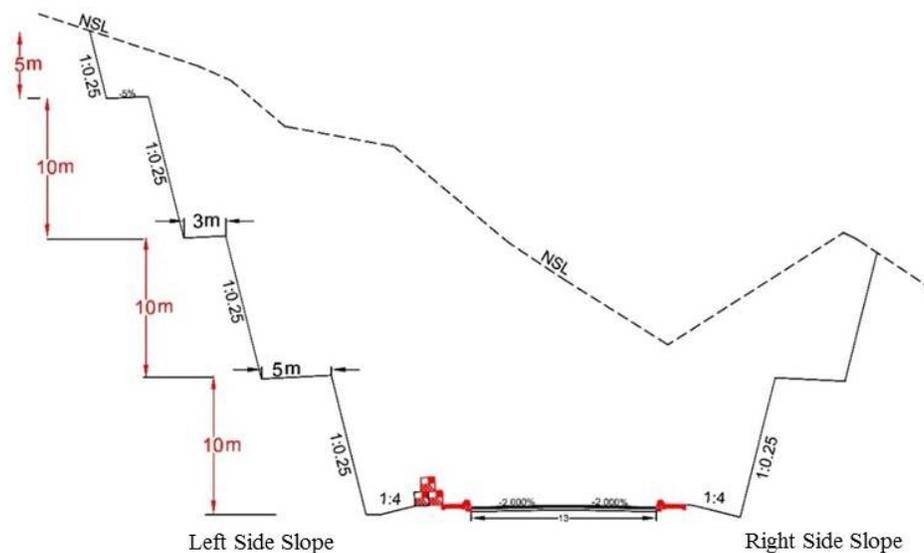
The maximum height of the rock slope in these cuts reaches 50 m with a cut slope of 1V:0.25H (76°) and 3 m wide benches at every 10 m height interval. A typical section of box cut at RD 0+420 m is shown in Figure 2. The initial design included slope protection measures such as short length rock bolts and reinforced shotcrete.

Figure 2. Slope and roadway configuration at station RD 0+420 m in Box Cut#1.

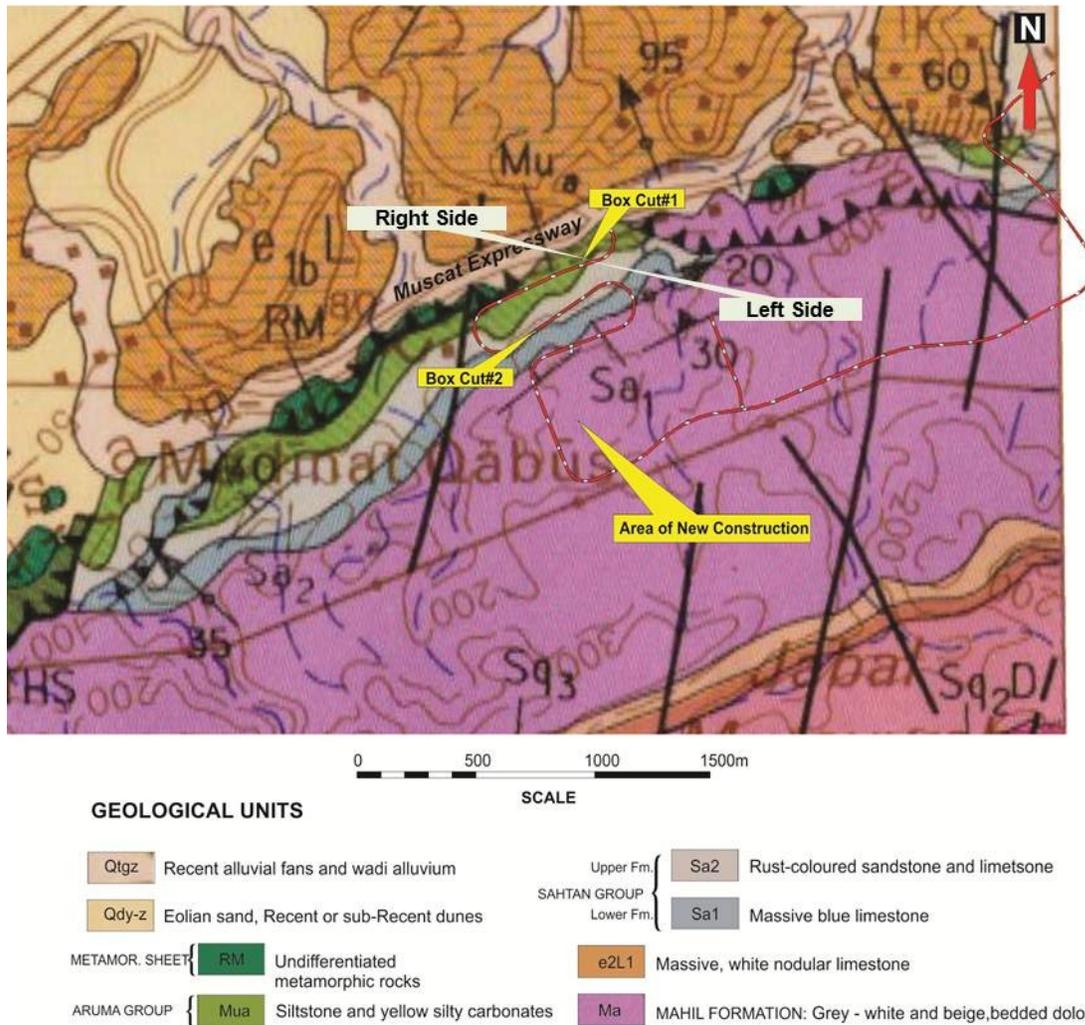
An extract of the Sib area geological sheet is shown in Figure 3. It illustrates the geology of Box Cut #1, which consists of ground making a contact between Aruma Group, and Sa2; the Upper Formation of the Sahtan Group. Box Cut #2 follows the contact between Units Sa2 and Sa1.

It is interpreted that the Lower Formation of the Sahtan Group is exposed in Box Cut #1 and the Upper Formation is exposed partly in box Cut #2. There was a discrepancy between the map and what was observed on the ground, i.e. when the built up landmarks were aligned, the geology did not match exactly and vice versa. This could be due to a shift in datum between the 1986 map and the project grid. What was observed and mapped on the ground was used in design.

Figure 3. Geological map of the project area.

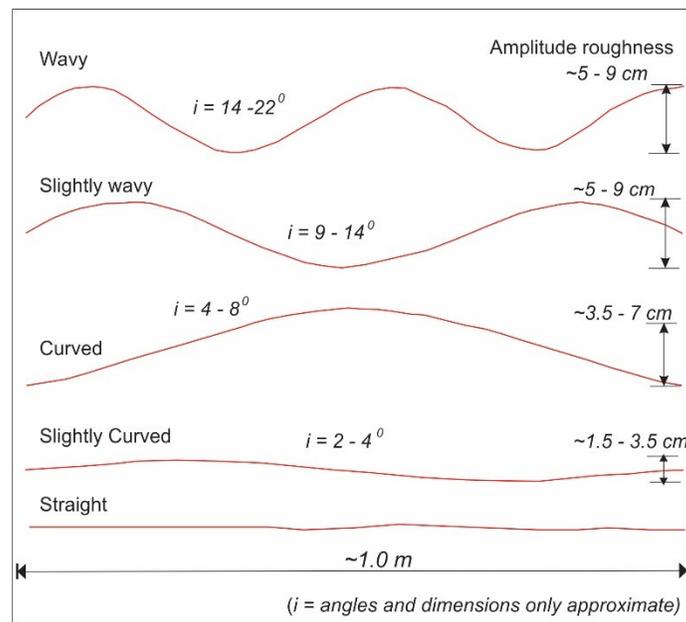
Hack et. al. (2003) reported that the large scale waviness contributed in increasing the friction angle of a discontinuity. Figure 6 shows the approximate addition to the friction angle that should be incorporated in the design for waviness of various amplitudes in the discontinuities over 1 meter length (Hack et. al. 2003). Miller (1988) reported that the waviness angle could be calculated from the observed variation in the dip of any discontinuity in the field.

Figure 6. Large scale roughness profiles.

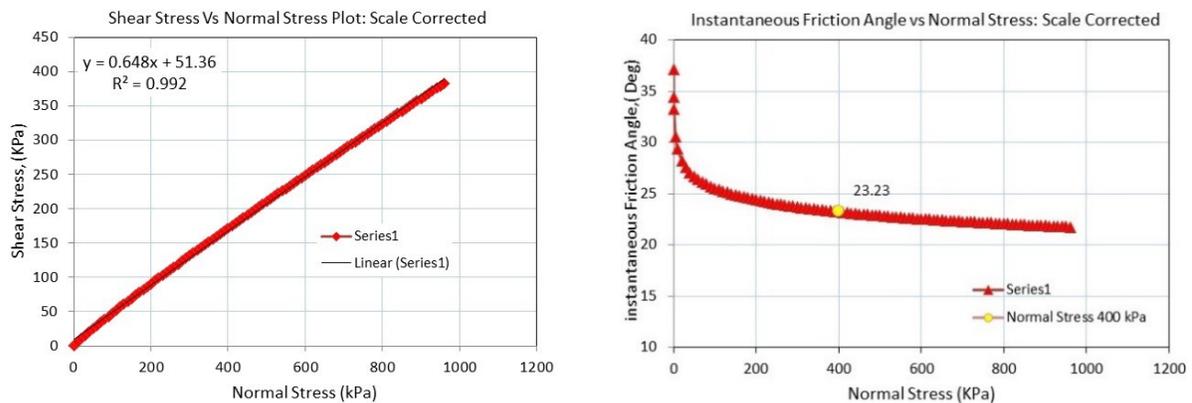
Using Equation 4, σ_n - τ plot was developed for 0 to 1200 kPa normal stress levels as shown in Figure 7. Since, the friction angle is normal stress dependent, the friction angle for any normal stress level was calculated using the relationship given below (Hoek, 2007).

Figure 7 shows the spreadsheet results of ϕ_L at various normal stress levels for deep seated failures.

Figure 7. Friction angle at various stress levels for a deep seated sliding plane.

The average normal stress range was found to be about 400 kPa. Considering this, the corresponding friction angle (ϕ_L) was selected as 23.2° from Figure 7. In addition, based on site observations of intact rock bridges and test results, a cohesion value of 80 kPa was selected for analysis in deep seated failures. Similarly, for small scale failure, the ϕ_L value was calculated as 28° and zero cohesion was assumed in this case.
