# Geotechnical Damage Caused by the 2016 Kumamoto Earthquake, Japan

**ABSTRACT:** On the 16<sup>th</sup> of April 2016, the Kumamoto earthquake ( $M_w$  7.0) hit the Central Kyushu Region, Japan, following a  $M_w$  6.2 shock on the 14<sup>th</sup> of April. The earthquake sequences caused severe damage in Kumamoto Prefecture. This paper presents quick reconnaissance results focusing on geotechnical damage features, which were observed during field investigations immediately after, one, and two weeks after the main shock. The damage surveys were carried out in southern Kumamoto City, Mashiki Town, Aso Caldera area and their suburbs. In southern Kumamoto City, evidence of liquefaction was found at many locations, and some buildings and river levees suffered from significant settlement and deformation; damage to an embankment of Kyushu Highway also seemed to be the result of liquefaction. The majority of the damaged residential houses were found in Mashiki Town and its suburbs, which may be linked to intense earthquake motions associated with the seismic fault location. In Aso Caldera area, a number of moderate to large scale landslides and their significant impact to structures wer

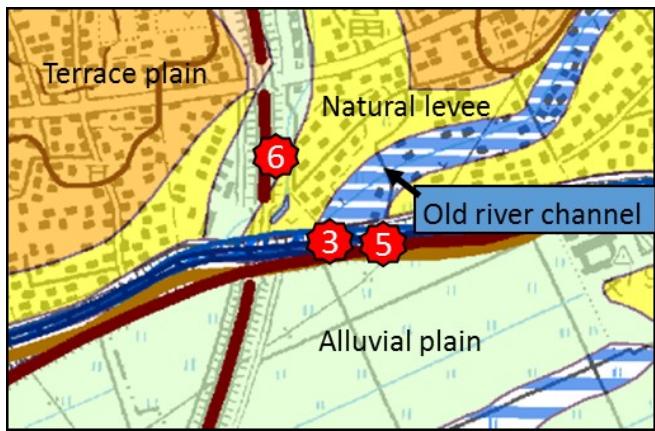
Figure 7. Landform classification map and location of the damaged sites (Modified from GSI's map).

Figure 6 shows the typical liquefaction-induced damage to a river levee (site 3). Large settlement and lateral deformation was found at the levee along Akitsugawa-River. According to a landform classification map for flood control, provided by Geospatial Information Authority of Japan (GSI) shown in Fig. 7, the damaged levee is located at the old river channel, which suggests that a shallow soft deposit liquefied, inducing lateral spreading toward the river. Kyushu Regional Development Bureau of MLIT (2016) reported damage of variable severity to the levees of the Midorikawa-River and Shirakawa-River. They identified a total of 171 sites, however, their emergency restoration was almost completed as of middle of May. The settlement of levees, for example, caused a large gap between the embankment and bridge girders leading to a transportation problem (Figure 8, site 4). As of the end of April, such problems have occurred at many locations, however, they have been temporally solved by the installation of a filled slope (Figure 9, site 5). Although the locations of liquefaction are widespread in Kumamoto City (Wakamatsu et al., 2016), there have been no official report of serious liquefaction-induced damage; there are neither collapse of buildings nor washout of levees due to liquefaction.

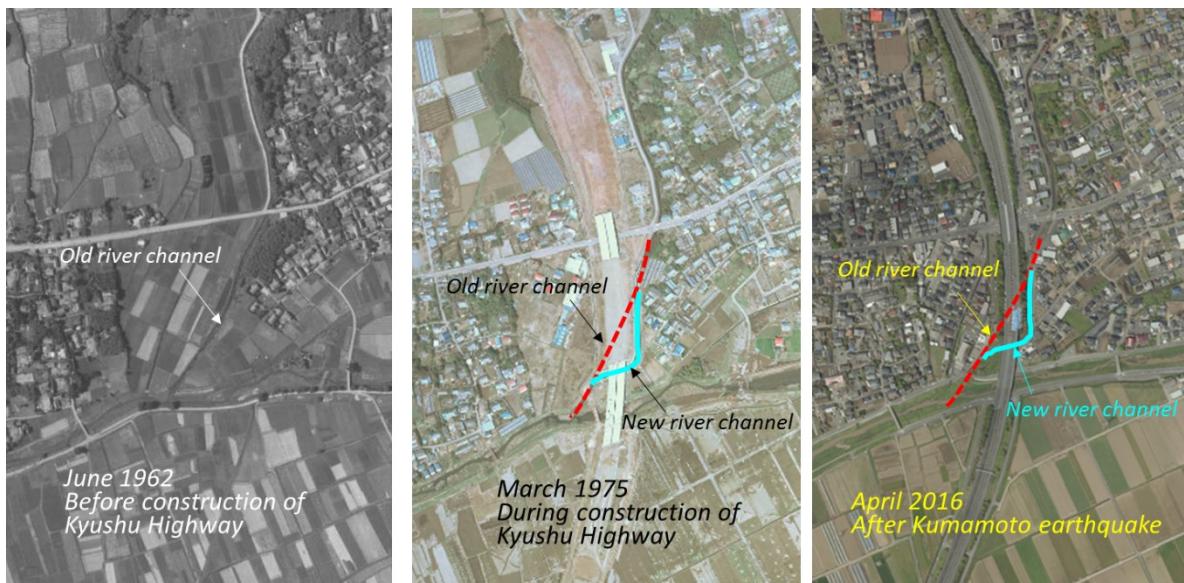
Figure 11. Aerial photo of damaged highway embankment before and after the 2016 Kumamoto earthquake (Modified from GSI aerial photo).

At site 6 in Fig. 3, a 50 m-long embankment on one side of Kyushu Highway, which connects Fukuoka to Kagoshima, suffered from significant damage (Fig. 10). The damage was caused by the earthquake on the 14<sup>th</sup> of April, in the form of subsidence and lateral flow. The highway was closed to traffic until the end of April, which disrupted emergency distributions in the affected areas. According to the land classification map (Fig. 7) and old aerial photos taken before the construction of the highway provided by GSI (2016) (Fig. 11), the exact location of the damaged embankment used to be a small river channel, which suggest that the process of liquefaction of saturated loose filled soil was the potential cause of damage to the embankment. In fact, the residential house near the damaged embankment suffered from large tilting as shown in Figure 10, indicating a bearing capacity lowering of foundation ground due to liquefaction.

Since the other side of the embankment survived the earthquake, as an emergency response, the number of driving lanes at the damaged embankment was temporarily reduced to one in each direction, and only the one-lane reopened from the 29<sup>th</sup> of April. Due to the critical importance of the Kyushu Highway, however, careful investigation shall be conducted to thoroughly understand the cause of the damage observed and to propose effective countermeasures for the conclusive restoration of the embankment.

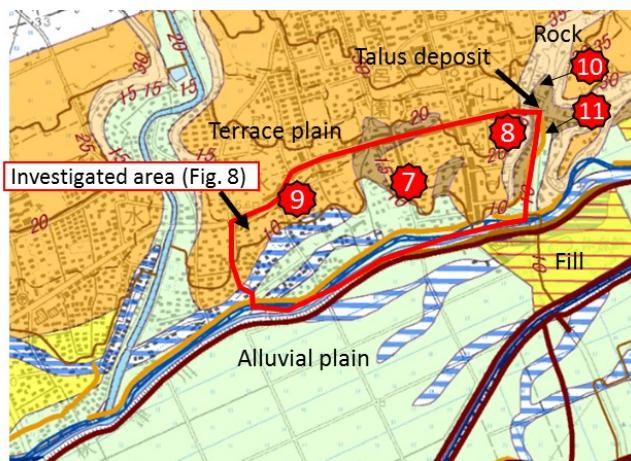
Figure 14. Landform classification map around the survey area in Mashiki Town (Modified from GSI's map, c.f. Fig. 12).

According to the landform classification map in Fig. 14, the significantly damaged area (yellow-colored in Fig. 12) consists of terrace plain (late Pleistocene), talus deposit and alluvial soil. The area is also gently sloping to the south, thus different site amplification effects due to the different soil conditions and residual deformation of sloped ground may be expected. There were some reported cases following recent earthquakes in Japan where residential houses in a developed area of sloping ground suffered from significant damage due to ground deformation associated with a large scale landslide (Mori et al., 2012). A walk-through survey was therefore conducted to understand the effects of ground deformation on the damage to houses in this area.

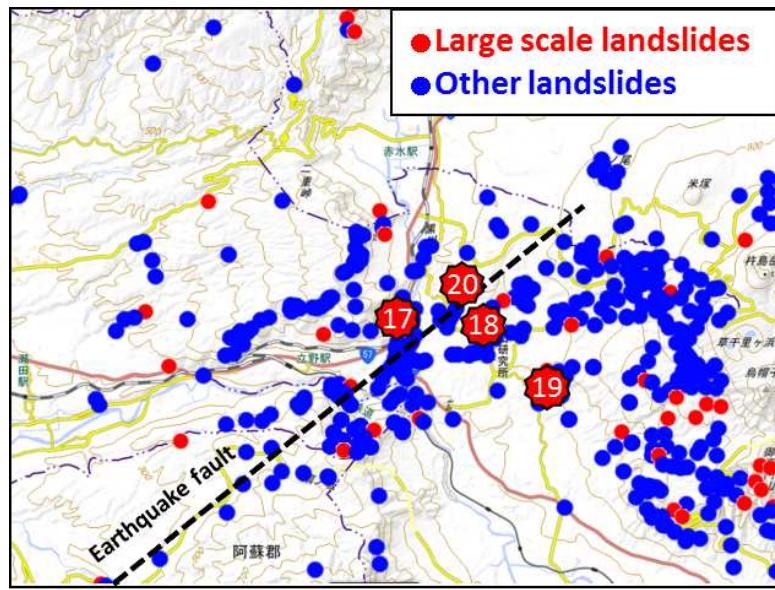
Figure 27. Positional relationship between fault and landslides in and around Aso Caldera area (Modified from landslide map of GSI, 2016).

A large number of natural slopes and road embankments failed in Aso Caldera area. Figure 27 shows the positional relationship between earthquake fault and landslides caused by the Kumamoto earthquake. The landslides in the figure were mapped by GSI (2016), and the data is available on their website. Aerial photos taken before and after the earthquake were used to generate this map. A spatial distribution of earthquake-induced landslides is affected by the fault mechanism (Hasi et al., 2011). The map shows that the landslides are on both sides of the seismic fault. This may be because a strike-slip component was the dominant fault movement of the earthquake.

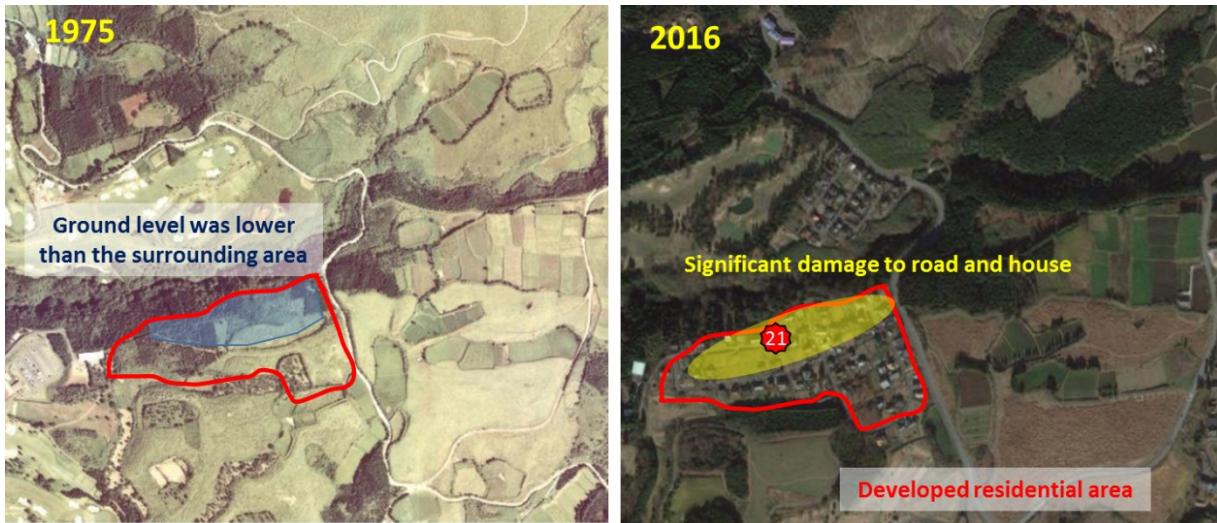
Figure 32 and 33 show damage of the road and house at site 21. Although this area reportedly survived the earthquake on the 14<sup>th</sup> of April, significant distortion of subsurface ground occurred during the main shock on the 16<sup>th</sup> of April. The spatial distribution of damage was severe at the northern part of the residential area. Figure 34 shows a comparison of aerial photos taken in 1975 and in 2016 (GSI, 2016), indicating that the damaged area used to be a paddy field but had subsequently been infilled during the construction of the housing estate. The filled soil in the damaged area is a local volcanic ash soil. Tanoue et al. (2005) reported that it is usually hard to construct a stable embankment from the ash deposited in the Central Kyushu area. It seems from Fig. 34 that the ground level of the northern part of the residential area was comparatively low in 1975, the filled soil might have been thicker for the northern side than the southern side. This might be why the earthquake-induced damage to the land was found to be severe in the northern side, however, structural damage to the residential houses in this area was negligible despite large ground deformation.

Figure 34. Aerial photo of damaged residential area in 1975 and after the 2016 Kumamoto earthquake (Modified from aerial photo of GSI, 2016).

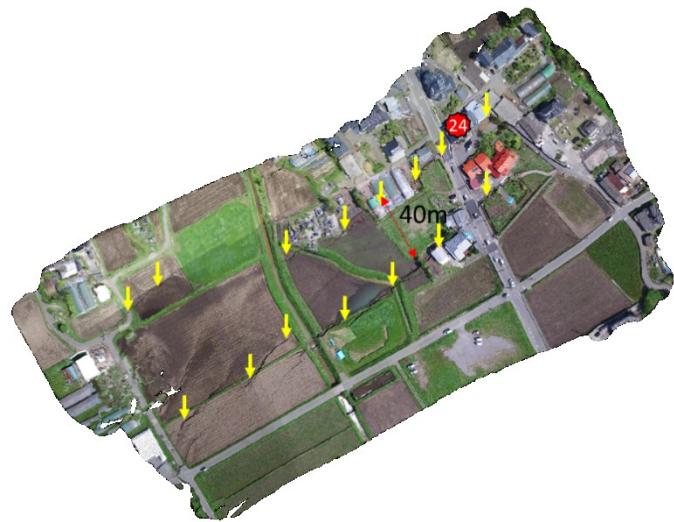
A trough-like depression was found at several locations in the basin of Aso Caldera. According to both the authors' site investigation and aerial photointerpretation of cracks on ground surface provided by the GSI (2016) and Kokusai Kogyo co. ltd (2016), the trough-like depression, with a maximum depth of about 1-1.5 m, was found to stretch several kilometers in length, the width of the depression was several tens of meters. At site 23, the ground depression caused damage to a residential house (Fig. 36). The damage due to the depression has also been harmful to agriculture in this area (Figure 37). The mechanism of the depression, however, is not yet identified. The residents in the affected area reported that the depression occurred immediately when the main shock occurred on the 16<sup>th</sup> of April. The fact indicates that the cause of the depression was probably not liquefaction. Refer to a separate report by Konagai et al. (2016) for further information about this feature.

Figure 37. Digital image obtained by UAV around the trough-like depression area (c.f. Fig. 26).
