Geotechnical Damage Caused by the 2016 Kumamoto Earthquake, Japan

ABSTRACT: On the 16th of April 2016, the Kumamoto earthquake (M_w 7.0) hit the Central Kyushu Region, Japan, following a M_w 6.2 shock on the 14th of April. The earthquake sequences caused severe damage in Kumamoto Prefecture. This paper presents quick reconnaissance results focusing on geotechnical damage features, which were observed during field investigations immediately after, one, and two weeks after the main shock. The damage surveys were carried out in southern Kumamoto City, Mashiki Town, Aso Caldera area and their suburbs. In southern Kumamoto City, evidence of liquefaction was found at many locations, and some buildings and river levees suffered from significant settlement and deformation; damage to an embankment of Kyushu Highway also seemed to be the result of liquefaction. The majority of the damaged residential houses were found in Mashiki Town and its suburbs, which may be linked to intense earthquake motions associated with the seismic fault location. In Aso Caldera area, a number of moderate to large scale landslides and their significant impact to structures were observed. The greater part of land

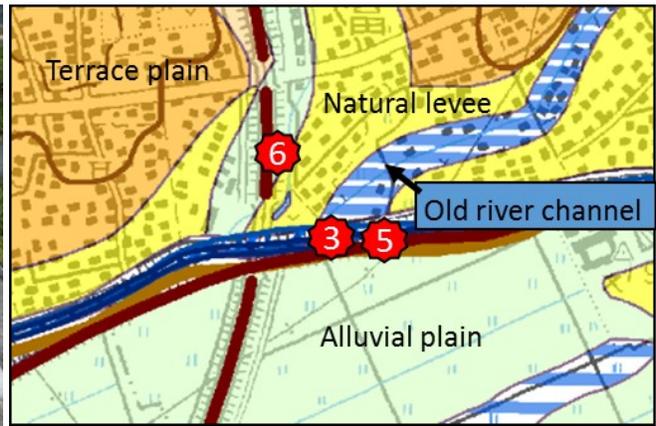
Figure 7. Landform classification map and location of the damaged sites (Modified from GSI's map).

Figure 6 shows the typical liquefaction-induced damage to a river levee (site 3). Large settlement and lateral deformation was found at the levee along Akitsukawa-River. According to a landform classification map for flood control, provided by Geospatial Information Authority of Japan (GSI) shown in Fig. 7, the damaged levee is located at the old river channel, which suggests that a shallow soft deposit liquefied, inducing lateral spreading toward the river. Kyushu Regional Development Bureau of MLIT (2016) reported damage of variable severity to the levees of the Midorikawa-River and Shirakawa-River. They identified a total of 171 sites, however, their emergency restoration was almost completed as of middle of May. The settlement of levees, for example, caused a large gap between the embankment and bridge girders leading to a transportation problem (Figure 8, site 4). As of the end of April, such problems have occurred at many locations, however, they have been temporally solved by the installation of a filled slope (Figure 9, site 5). Although the locations of liquefaction are widespread in Kumamoto City (Wakamatsu et al., 2016), there have been no official report of serious liquefaction-induced damage; there are neither collapse of buildings nor washout of levees due to liquefaction.

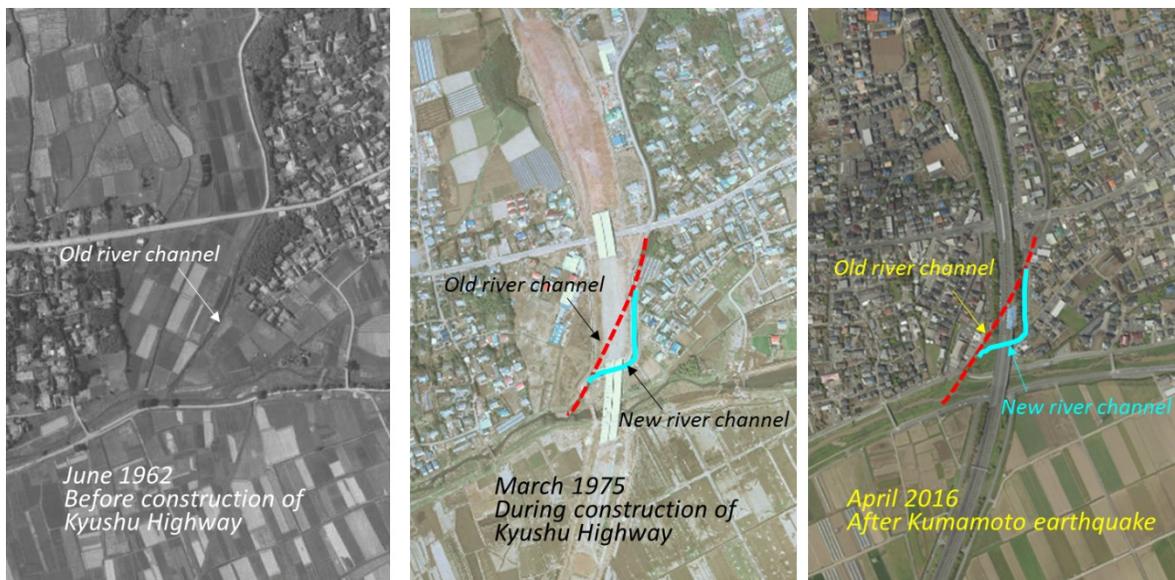
Figure 11. Aerial photo of damaged highway embankment before and after the 2016 Kumamoto earthquake (Modified from GSI aerial photo).

At site 6 in Fig. 3, a 50 m-long embankment on one side of Kyushu Highway, which connects Fukuoka to Kagoshima, suffered from significant damage (Fig. 10). The damage was caused by the earthquake on the 14th of April, in the form of subsidence and lateral flow. The highway was closed to traffic until the end of April, which disrupted emergency distributions in the affected areas. According to the land classification map (Fig. 7) and old aerial photos taken before the construction of the highway provided by GSI (2016) (Fig. 11), the exact location of the damaged embankment used to be a small river channel, which suggests that the process of liquefaction of saturated loose filled soil was the potential cause of damage to the embankment. In fact, the residential house near the damaged embankment suffered from large tilting as shown in Figure 10, indicating a bearing capacity lowering of foundation ground due to liquefaction.

Since the other side of the embankment survived the earthquake, as an emergency response, the number of driving lanes at the damaged embankment was temporarily reduced to one in each direction, and only the one-lane reopened from the 29th of April. Due to the critical importance of the Kyushu Highway, however, careful investigation shall be conducted to thoroughly understand the cause of the damage observed and to propose effective countermeasures for the conclusive restoration of the embankment.

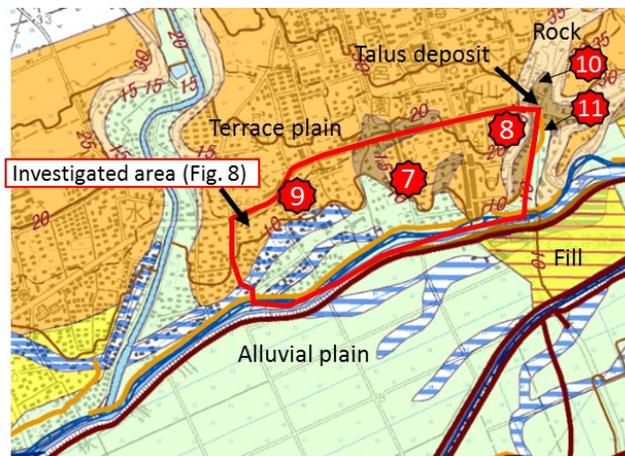
Figure 14. Landform classification map around the survey area in Mashiki Town (Modified from GSI's map, c.f. Fig. 12).

According to the landform classification map in Fig. 14, the significantly damaged area (yellow-colored in Fig. 12) consists of terrace plain (late Pleistocene), talus deposit and alluvial soil. The area is also gently sloping to the south, thus different site amplification effects due to the different soil conditions and residual deformation of sloped ground may be expected. There were some reported cases following recent earthquakes in Japan where residential houses in a developed area of sloping ground suffered from significant damage due to ground deformation associated with a large scale landslide (Mori et al., 2012). A walk-through survey was therefore conducted to understand the effects of ground deformation on the damage to houses in this area.

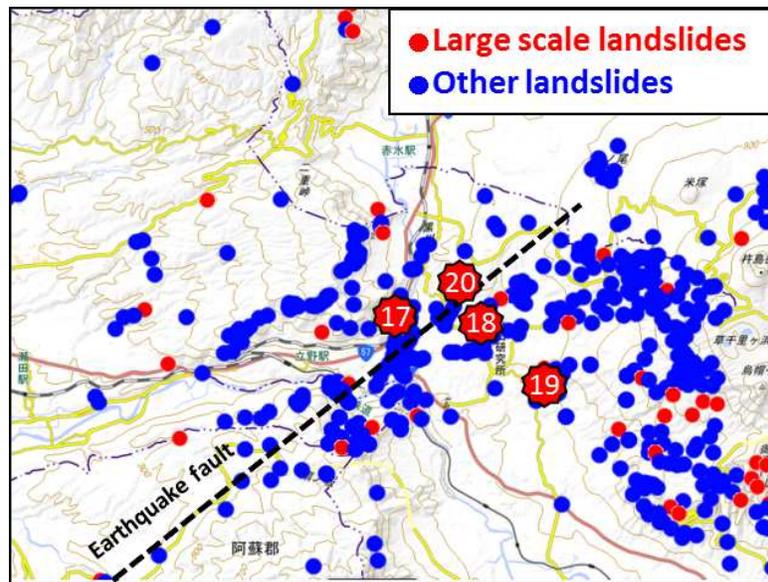
Figure 27. Positional relationship between fault and landslides in and around Aso Caldera area (Modified from landslide map of GSI, 2016).

A large number of natural slopes and road embankments failed in Aso Caldera area. Figure 27 shows the positional relationship between earthquake fault and landslides caused by the Kumamoto earthquake. The landslides in the figure were mapped by GSI (2016), and the data is available on their website. Aerial photos taken before and after the earthquake were used to generate this map. A spatial distribution of earthquake-induced landslides is affected by the fault mechanism (Hasi et al., 2011). The map shows that the landslides are on both sides of the seismic fault. This may be because a strike-slip component was the dominant fault movement of the earthquake.

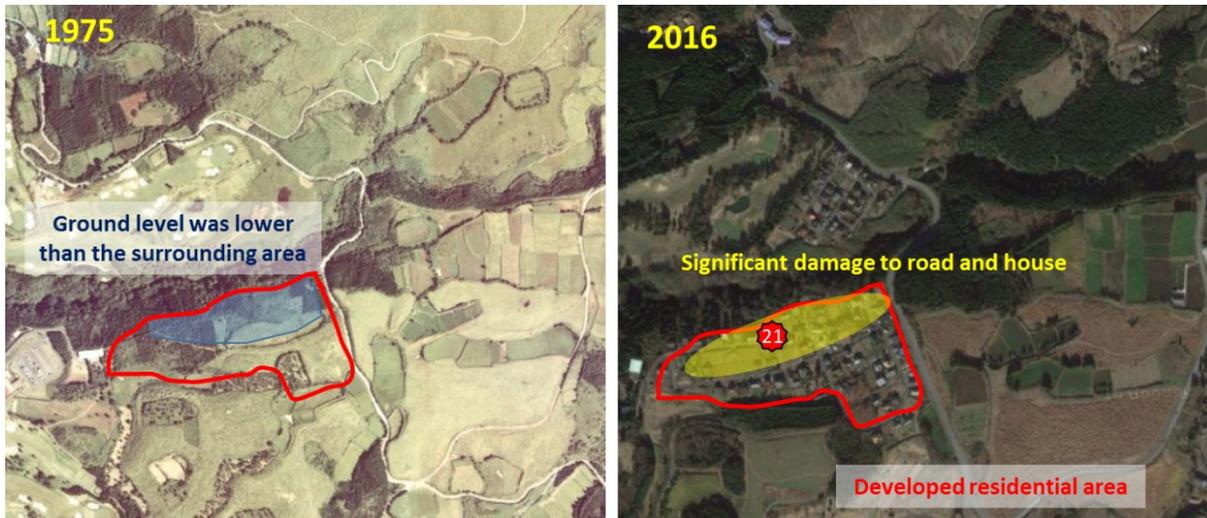
Figure 34. Aerial photo of damaged residential area in 1975 and after the 2016 Kumamoto earthquake (Modified from aerial photo of GSI, 2016).

Figure 32 and 33 show damage of the road and house at site 21. Although this area reportedly survived the earthquake on the 14th of April, significant distortion of subsurface ground occurred during the main shock on the 16th of April. The spatial distribution of damage was severe at the northern part of the residential area. Figure 34 shows a comparison of aerial photos taken in 1975 and in 2016 (GSI, 2016), indicating that the damaged area used to be a paddy field but had subsequently been infilled during the construction of the housing estate. The filled soil in the damaged area is a local volcanic ash soil. Tanoue et al. (2005) reported that it is usually hard to construct a stable embankment from the ash deposited in the Central Kyushu area. It seems from Fig. 34 that the ground level of the northern part of the residential area was comparatively low in 1975, the filled soil might have been thicker for the northern side than the southern side. This might be why the earthquake-induced damage to the land was found to be severe in the northern side, however, structural damage to the residential houses in this area was negligible despite large ground deformation.

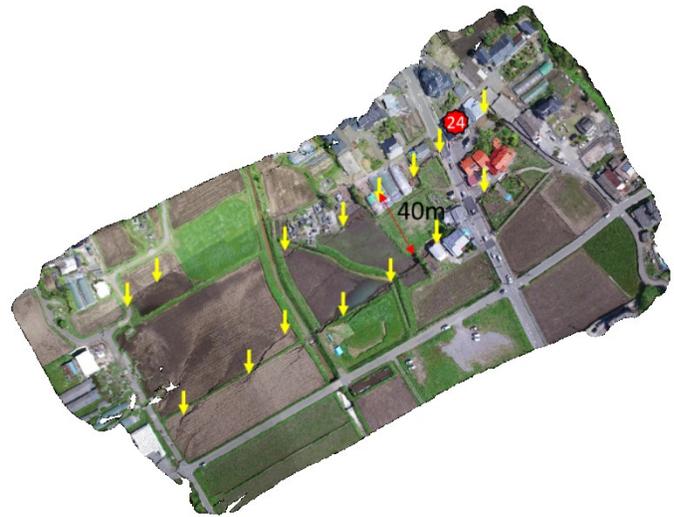
Figure 37. Digital image obtained by UAV around the trough-like depression area (c.f. Fig. 26).

A trough-like depression was found at several locations in the basin of Aso Caldera. According to both the authors' site investigation and aerial photointerpretation of cracks on ground surface provided by the GSI (2016) and Kokusai Kogyo co. Ltd (2016), the trough-like depression, with a maximum depth of about 1-1.5 m, was found to stretch several kilometers in length, the width of the depression was several tens of meters. At site 23, the ground depression caused damage to a residential house (Fig. 36). The damage due to the depression has also been harmful to agriculture in this area (Figure 37). The mechanism of the depression, however, is not yet identified. The residents in the affected area reported that the depression occurred immediately when the main shock occurred on the 16th of April. The fact indicates that the cause of the depression was probably not liquefaction. Refer to a separate report by Konagai et al. (2016) for further information about this feature.
