# Geotechnical Damage Caused by the 2016 Kumamoto Earthquake, Japan

Reference: Kiyota, T., Ikeda, T., Konagai, K. and Shiga, M. (2017). *Geotechnical Damage Caused by the 2016 Kumamoto Earthquake, Japan*. International Journal of Geoengineering Case histories, <http://casehistories.geoengineer.org>, Vol.4, Issue 2, p.78-95. doi: 10.4417/IJGCH-04-02-01

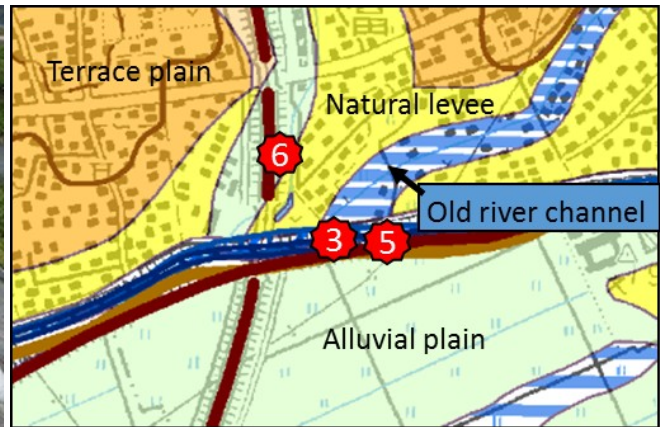
Figure 7. Landform classification map and location of the damaged sites (Modified from GSI's map).

Figure 6 shows the typical liquefaction-induced damage to a river levee (site 3). Large settlement and lateral deformation was found at the levee along Akitsukawa-River. According to a landform classification map for flood control, provided by Geospatial Information Authority of Japan (GSI) shown in Fig. 7, the damaged levee is located at the old river channel, which suggests that a shallow soft deposit liquefied, inducing lateral spreading toward the river. Kyushu Regional Development Bureau of MLIT (2016) reported damage of variable severity to the levees of the Midorikawa-River and Shirakawa-River. They identified a total of 171 sites, however, their emergency restoration was almost completed as of middle of May. The settlement of levees, for example, caused a large gap between the embankment and bridge girders leading to a transportation problem (Figure 8, site 4). As of the end of April, such problems have occurred at many locations, however, they have been temporally solved by the installation of a filled slope (Figure 9, site 5). Although the locations of liquefaction are widespread in Kumamoto City (Wakamatsu et al., 2016), there have been no official report of serious liquefaction-induced damage; there are neither collapse of buildings nor washout of levees due to liquefaction.

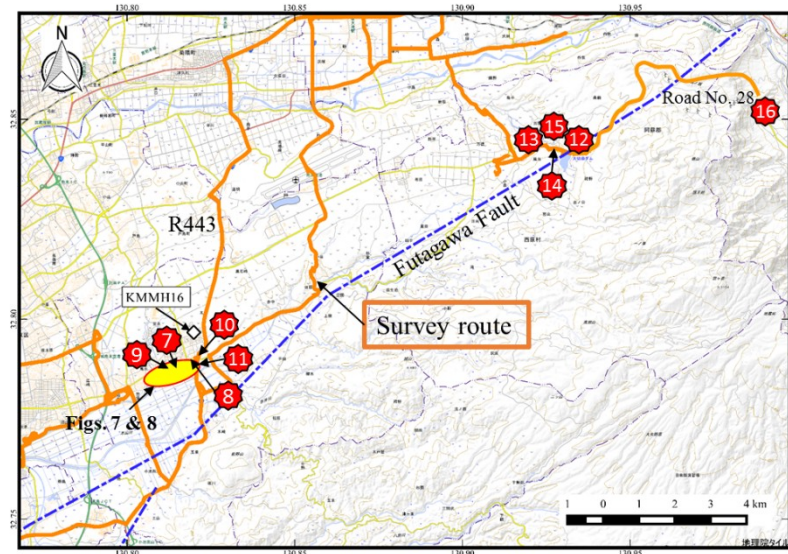
Figure 12. Survey route and locations of investigation sites in Mashiki Town and suburb area.

Figure 12 shows the survey route and the location of investigation sites in this section. Many residential houses in Mashiki Town were devastated, especially the yellow-colored area in the figure, causing about 40% of total death due to the earthquake sequences. Along the Route 443 in Mashiki Town, a section of road (about 100 m in length) built upon embankments was damaged. In addition, a variety of geotechnical and structural damage was observed in some Mashiki suburbs.

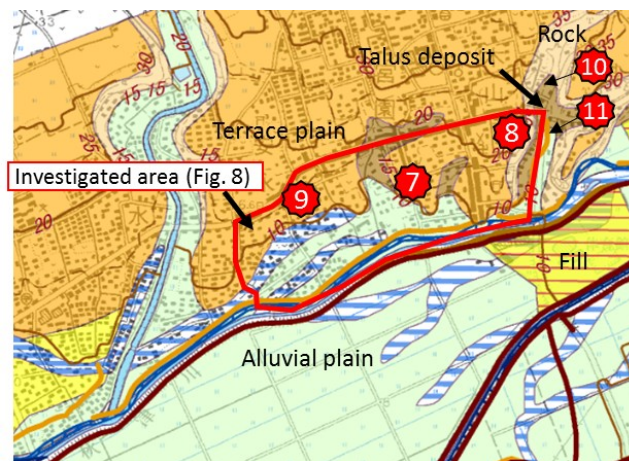
Figure 14. Landform classification map around the survey area in Mashiki Town (Modified from GSI's map, c.f. Fig. 12).

According to the landform classification map in Fig. 14, the significantly damaged area (yellow-colored in Fig. 12) consists of terrace plain (late Pleistocene), talus deposit and alluvial soil. The area is also gently sloping to the south, thus different site amplification effects due to the different soil conditions and residual deformation of sloped ground may be expected. There were some reported cases following recent earthquakes in Japan where residential houses in a developed area of sloping ground suffered from significant damage due to ground deformation associated with a large scale landslide (Mori et al., 2012). A walk-through survey was therefore conducted to understand the effects of ground deformation on the damage to houses in this area.

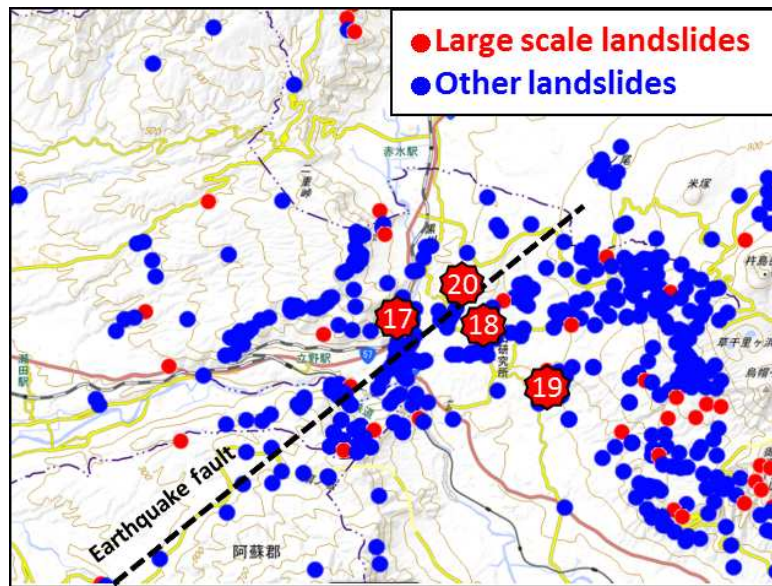
Figure 27. Positional relationship between fault and landslides in and around Aso Caldera area (Modified from landslide map of GSI, 2016).

A large number of natural slopes and road embankments failed in Aso Caldera area. Figure 27 shows the positional relationship between earthquake fault and landslides caused by the Kumamoto earthquake. The landslides in the figure were mapped by GSI (2016), and the data is available on their website. Aerial photos taken before and after the earthquake were used to generate this map. A spatial distribution of earthquake-induced landslides is affected by the fault mechanism (Hasi et al., 2011). The map shows that the landslides are on both sides of the seismic fault. This may be because a strike-slip component was the dominant fault movement of the earthquake.
