Uplift of an Underground Tank in Northern Malabar Region, India

ABSTRACT: *An underground reinforced concrete tank was constructed for a project in the southwest region of India. The tank was 90 m x 35 m in plan and 7.3 m deep resting on partly filled-up and partly native soil. During the peak monsoon, a sudden uplifting of the base slab by about 300 mm and subsequent failure of the foundation raft and a partition wall was observed. Laboratory testing was executed and hydrogeological survey was carried out using ground penetrating radar, seismic refraction and infiltrometer testing, and an analytical study was carried out to identify the root cause of the tank uplifting. Based on this study, it was observed that the uplifting and structural failure was essentially due to the peculiar land terrain and soil properties and the development of excess hydraulic head below the bottom of the tank. After considering different options, the rectification measures were carried out by provision of dewatering wells along the tank periphery to release the excess hydrostatic pressure and stabilize the foundation raft. The structural repair of the top of the foundation raft and partition wall was

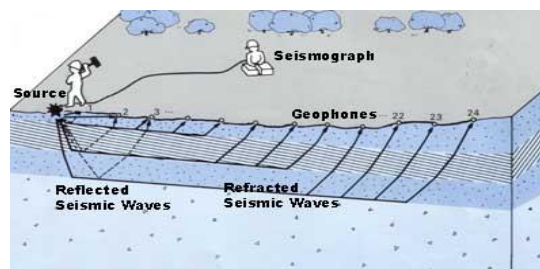
Figure 4. Typical set up for seismic refraction survey.

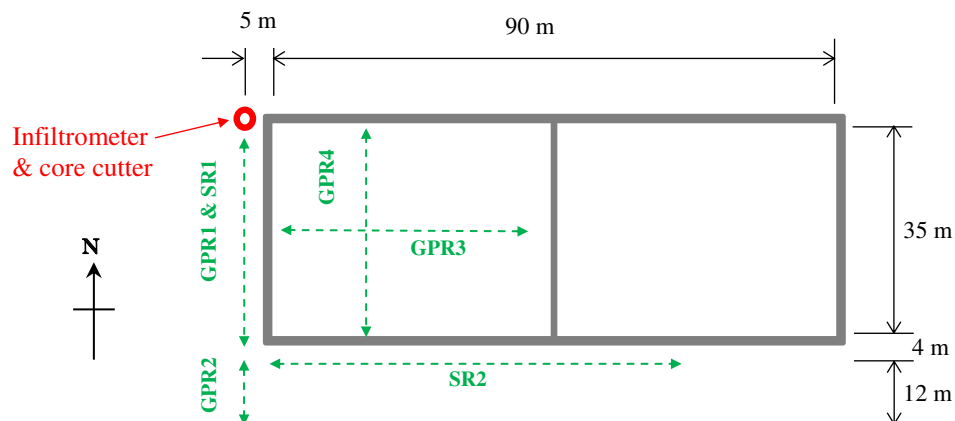
Figure 5. The schematic plan illustrating the location of GPR profiles, seismic refraction (SR) survey profiles and soil samples (see also Table 2).
