Uplift of an Underground Tank in Northern Malabar Region, India

ABSTRACT: An underground reinforced concrete tank was constructed for a project in the southwest region of India. The tank was 90 m x 35 m in plan and 7.3 m deep resting on partly filled-up and partly native soil. During the peak monsoon, a sudden uplifting of the base slab by about 300 mm and subsequent failure of the foundation raft and a partition wall was observed. Laboratory testing was executed and hydrogeological survey was carried out using ground penetrating radar, seismic refraction and infiltrometer testing, and an analytical study was carried out to identify the root cause of the tank uplifting. Based on this study, it was observed that the uplifting and structural failure was essentially due to the peculiar land terrain and soil properties and the development of excess hydraulic head below the bottom of the tank. After considering different options, the rectification measures were carried out by provision of dewatering wells along the tank periphery to release the excess hydrostatic pressure and stabilize the foundation raft. The structural repair of the top of the foundation raft and partition wall was c

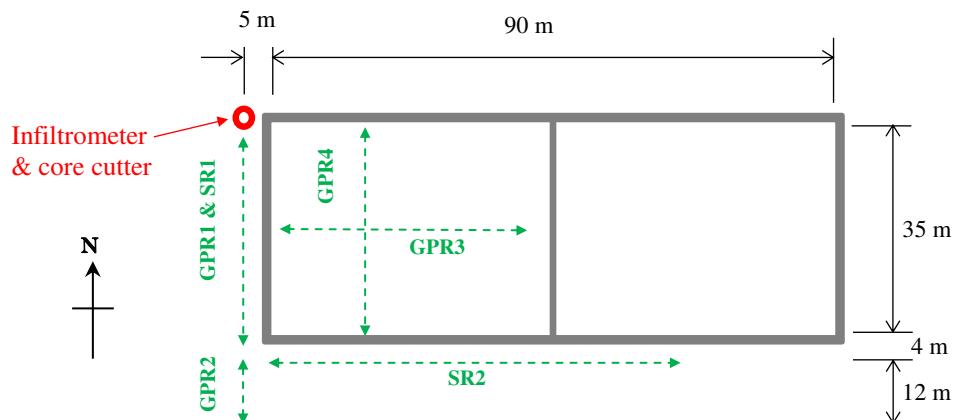
Figure 5. The schematic plan illustrating the location of GPR profiles, seismic refraction (SR) survey profiles and soil samples (see also Table 2).

The investigation was focused on the west and south periphery of the tank, where the ground was submerged. It shall also be noted that historically there was a perennial water well near the southwest corner of the tank which was filled up with soil and boulders during construction. The water from this well was used for household purposes by the local villagers. The concrete slab was also cast on top of this well during construction. The area on north and east of the tank was observed to be relatively dry.

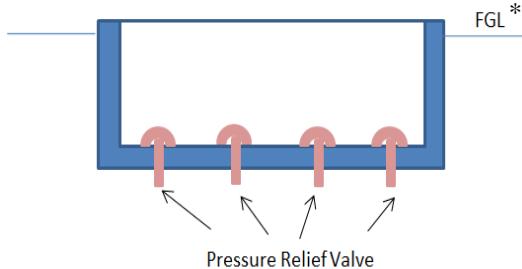
Option 3	NON-RETURN PRESSURE RELIEF VALVES: Provision of non-return pressure relief valves on the bottom slab to release groundwater pressure, by allowing the groundwater to enter the tank through these valves.

There is a chance of groundwater contamination in case of malfunctioning of the non-return valve. This was not acceptable from an operation point of view.
Option 4	DEAD WEIGHT: Provision of dead weight in terms of 1.2 m thick layer of plain cement concrete (PCC) on top of the foundation raft inside the tank. This would increase the dead weight of the tank and would counterbalance the uplifting due to groundwater pressure.

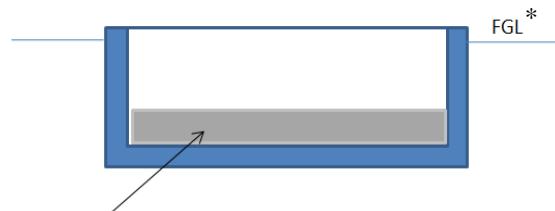
Provision of PCC would also reduce the volume and ultimate capacity of the tank which was not acceptable from an operation point of view. Very high cost involved in this option.
Option 5	GROUND ANCHORS: Provision of ground anchors to hold the tank against uplifting.

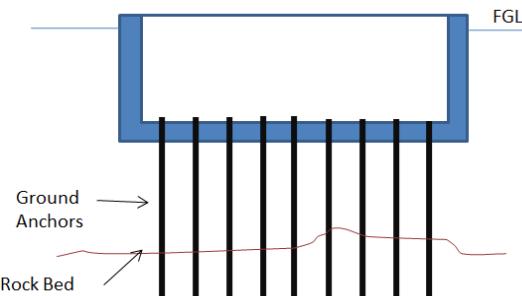
During execution of ground anchors from inside the tank, dewatering of tank is required and has a risk of tank uplifting and cracking after dewatering. Else the groundwater level has to be temporarily lowered during anchoring by means of a well point system. Very high cost involved in this option.
