# Uplift of an Underground Tank in Northern Malabar Region, India

ABSTRACT: An underground reinforced concrete tank was constructed for a project in the southwest region of India. The tank was 90 m x 35 m in plan and 7.3 m deep resting on partly filled-up and partly native soil. During the peak monsoon, a sudden uplifting of the base slab by about 300 mm and subsequent failure of the foundation raft and a partition wall was observed. Laboratory testing was executed and hydrogeological survey was carried out using ground penetrating radar, seismic refraction and infiltrometer testing, and an analytical study was carried out to identify the root cause of the tank uplifting. Based on this study, it was observed that the uplifting and structural failure was essentially due to the peculiar land terrain and soil properties and the development of excess hydraulic head below the bottom of the tank. After considering different options, the rectification measures were carried out by provision of dewatering wells along the tank periphery to release the excess hydrostatic pressure and stabilize the foundation raft. The structural repair of the top of the foundation raft and partition wall was

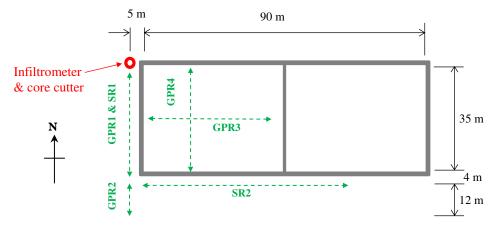
The numbers and tentative locations of GPR, SR tests and other field tests, with respect to the tank location, are indicated in Fig. 5 and Table 2.

Figure 5. The schematic plan illustrating the location of GPR profiles, seismic refraction (SR) survey profiles and soil samples (see also Table 2).
