Lessons Learned from Dike Failures in Recent Decades

ABSTRACT: The paper describes five different dike failures that occurred in recent decades. The case histories were located on different rivers and involved different loading conditions. The observed failure mechanisms involved erosion and stability problems. The types of erosion observed were both internal erosion due to extreme groundwater flow and external erosion caused by the river flow and wave action. The case involving instability was caused by uplift, i.e., increased hydraulic head led to a sharp reduction in maximum shear strength between subsoil layers. Two cases demonstrate the importance of dike management and maintenance. Despite the variations in the loading conditions and failure mechanisms, all the cases show that the strength of a dike depends not only on the material used to build the dike but also on the strength of the subsoil.

Lessons Learned from Dike Failures in Recent Decades. International Journal of Geoengineering Case Histories, Vol.4, Issue 3, p.203-229. doi: 10.4417/IJGCH-04-03-04

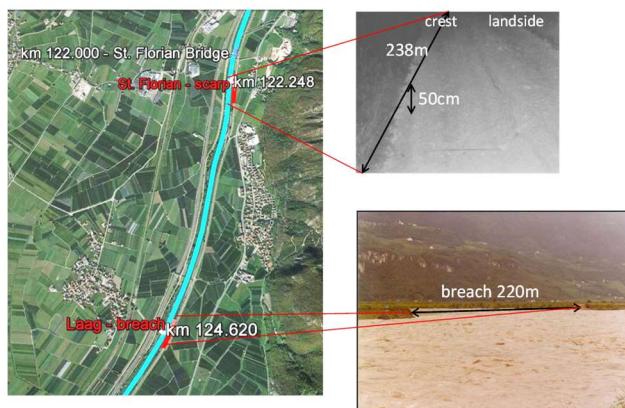
Figure 16. Overview of the two considered segments of the Adige River at Laag and St Florian

The flood event in 1981 led to the collapse of a 220-m-long section of the left flood embankment (chainage 124.450 km to 124.670 km) in Laag (Figure 16). At the same time, a scarp with a differential height of 50 cm was formed on a 238-m-long section in St Florian (chainage 122.150 km to 122.390 km), as shown in Figure 16.

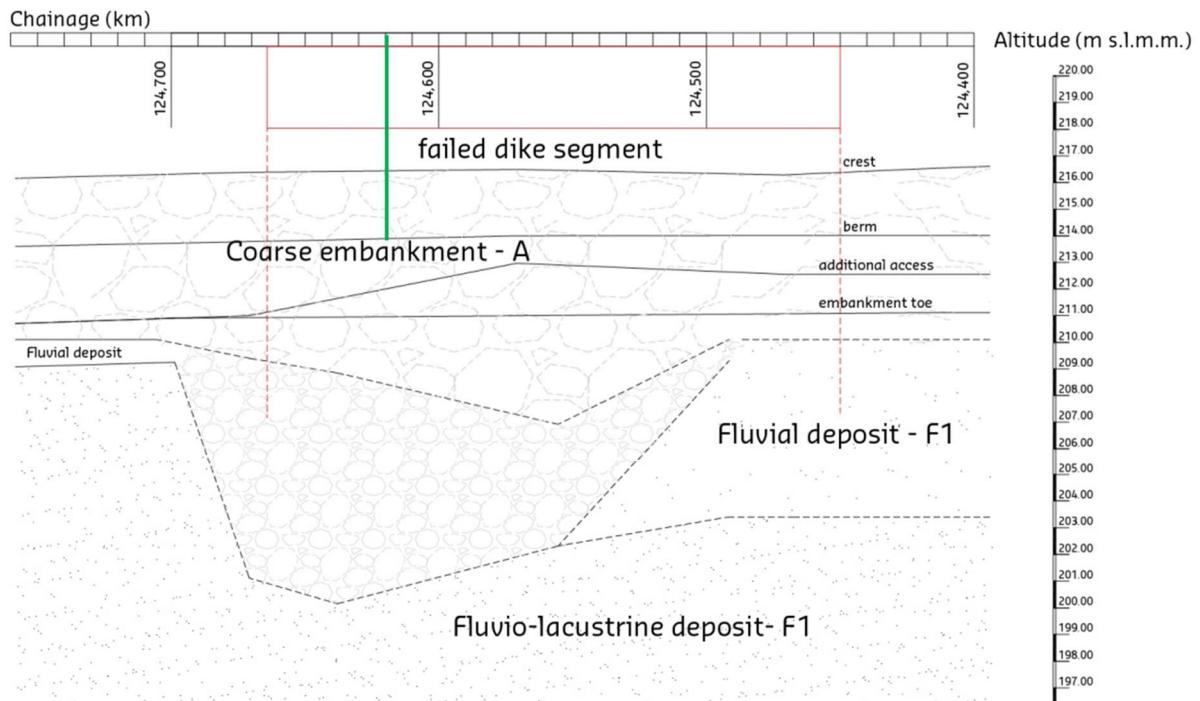
Figure 20. Longitudinal soil profile of the dike segment in Laag that includes the section breached in 1981. The location of the representative cross-section is indicated by the green line.

Figure 20 shows the longitudinal soil profile that includes the segment of the dike in Laag breached in 1981 and then reconstructed after 1981. The dip in the interface between the coarse-grained embankment and the ancient river bed is attributable to the excavation of the ancient river bed material after the dike was breached. During the flood, the embankment was patrolled frequently (a few times a day) and no evidence of sand boiling was detected. It is not possible to exclude that

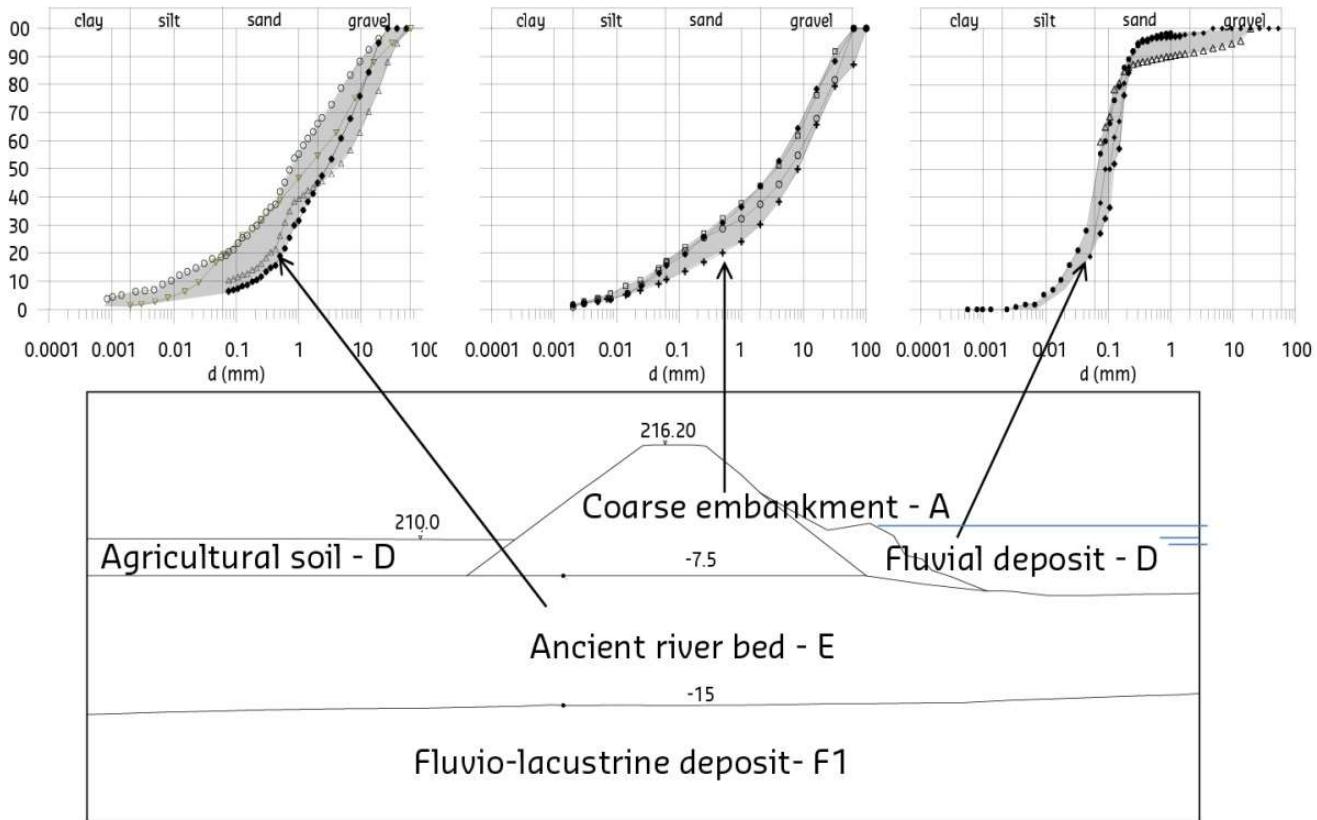
Figure 21. Soil profile for the cross-section representative of the dike segment in Laag breached in 1981 (chainage 124.620 km)

sand boiling was occurring between one visual inspection and another. However, it would appear that failure was mainly caused by underseepage rather than erosion triggered by uplift pressures at the landside toe of the embankment.

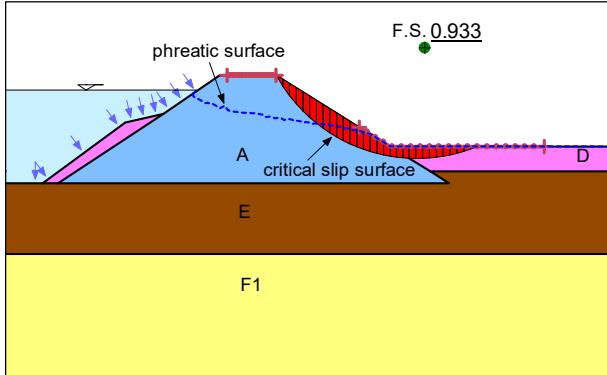
Figure 24. Stability analysis and relevant soil parameters at flood peak and transient flow condition of the section at km 124.62 in Laag; $c' = 0 \text{ kN/m}^2$

where σ_n is the normal stress, ϑ_w is the volumetric water content, ϑ_s is the saturated volumetric water content and ϑ_r is the residual volumetric water content. The results of the stability analyses at flood peak for the two cross-sections based on transient flow conditions are shown in Figures 24 and 25. The stability analysis consistently returns factors of safety < 1 for these sections, which proved to be unstable in 1981.

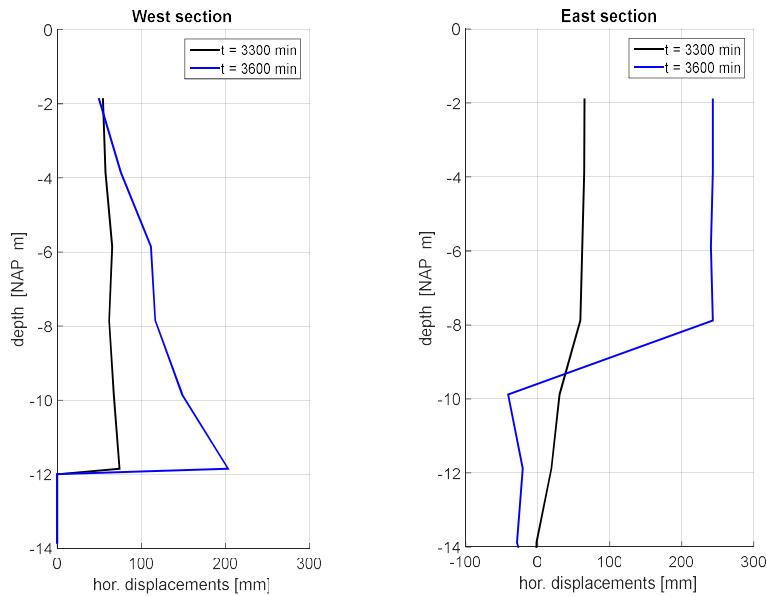
Figure 33 shows the horizontal displacements measured at the toe in the eastern and western sections at $t = 3300$ min (55 h) and $t = 3600$ min (60 hours). Note that there was no inclinometer in the central section. The maximum displacement was found at the transition between the Pleistocene and Holocene layers, which was not at the same depth in both sections. Figure 34 shows the development of the maximum displacement for both sections. In the western section, horizontal displacements started to develop as soon as infiltration began. At approximately $t = 1500$ min, infiltration was suspended temporarily and no further deformation was observed until $t = 2500$ min, when infiltration resumed. Soon after, horizontal displacement developed in the eastern section as well. Infiltration was suspended for a second time, and horizontal displacement stopped again. Soon after infiltration resumed, displacement accelerated until the dike failed at $t = 3450$ min (57.5 hours) after the start of the test.

Figure 33. Horizontal displacement at the toe (both polder-side west respectively east of the central section as shown in Figure 27a)

Figure 33 shows that horizontal displacement in the western section was initially higher than in the eastern section. This corresponds well to the lower μ -value found for the west section, indicating that uplift was reached at an early stage of the test in the western section. The dike was seen to fail when the μ -value reached the lowest level during the test in the central section, $\mu = 1.01$, and eastern section, $\mu = 1.05$.

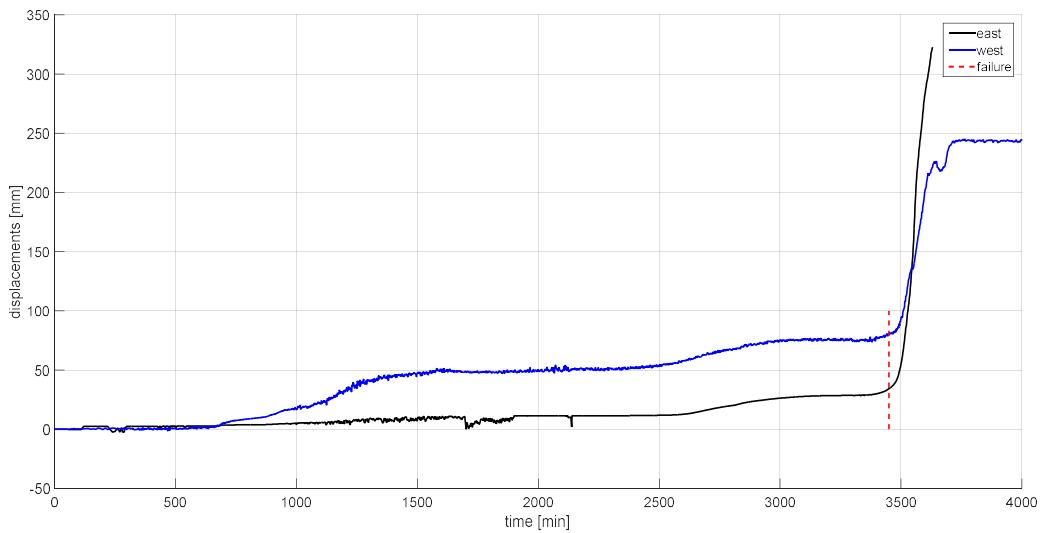
Figure 34. Development of maximum horizontal displacement during the test

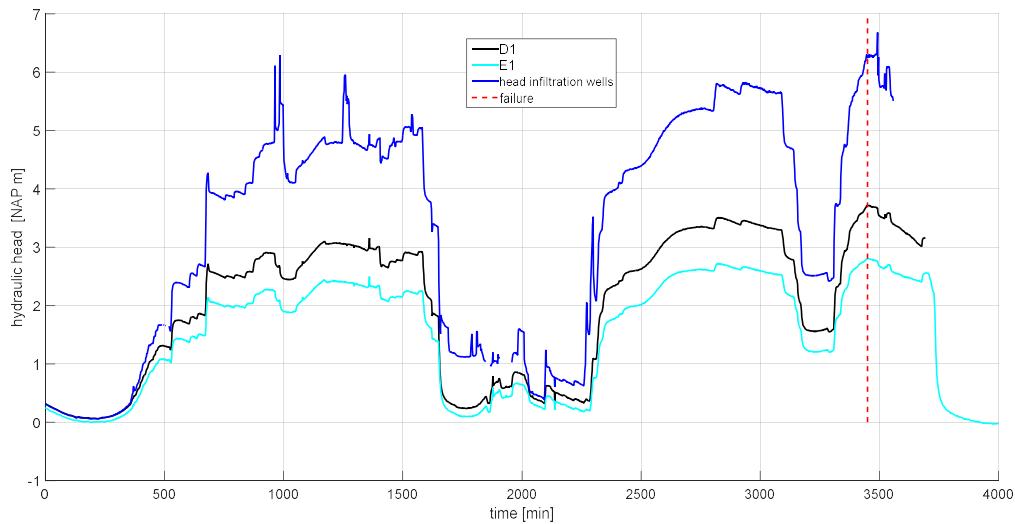
Figure 35. Hydraulic head in Pleistocene sand layer, locations D1 and E1 (see Figure 29)

Figure 35 shows the hydraulic head observed in the Pleistocene sand layer at distances of 21 and 42 m from the infiltration wells. The effect of infiltration declined with increasing distance from the well; the hydraulic head at D1 was lower than in the infiltration wells and a further reduction in maximum head was observed in E1.

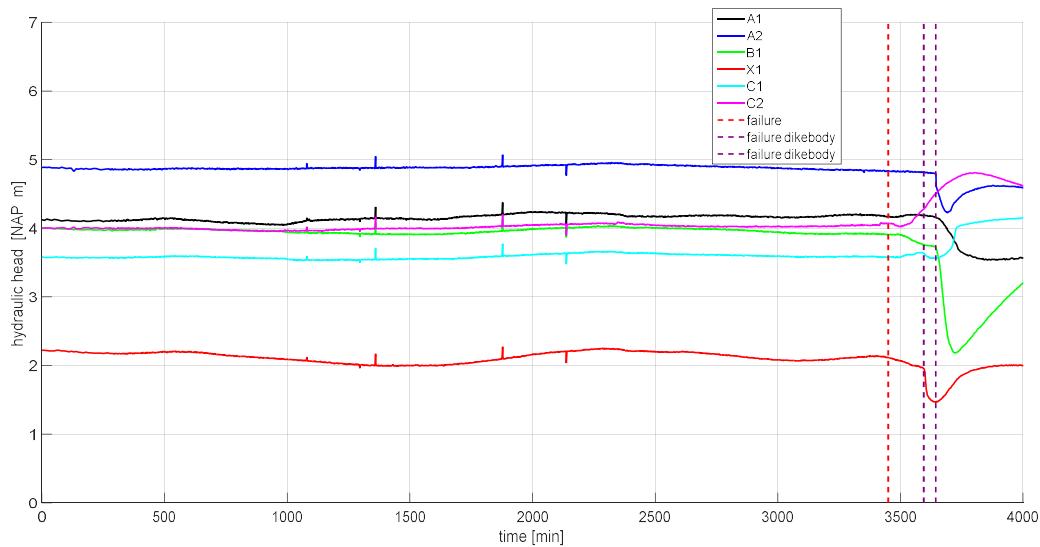
Figure 36 shows how hydraulic head developed inside the dike body. Prior to failure there was no significant fluctuation in hydraulic head. The range in hydraulic heads measured by the different transducers can probably be explained by suction forces at the top of the dike. With the exception of C2, there was a sharp drop indicating failure. Close inspection shows that, inside the dike body, the response to failure was later than given by the observed horizontal displacement at the toe, $t = 3450$ min at which only the pore pressure at location C2 shows a response. There was a minor initial response at B1 and C1 shortly after $t = 3450$ min. The sharp drop in hydraulic head was observed later. The drop at X1 and C1 was observed at $t = 3595$ min, or 145 min (2.4 hours) later. At $t = 3644$ min (50 minutes later) the hydraulic head at B1 and A2 dropped significantly. The time differences for local failure found at different locations shows the propagation of the failure plane, starting deep in the subsoil and moving towards the crest. It should be noted that the development of the failure plane resulted in breakage of the infiltration wells. When infiltration ceased, the uplift conditions were no longer in place and sliding along the slip plane as indicated by Figure 28 stopped.

Figure 36. Hydraulic head in the dike body for locations A1 to C2 (see Figure 29)

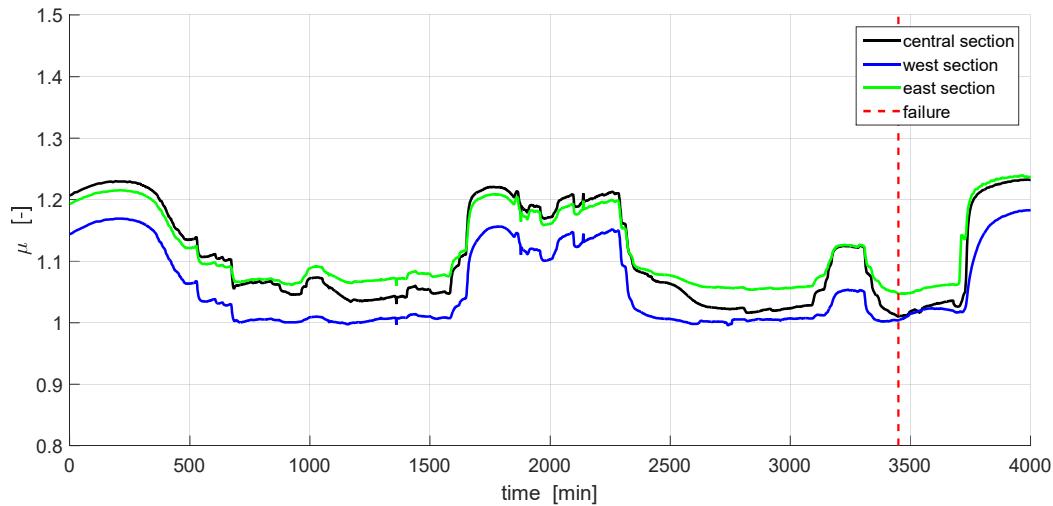
Figure 37. Ratio of total overburden pressure to pore pressure, μ , during the test

To check on the uplift conditions during the test, the ratio, μ , of the weight of the Holocene layer to pore pressure in the Pleistocene sand layer was determined for each of the transducers in the Pleistocene sand layer. Figure 37 shows the ratio, μ , during the test for the transducers placed at 46 m from the crest of the dike in the central, eastern and western sections. Initially, $\mu = 1.2$. When infiltration began, this value reduced, as expected. Due to differences in the subsoil layer, μ varied for the different sections, with the lowest value in the western section, where the value remained approximately 1. In the central and eastern sections, μ seemed to reduce slightly during the test. This corresponds to the slight increase in infiltration pressure during the test, as shown in Figure 35. The value did not drop significantly below 1.0. This could be explained by the pumping capacity, which does not allow for any further increase in pore pressure in the sand layer at the toe of the dike. It can also be hypothesized that when the pore pressure in the sand layer starts to exceed the weight of the clay and peat layers above it, a gap is created which is filled with pore water from the sand layer until a new equilibrium is attained. When pumping capacity is further increased, the gap may be widened, maintaining the equilibrium in vertical forces. In this hypothesis, $\mu = 1.0$ could be a physical boundary that will have prevented any further decline in the μ value in the western section during the test. It should be noted that, at larger distances from the dike, the Pleistocene hydraulic head decreased, causing an increase in μ . Close to the dike, μ is affected by the weight of the dike body.

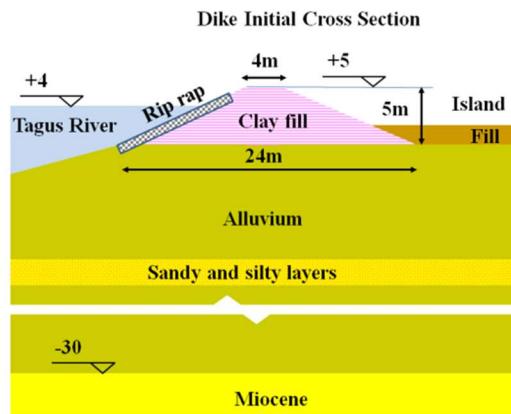
Given the location of the island in the Tagus River delta, one of the widest estuaries in Europe, the geological scenario is very complex: alluvium deposits, mainly very soft clays, with S_u not greater than 20 kPa, sometimes interbedded with silty and sandy layers, with an overall depth of approximately 30 m (Figure 39). The alluvium rests on the bedrock of Miocene sandstone.

The main failure mechanism is related to the erosion of the clay fill due to water inflow and the mechanical action of the waves on the outer face of the dike. Failure originated with the erosion of the riprap revetment (Figure 39). The presence of a permeable sandy layer below the dike foundations also contributed to the failure mechanism. The actual dike failure began during the severe winter of 2015 - 2016 and involved a section with an overall length of approximately 30 m. When the failure occurred, the water level in the Tagus River was approximately Mean Sea Level, MSL, +4.20 m. In October 2016, the overall length of the dike failure line had increased to approximately 80 m.

Figure 39. Initial dike cross-section and geotechnical profile.
